STUDY ON THE SURFACE INFILTRATION RATE OF PERMEABLE PAVEMENTS

May 26, 2004

Prepared for:
Interlocking Concrete Pavement Institute

By: Eban Z. Bean, Engineering Intern
William F. Hunt, Ph.D., PE
David A. Bidelsbach, Engineering Intern
Jonathan T. Smith, PE

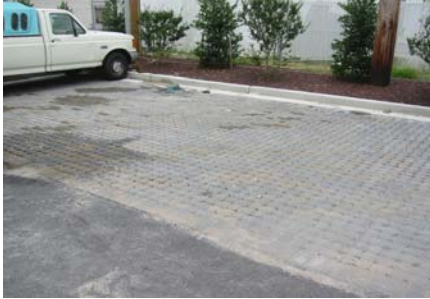
Site 1: Captiva Bay Condos
Type of Surface: Permeable Interlocking Concrete Pavements
Use: Residential Parking

Size (stalls/sq. ft.): 3,360 sq. ft.
Approximate Drainage Area: Equal to permeable area
Construction Date: 2003
Address: 85th St., Ocean City, MD
Test Date: July 29, 2003
Visual Assessment: Condos under construction w/ hay bales around test site.
Maintenance Practice: New

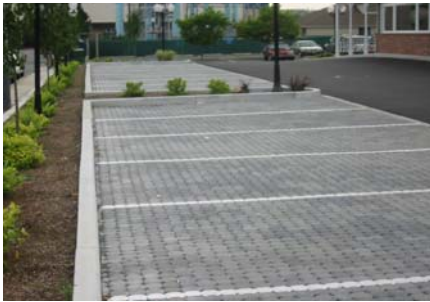
Site 3: Dough Roller's
Type of Surface: Permeable Interlocking Concrete Pavements
Use: Resteraunt parking

Size (stalls/sq. ft.): 6,000 sq. ft.
Approximate Drainage Area: 8,500 sq. ft.
Construction Date: 2003
Address: 41st St. & Coastal Highway, Ocean City, MD
Test Date: July 29, 2003
Visual Assessment: Clean and open pores.
Maintenance Practice: New Site

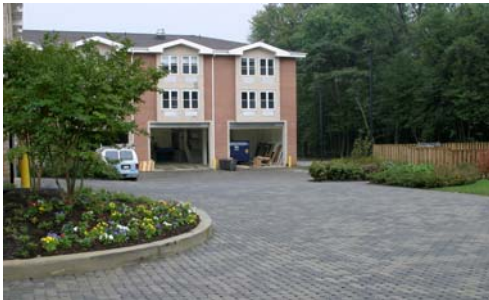
Site 4: Baywoods of Annapolis Assisted Living Center
Type of Surface: Permeable Interlocking Concrete Pavements
Use: Parking and drive areas of assisted living center

Size (stalls/sq. ft.): 14,000 sf.
Approximate Drainage Area: Permeable area
Construction Date: 2002
Address: Bembe Beach Rd, Annapolis, MD
Test Date: July 28, 2003
Visual Assessment: Looks as though voids are permeable.
Maintenance Practice: None

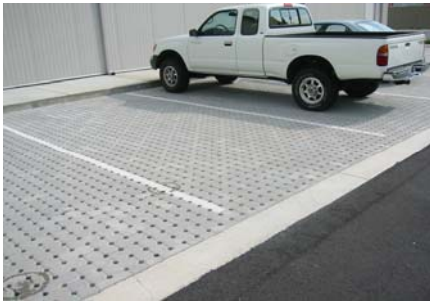
Site 5: Mickey's Pastry Shop
 Type of Surface: Permeable Interlocking Concrete Pavements
 Use: Public parking for bakery

Size (stalls/sq. ft.): 30
 Approximate Drainage Area: Equal
 Construction Date: 2001
 Address: 2704 Graves Dr., Goldsboro, NC
 Test Date: July 22, 2003
 Visual Assessment: Looks very clean with minimal debris in voids.
 Maintenance Practice: None

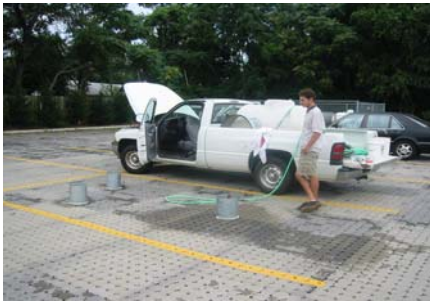
Site 6: Wal-Mart
 Type of Surface: Permeable Interlocking Concrete Pavements
 Use: Overflow parking

Size (stalls/sq. ft.): 43,000 sq.ft.
 Approximate Drainage Area: Permeable area.
 Construction Date: Summer 2001
 Address: 4493 Highway One, Rehoboth Beach, DE
 Test Date: July 29, 2003
 Visual Assessment: Lot is rarely used. May have underdrain.
 Maintenance Practice: New
