## Bioengineering in Four Mile Run, Virginia

by Jay West, Save Our Streams Program, Izaak Walton League of America, Inc.

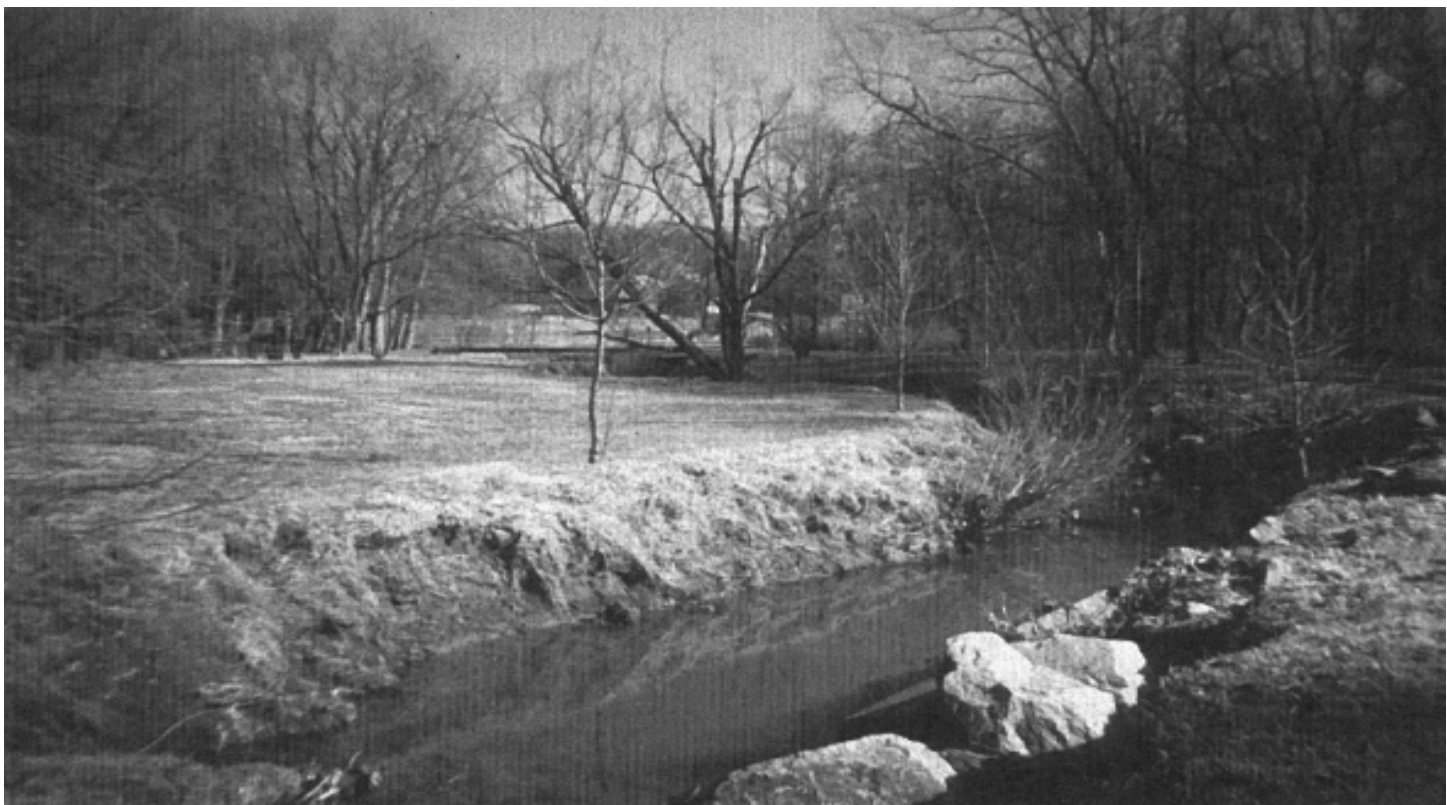
tat are poor. The remaining natural channels exhibit significant bank erosion, with vertical banks ranging from three to eight feet tall.

**Figure 2: Before Restoration, the Site Was Characterized by Actively Sloughing, Vertical Banks**

The project began in February 1994. The concept for bank stabilization was to employ bioengineering on the inside of a shallow bend. (An earlier project had placed rip-rap on the outside of the bend where erosional energy was greatest.) The bioengineering treatment involved regrading the bank to achieve a more gentle slope (2:1 horizontal to vertical.) Two shallow trenches were constructed parallel to the stream on the bank contour (see Figure 3). Fascines or bundles of dormant willows and dogwood were then placed in trenches along the contours of the bank. Each fascine was about seven feet long, with the rooted ends facing upstream.

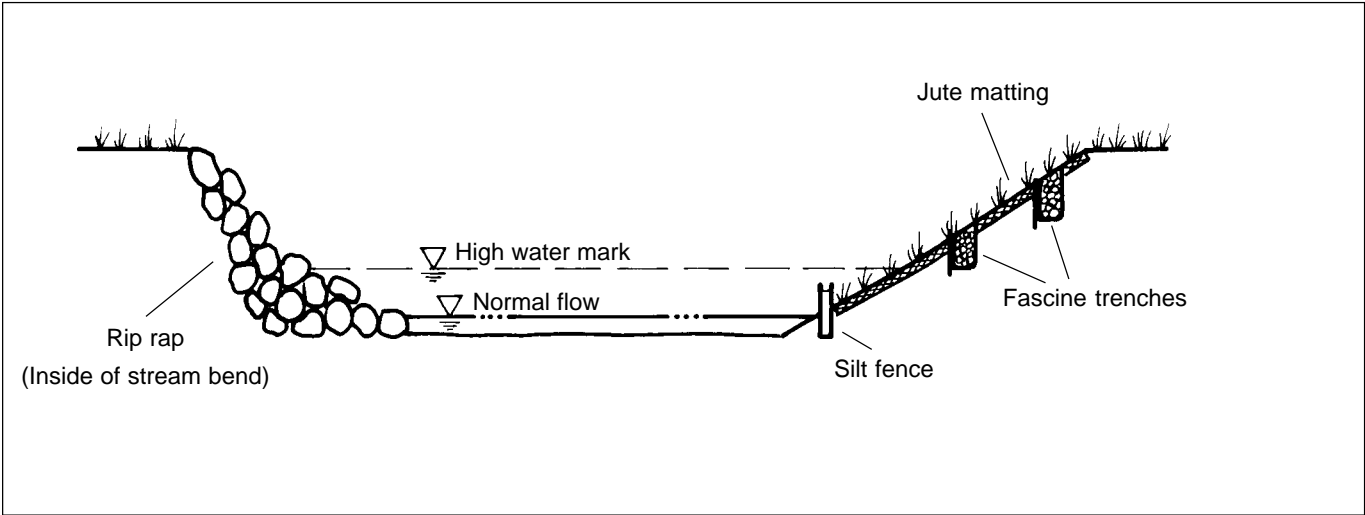
**Figure 3: Bank Stabilization Technique Used at Four Mile Run**

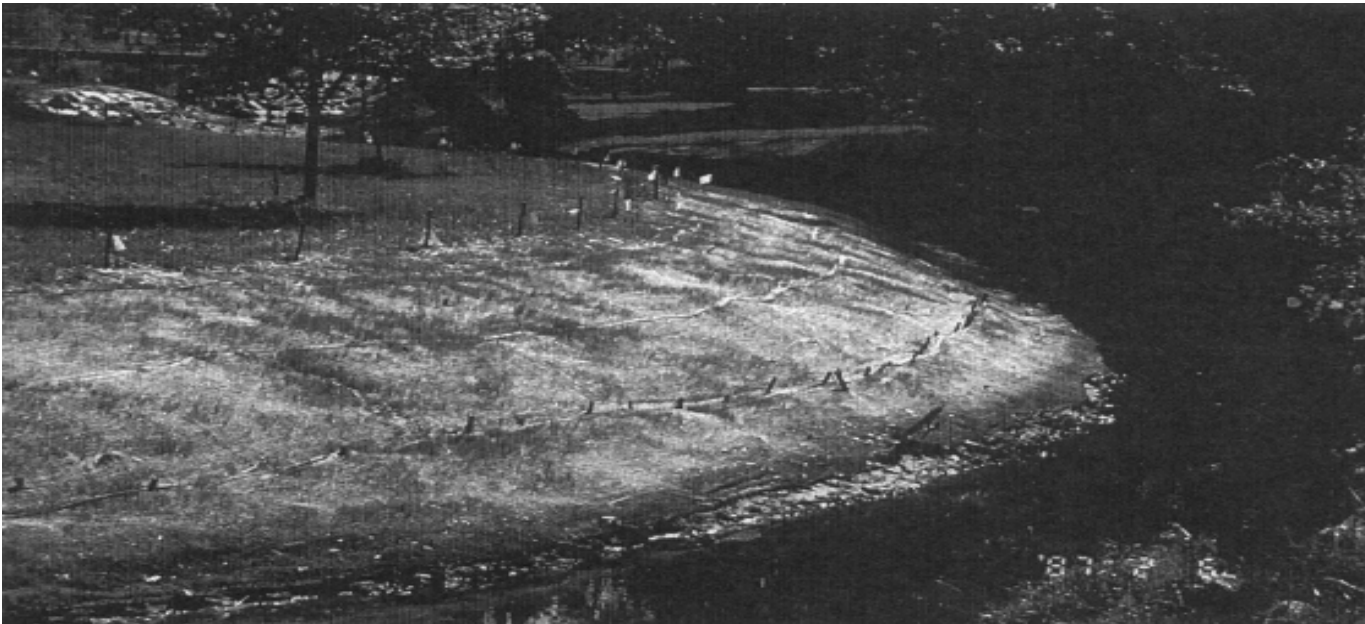
The site has been frequently inspected to see how well it holds up to erosive stormflows. Figure 4.3.4 shows the site two weeks after installation, shortly before the grass had become fully established. Within 10 weeks, the willows and dogwoods had sprouted, and a thin layer of fine silt had been deposited over the erosion control fabric. The growth and sprouting of the fascines was not as great as expected during the growing season, possibly because the fascines were not completely dormant at the time of planting. Overall, plant growth was relatively sparse, and some weeds had invaded the site. After four months, some erosion was reported at the toe of the bank, and the designers considered placing a rip-rap layer to protect the base of the slope. Inspection during the second growing season has indicated greater sprouting success for the willows and dogwoods.

**Figure 4: After Restoration: Two Weeks After Installation of the Plant Materials, Grass Started to Sprout**
