Kilmarnock Watershed Assessment Report

April 2013

**PREPARED FOR:
Town of Kilmarnock, VA**

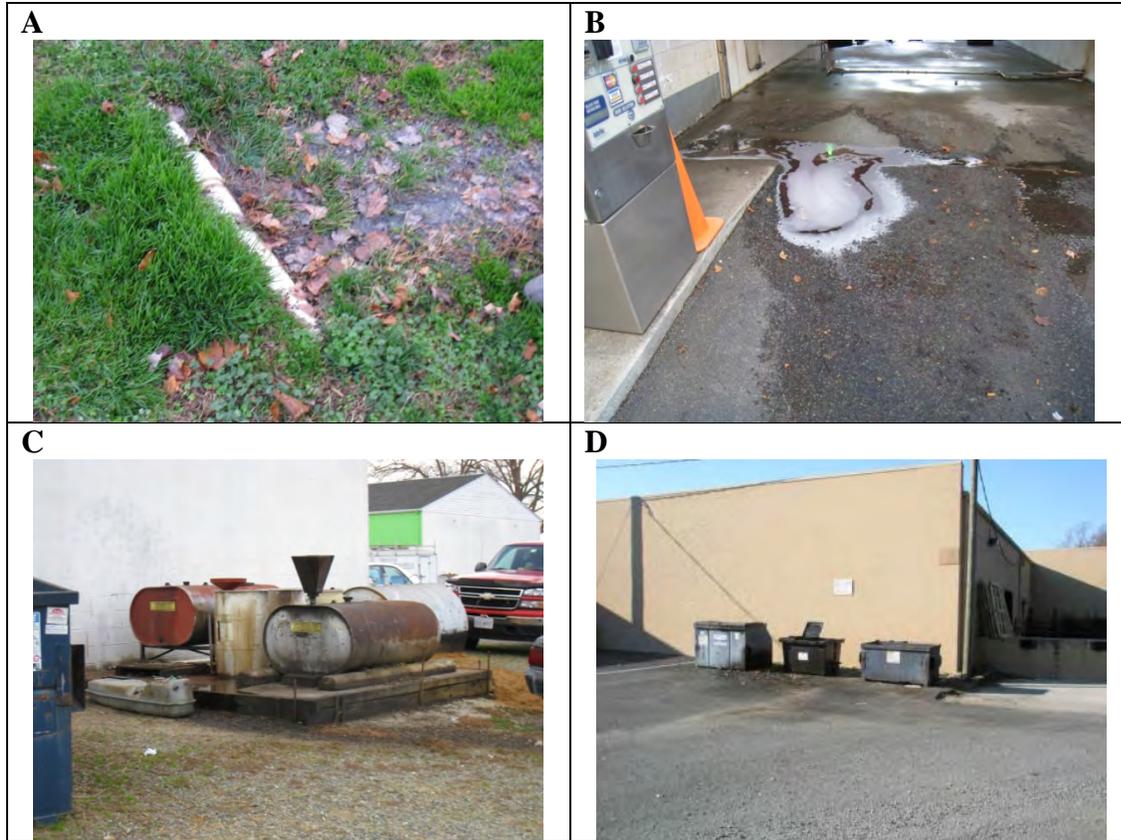
Leaking sewer pipe	<ul style="list-style-type: none"> • Sewer lateral pipe found leaking at ground level • In turn, town staff found and fixed major sewage block in sewer mains caused by grease and trash accumulation 	<ul style="list-style-type: none"> • Conduct systematic illicit discharge outfall investigations to find and fix other sources of untreated sewage to the stream.

Figure 6. Pollution producing behaviors found during the HSI: A. Leaking sewer lateral pipe; B. Car wash soapy water draining to parking lot; C. Fuel oil containers overflowing; D. Grease and trash containers leaking onto pavement.

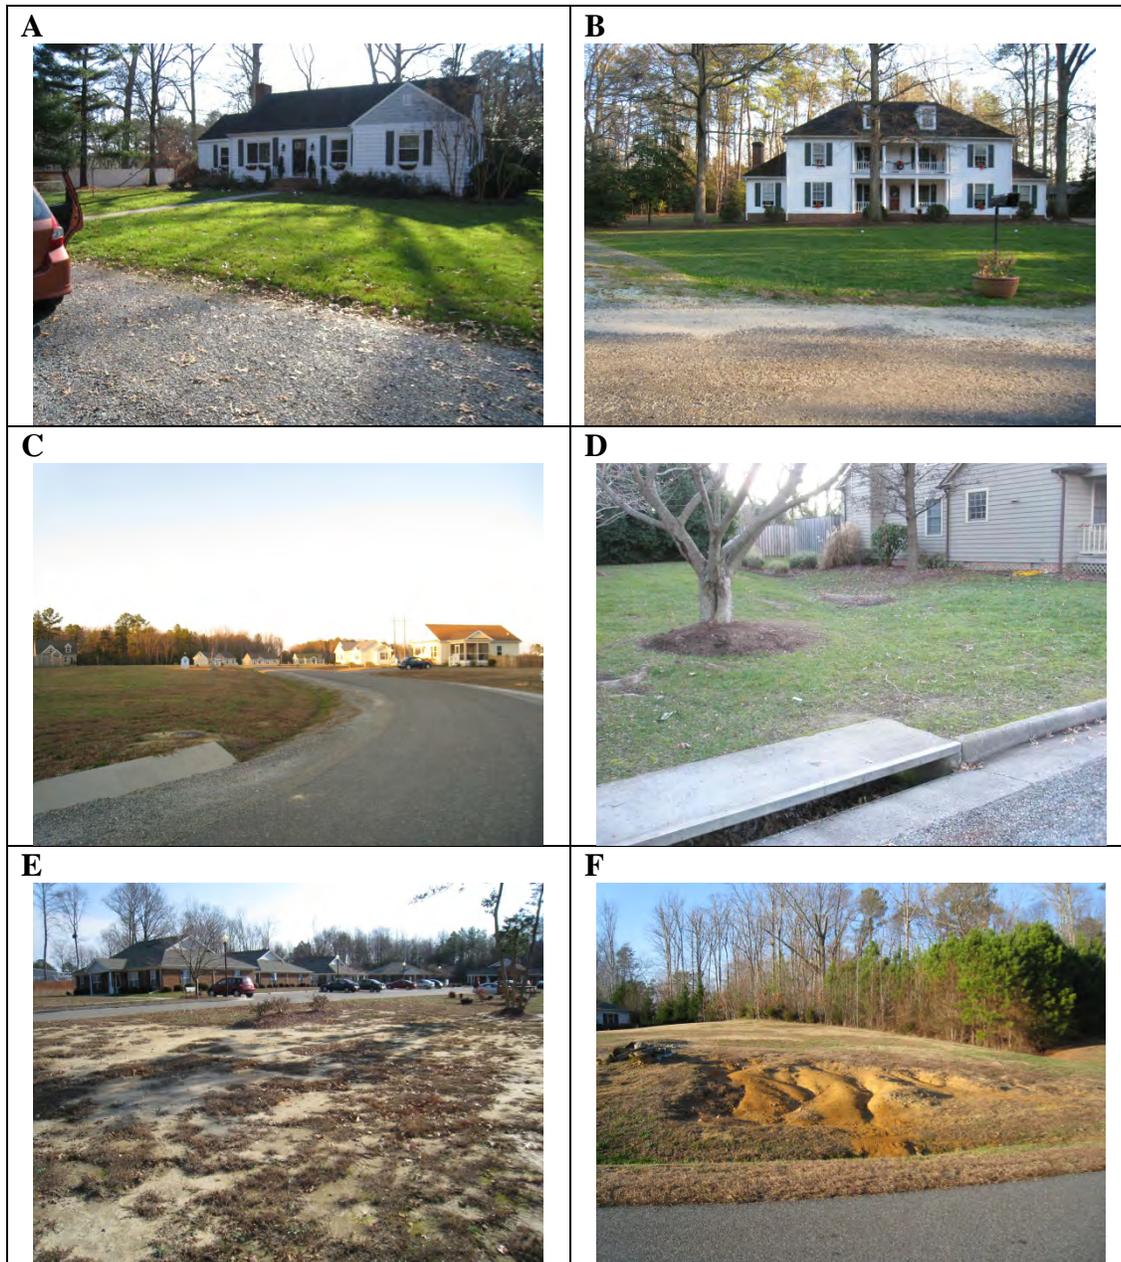
Figure 8. Examples of neighborhood conditions: A & B. Heavy fertilizer use (Sites N-103 & N-111); C. Lack of trees (Site N-121); D. Opportunity for rain garden (Site N-106); E. Establish better topsoil, plant trees and ground cover (Site N-113); F. Control erosion and reduce mowing, plant trees (Site N-112).

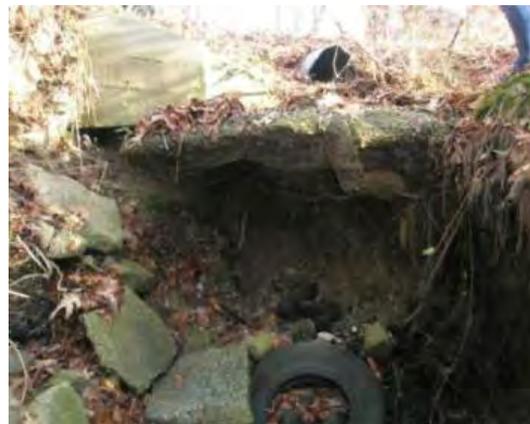
Figure 10. Head cut S-401

The most immediate impact to infrastructure is at the Lancaster Middle School (S-401). The outlet of the storm drainage pipe system that drains the visitor entrance driveway, the entire teacher parking lot, and the bus loop discharges into the adjacent woods southwest of the school building. The pipe outlet is suspended above a scour hole more than 5 feet deep and only 6 feet from the edge of the service drive to the School Street Pump Station (Figure 10). The outlet channel meanders through the wooded area and eventually meets the main stream channel.

The geomorphology of this channel includes a clay layer (blue marl, or marlstone, or other very stable clay-based material) that appears to have stopped the down-cutting of the channel at the elevation of the top of the layer. The channel may continue to erode by widening, but the particular geology of this channel appears to be holding the channel geometry relatively constant. Likewise, the head cut has reached the upstream limit (which has been armored with concrete).

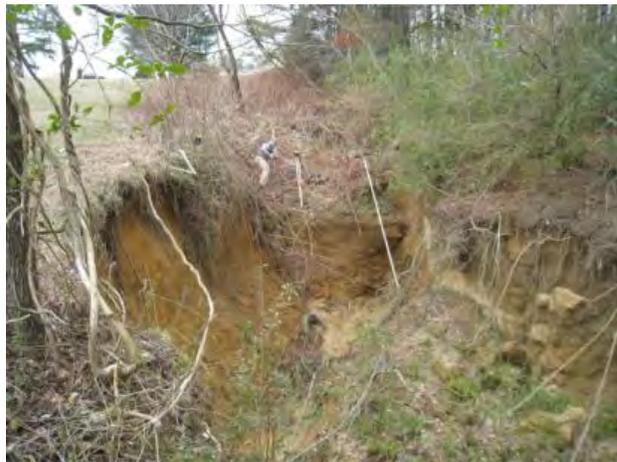
Figure 11: Head cut S-102

The head cut initially appears as a sunken area of grass that quickly drops into a gully (eighteen inches wide, two feet deep) with exposed soil on the sides and bottom. It then drops into a large cavernous channel (top width of 13 feet, bottom width of 6 feet, and approximately 6 feet deep) within a channel length of 50 feet (Figure 11). This eroded gully cross section continues to increase in size with sharp grade drops at intermediate locations as the channel erodes from the upper elevation down to the floodplain. Figure 12 shows a schematic profile of the channel as measured in the field.

The profile of head cut S-102 is consistent with the geomorphologic process of a channel eroding and creating a meander to establish equilibrium between the channel grade and the soil structure.

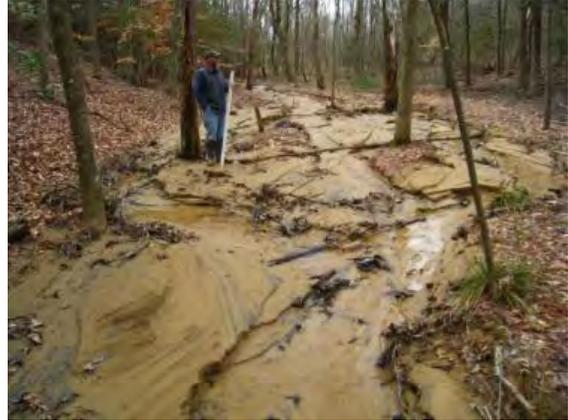
The quantity of sediment scoured from the channel can be approximated from the measured cross sections (approximately 3 ft² near the top of the head cut, to approximately 230 ft² at the bottom) and the total length of scour above the floodplain. The total length of scour was measured in a straight line, while the actual distance is considerably longer due to the meandering alignment of the erosion process. An inspection of the wide flat floodplain area (approximately 500 feet from the start of the head cut) reveals the stream's base flow braiding through a thick mat of sediment covering the entire width (Figure 13).

Figure 13: Floodplain below S-102

A very rough and conservative estimate is that approximately 1,650 cubic yards of soil has eroded into the floodplain below this outfall channel. Considering an average dump truck hauling capacity of 10 yd³, approximately 165 truckloads of sediment from S-102 have covered the flood plain and are slowly migrating towards Norris Pond (Figure 14). Unlike the outfall at S-401 there is no apparent clay layer to slow or limit the channel erosion in terms of the depth of the scour. The channel bottom may continue to down-cut with additional grade drops, the channel width may increase as the meander pushes against the near vertical side walls, and the upstream edge of the head cut will undoubtedly continue to migrate up-gradient. The amount of time before the head cut erosion reaches the edge of North Main Street is dependent on the amount and intensity of rainfall.

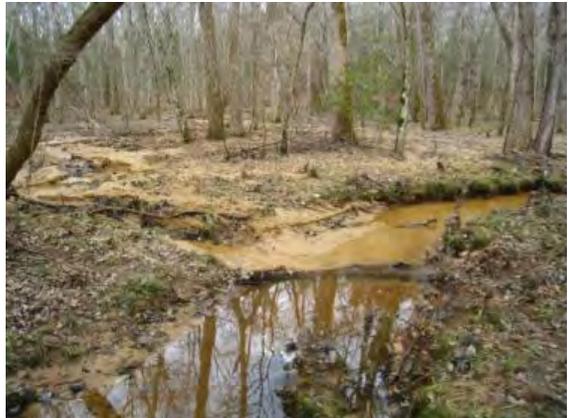
Figure 14: Sediment from S-102 fills downstream channel

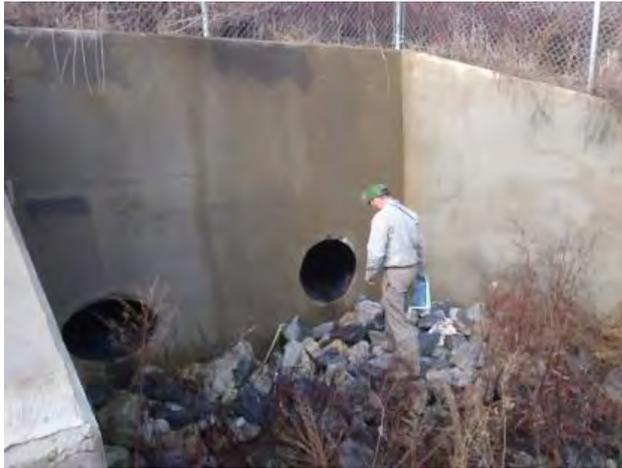
Figure 15: Concrete headwall above S-103

The head cut in the outfall channel at S-103 is similarly moving upstream. Although the head cut is not visible from Old Fairgrounds Way, there is evidence of soil instability and erosion in the vicinity of the Old Fairgrounds Way concrete retaining wall and the adjacent drainage system headwall (Figure 15). The overall condition of this head cut is very similar to that of S-102. A quick investigation of the downstream edge of the floodplain (where the outfall channel meets the main channel) as observed from the terminal point of the Baylor Park Nature Trail may indicate that the total volume of sediment that has moved downstream into the floodplain is greater than

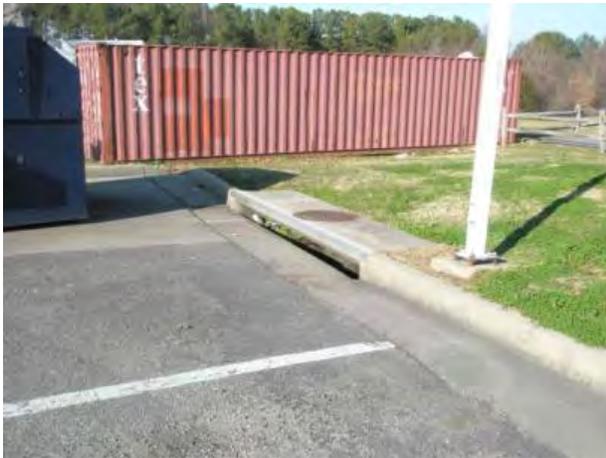
2. Investigate the existing grass strip and possible BMP on the eastern edge of H-105. This strip divides H-105 from the H-121 shopping center parking lot). This appears to be an ideal location for a dry swale or other linear BMP. However, there appears to be an existing underground structure. The outlet pipe from an existing curb inlet appears to go directly into the grass island, and there is no visible outlet pipe; also, the grass island has two PVC vent pipes protruding from the ground (Figures 3 and 4).

Figure 3: Curb inlet draining 0.8 ac gas station

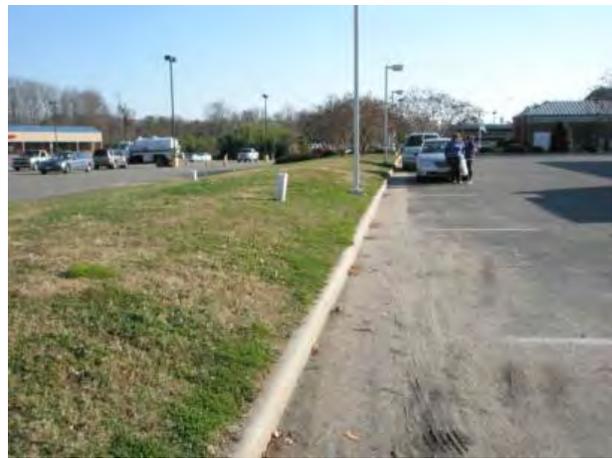
Figure 4: Grass island with vent pipes (there is no record of a BMP being located there).

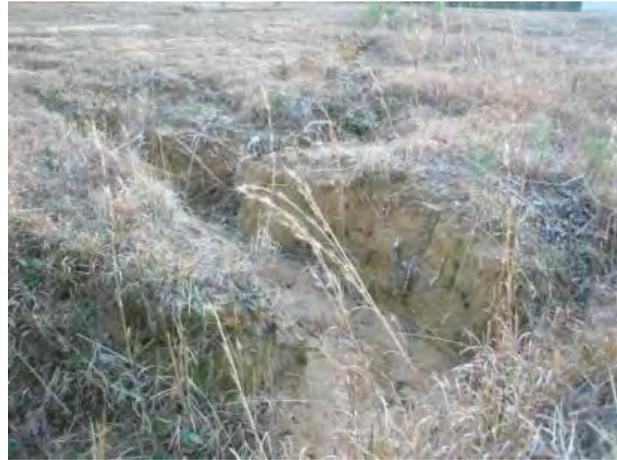
Figure 2: Erosion of outlet

Description: The Technology Park located off of Harris Road in the Dyrer Creek watershed consists of multiple businesses located on individual parcels. Several of the parcels include relatively new water quality BMPs that are functioning well. However, the last business located at the end of Technology Park Drive has an infiltration trench with low earthen berms to convey runoff from the turf and impervious areas of the site to the trench. The turf areas are cut extremely short (it could be described as too short as there is very little “stem density” to the vegetation and evidence of erosion and sediment transport within the turf areas). The trench has a diversion structure that appears to be designed to bypass larger storm flows. However, the accumulation of sediment appears to divert more flow than designed, and the outlet channel is experiencing erosion (Figure 2).

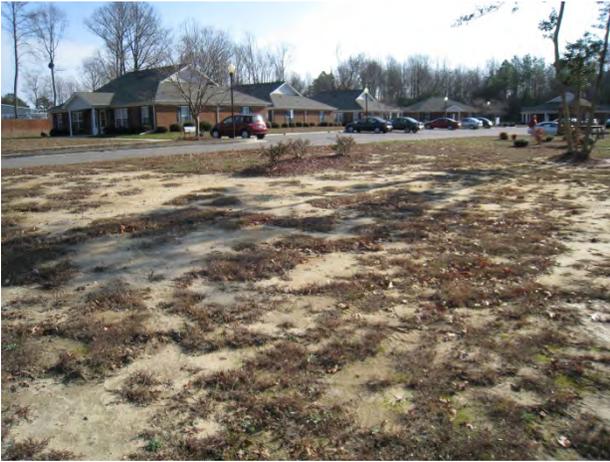
Figure 1. Bare soil in communal area

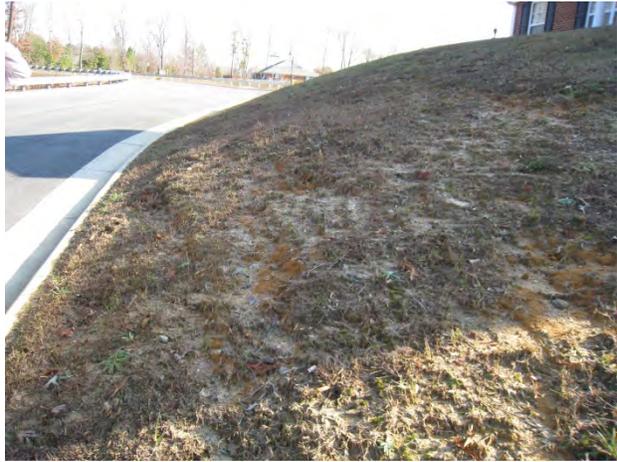
Figure 2. Bare, sandy soil on slopes

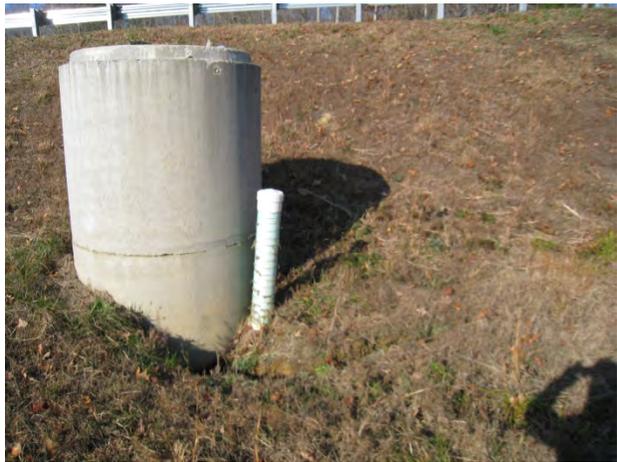
Figure 4. Basin outlet, with erosion at base

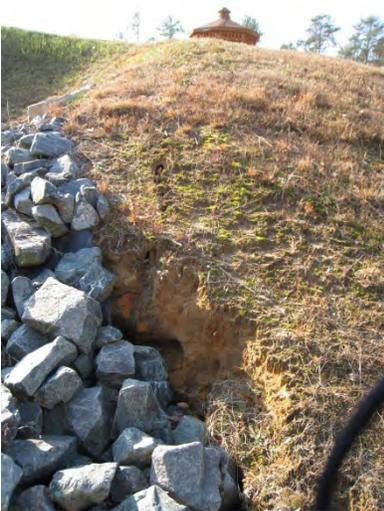
Figure 5. Steep basin inlet, eroding

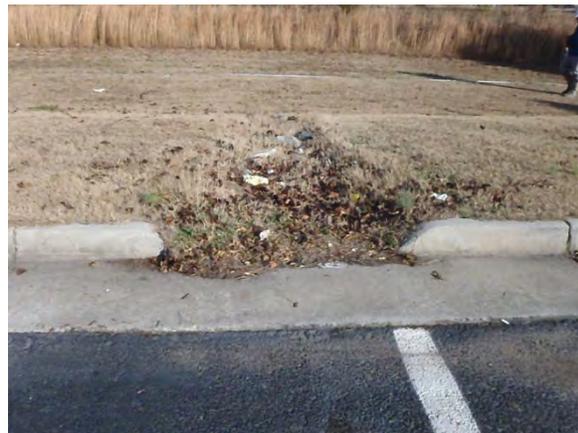
Figure 3: Partially clogged inlet to basin

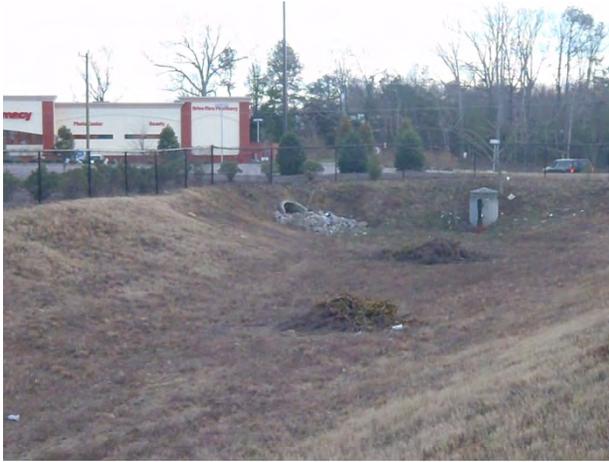
Figure 1: Shrub clippings in detention pond

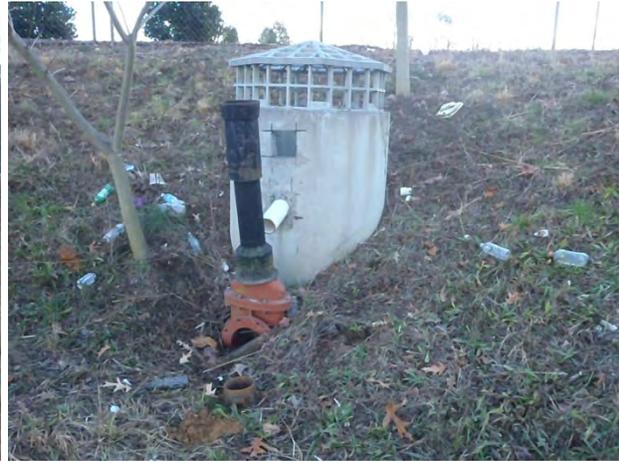
Figure 2: Trash around outlet structure

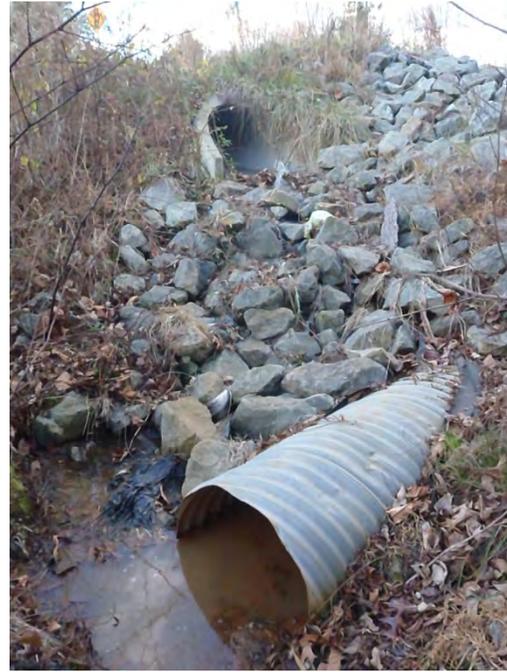
**Figure 2:** Metal outlet pipe partially clogged

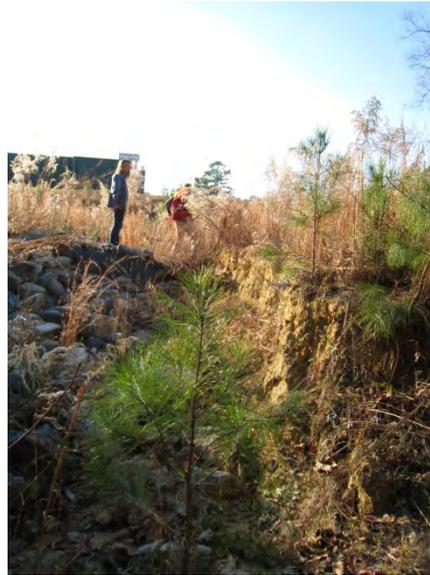
Figure 2: Dam section eroded out at spillway

Description: An existing stormwater detention or retention pond is located behind the new bowling alley on Main Street (Figure 1). A section of the earthen dam has blown out near the rip-rap spillway (Figure 2), depositing sand in the stream. With the dam un-secure, more erosion could occur and the pond will not retain as much stormwater as needed.

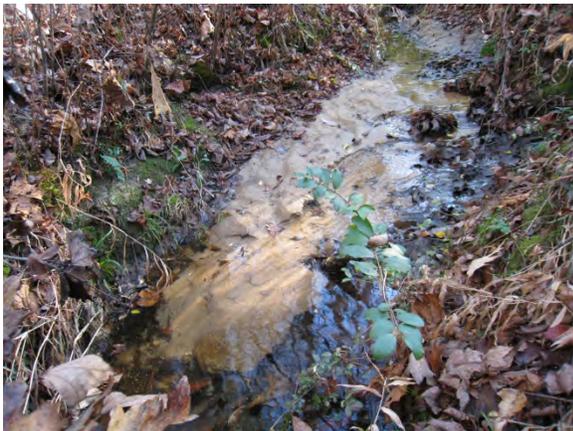
Figure 3: Stream filled in by sand from blown out dam

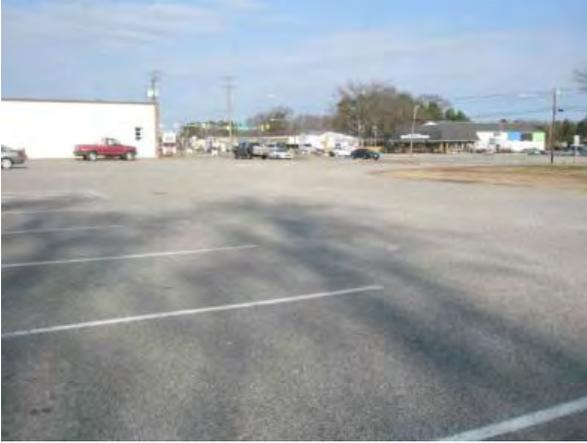
Figure 3: Paved area in front of building

2) Remove some pavement in the front parking lot (Figure 3) and either replace it with landscaping or bioretention to promote infiltration, or if the parking areas are needed for events, replace it with permeable pavers in select locations. The paved area in front of the building has only minimal markings for parking, so it is difficult to equate the parking demand with a specific number of spaces. However, utilizing input from the building occupants should allow for a quick assessment of the viability of the options – pavement removal and landscaping, or replacement with permeable pavers.
