# **Urban Stream Restoration Practices: An Initial Assessment**

## **Final Report**

Kenneth Brown  
Center for Watershed Protection  
8391 Main Street

**October, 2000**

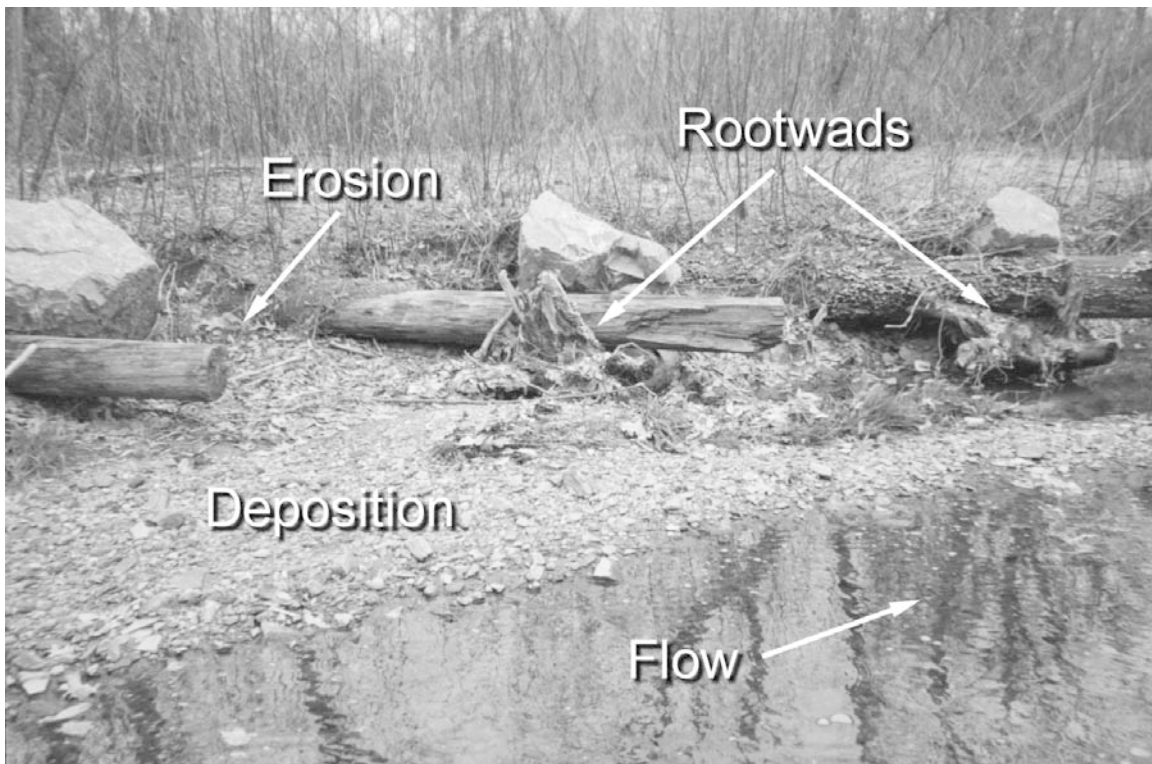
**Photo 4.1: Rootwad revetment that experienced both significant erosion and significant deposition. Revetment has remained in place but failed to protect streambank.**

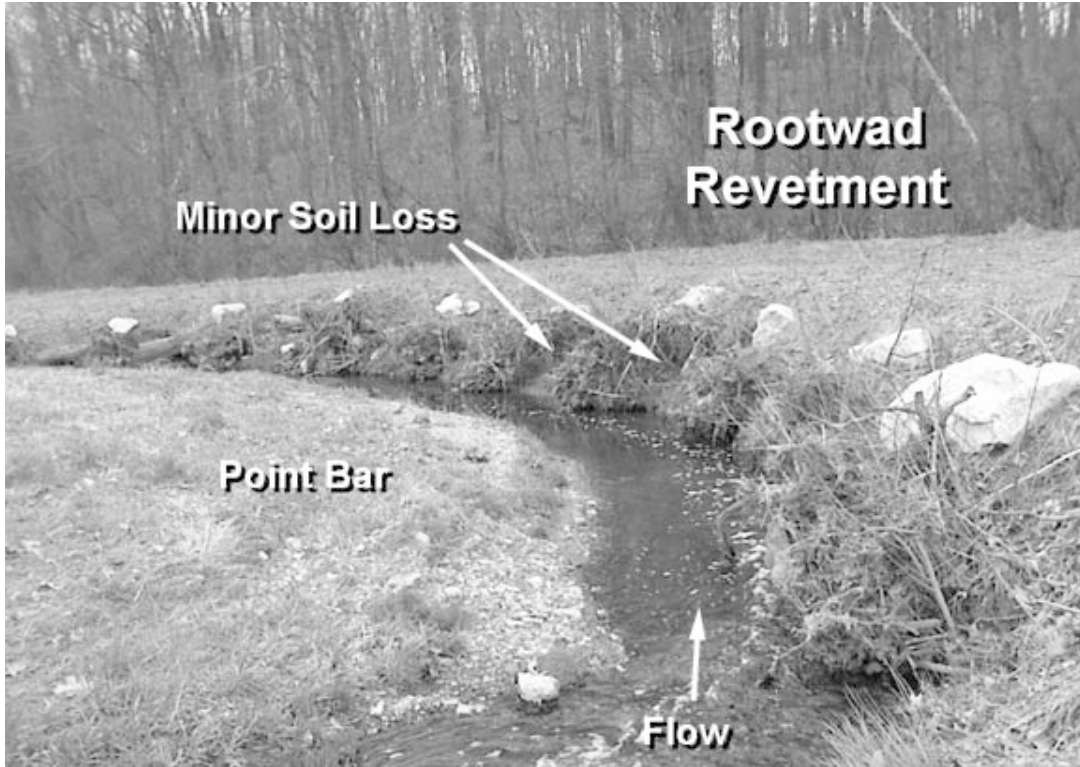
**Photo 4.2: Typical rootwad revetment depicting minor soil erosion between individual rootwads. This revetment is fully serving the design objective of bank protection.**

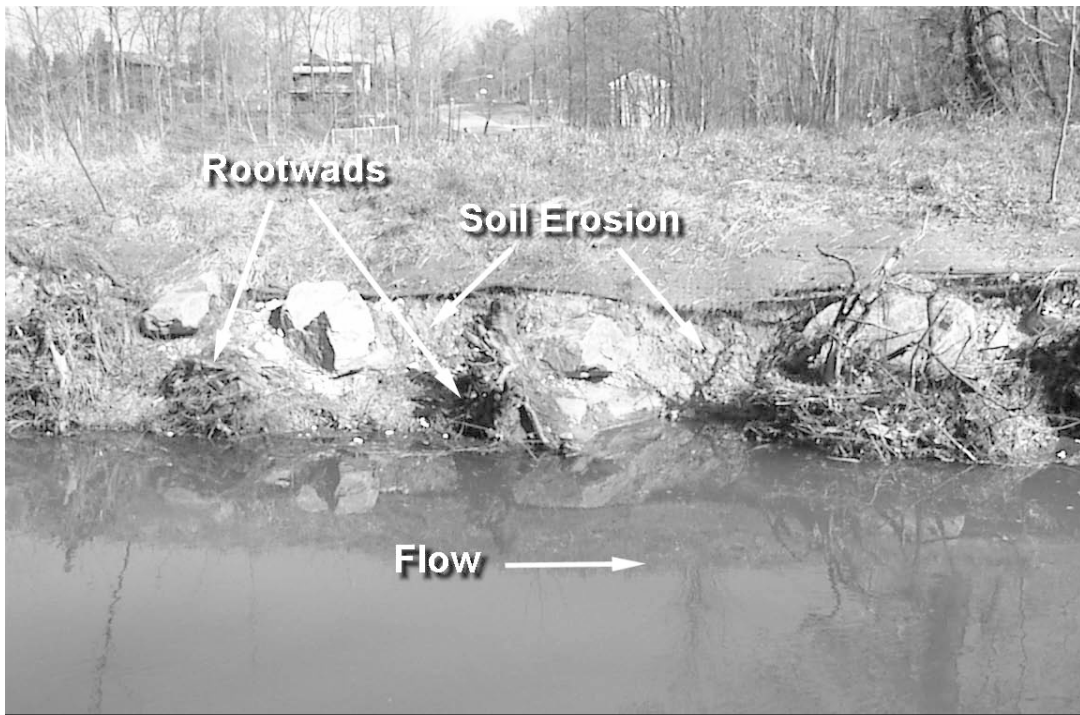
**Photo 4.3: Rootwad revetment that has experienced moderate soil loss between rootwads. Erosion control netting is exposed along the top of the revetment.**

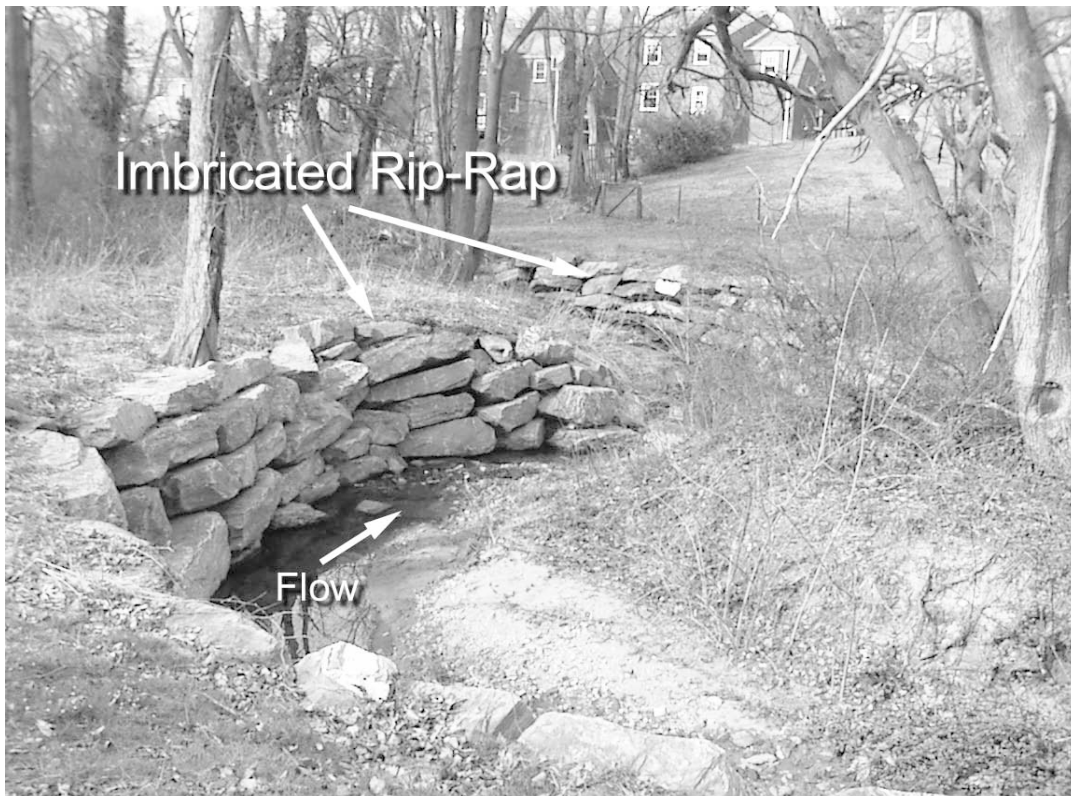
**Photo 4.4: Well designed and installed imbricated rip-rap revetment.**

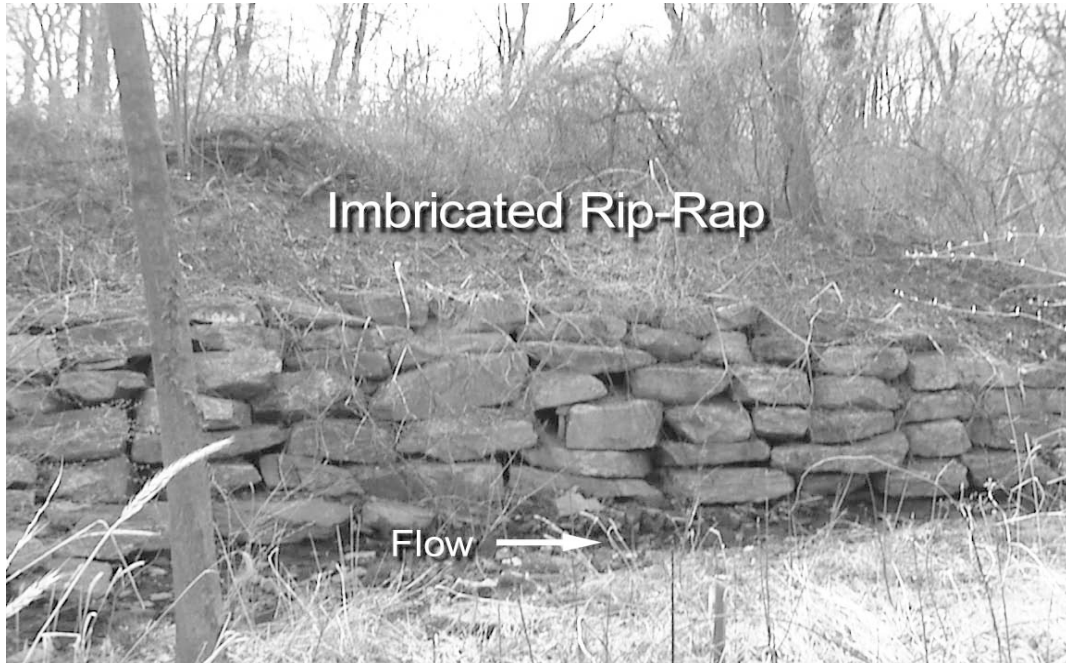
**Photo 4.5: Imbricated rip-rap revetment protecting 15 foot tall unstable streambank. A parking lot lies at the top of slope.**

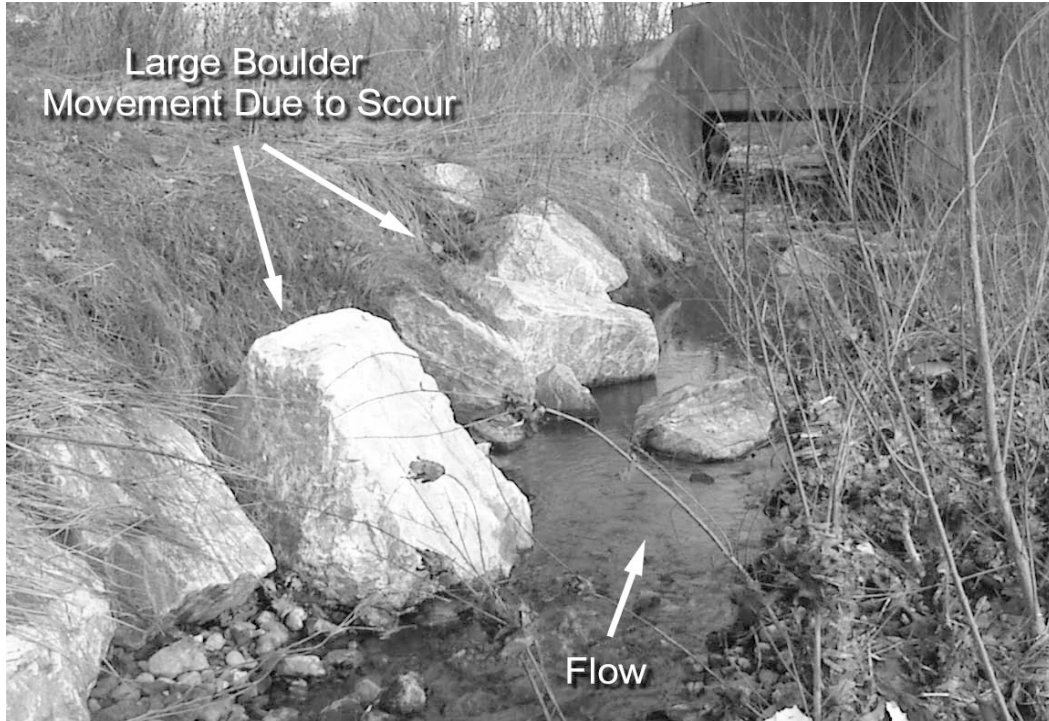
**Photo 4.6: Large boulder revetment that has experienced scouring along the toe of the streambank and movement of practice materials.**

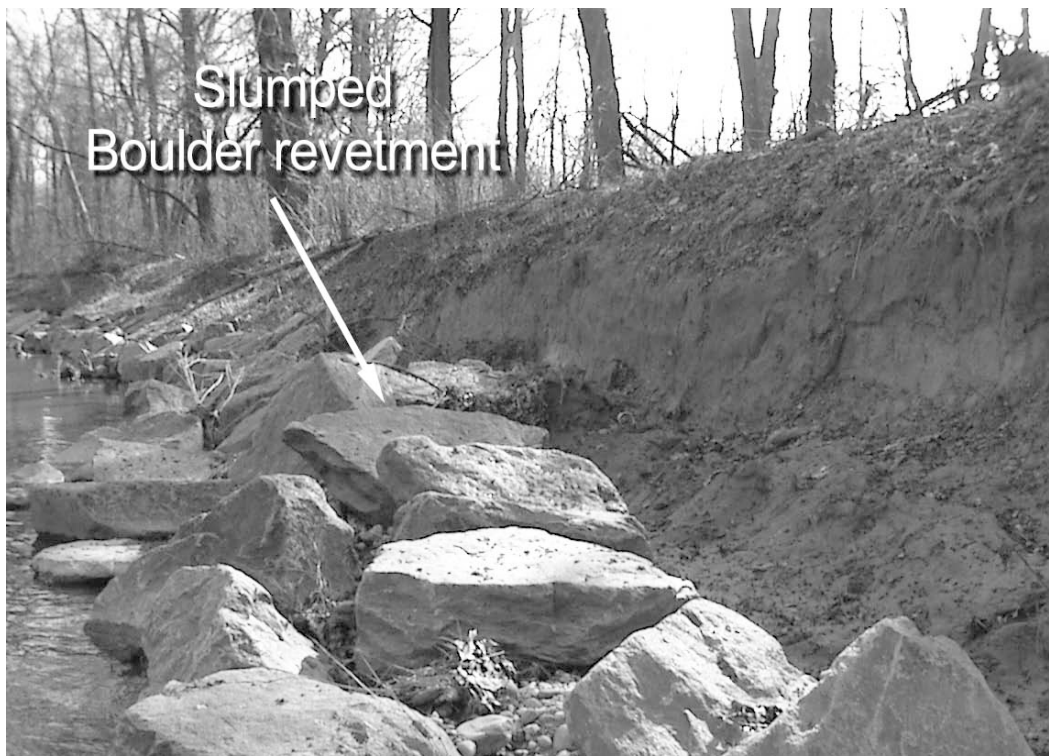
**Photo 4.7: Large boulder revetment that has slumped due to scouring at the streambank toe and saturated soil conditions within the streambank. Revetment moved in mass.**

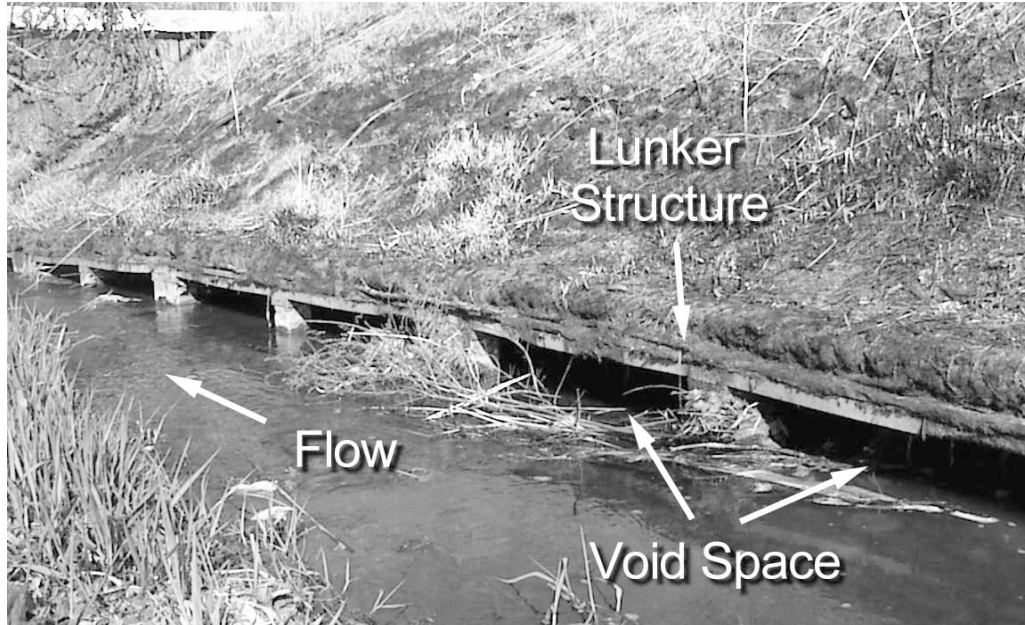
**Photo 4.8:** This photo depicts the void space created by a lunker structure. Upper bank slope was recently burned as part of prairie grass restoration project.

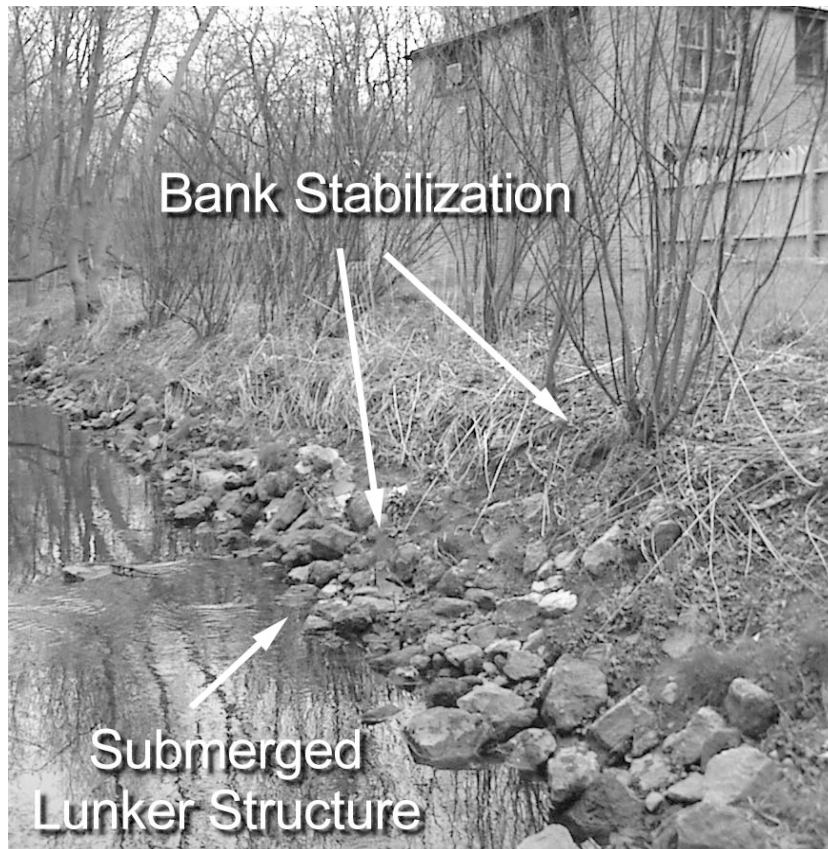
**Photo 4.9:** Submerged lunker structure showing rip-rap and vegetative stabilization.

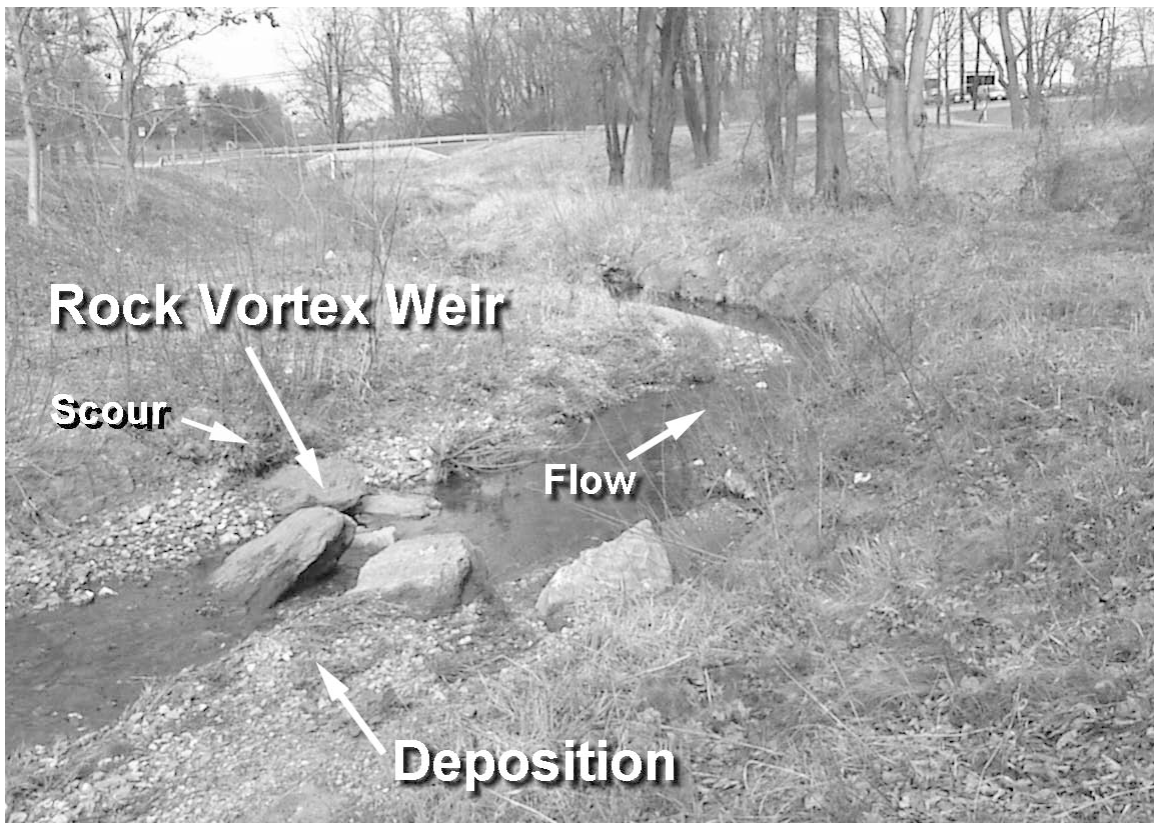
Photo 4.12: Rock vortex weir experiencing both upstream sediment deposition and scouring around the structure.

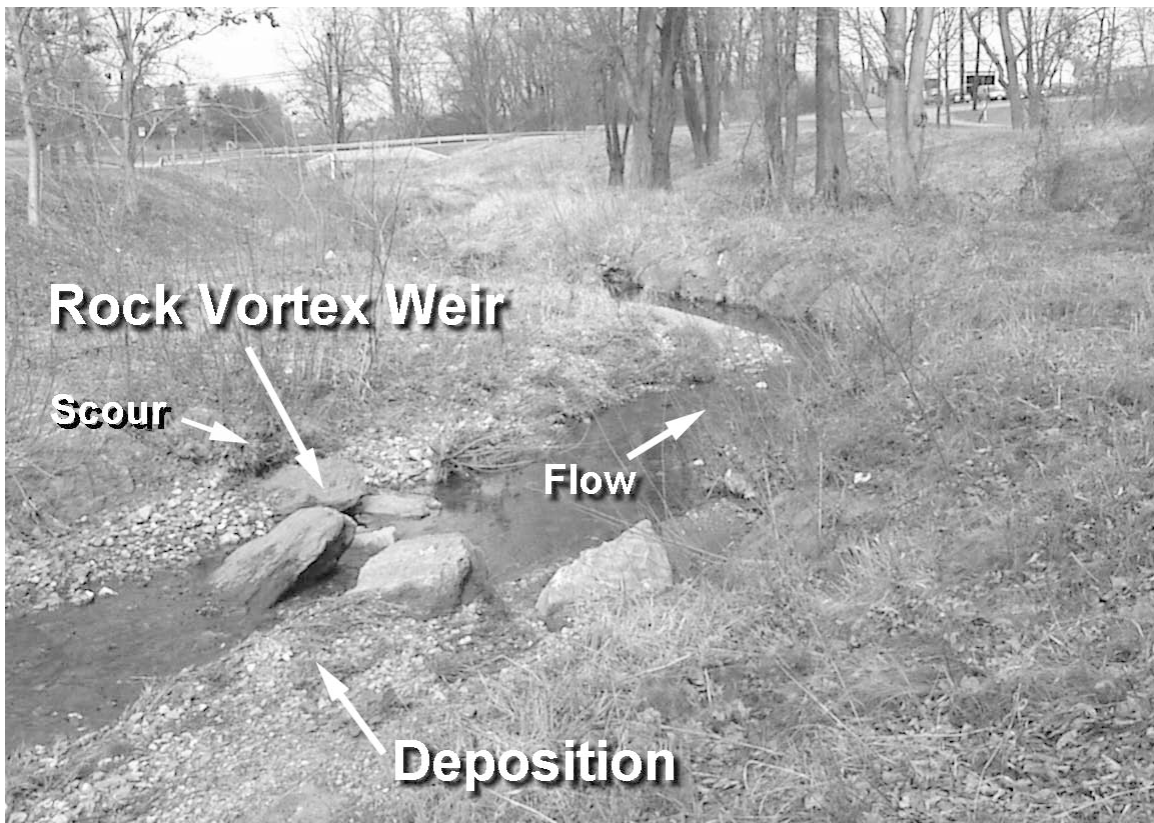
Photo 4.12: Rock vortex weir experiencing both upstream sediment deposition and scouring around the structure.

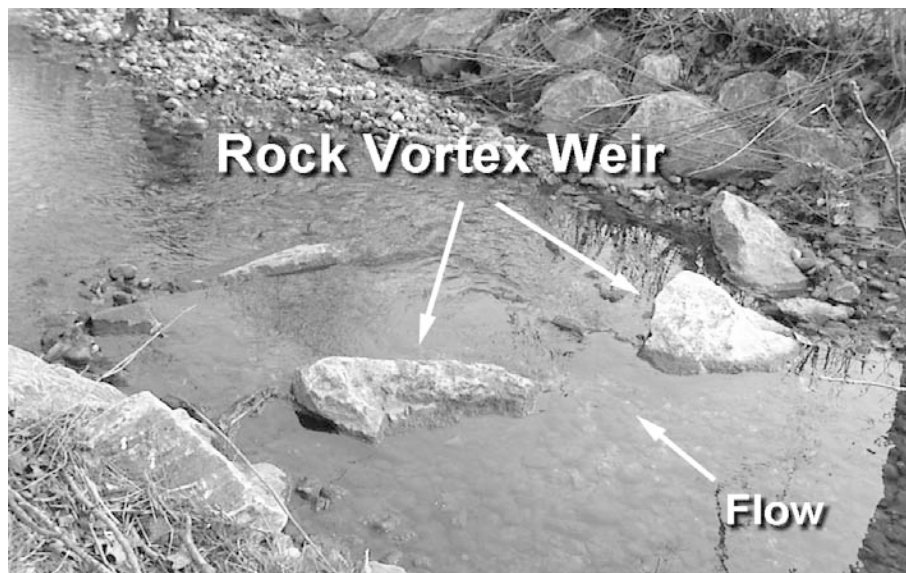
**Photo 4.13: Properly designed and installed rock vortex weir.**

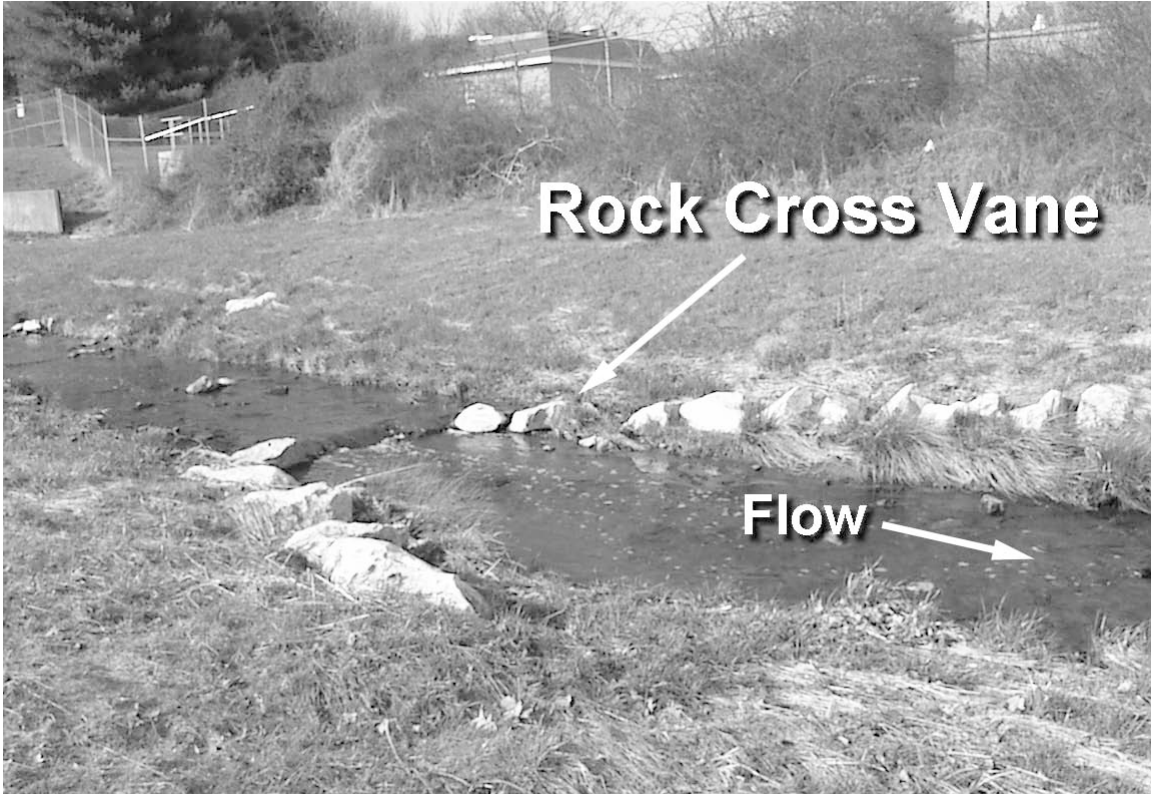
Photo 4.14: Effective, low profile rock cross vane installed on a small stream.

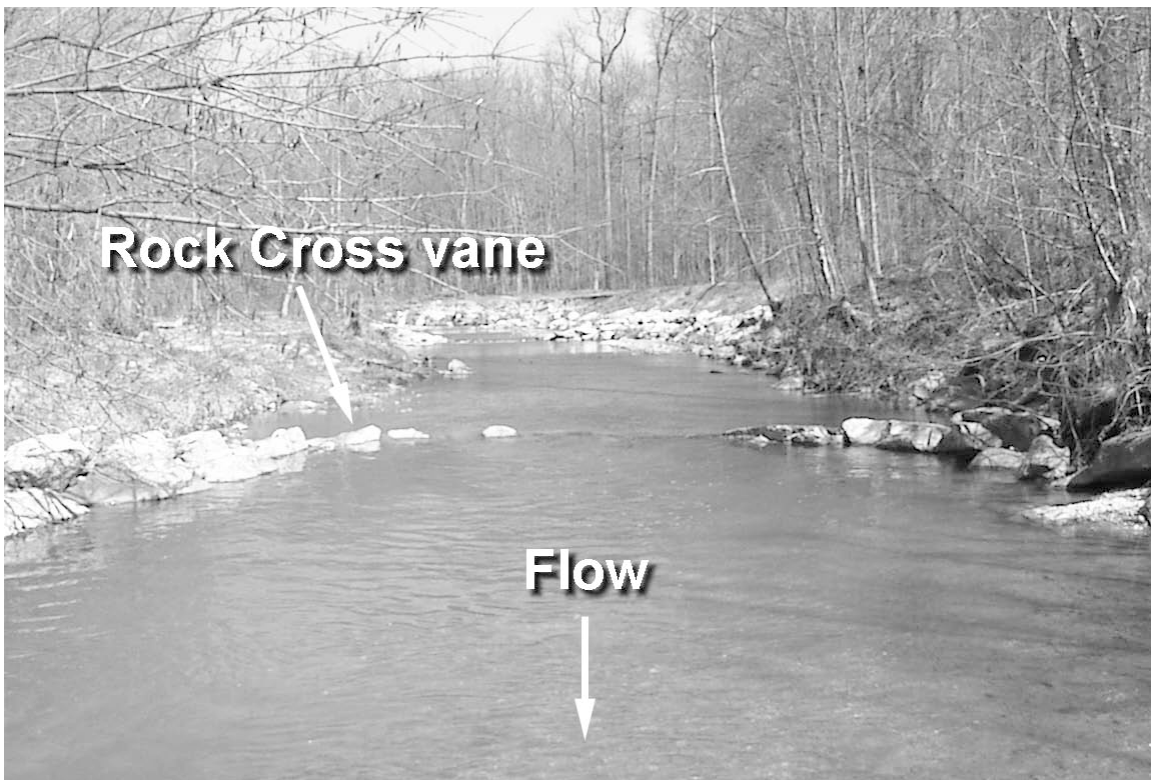
Photo 4.15: Well designed and constructed rock cross vane on large stream.

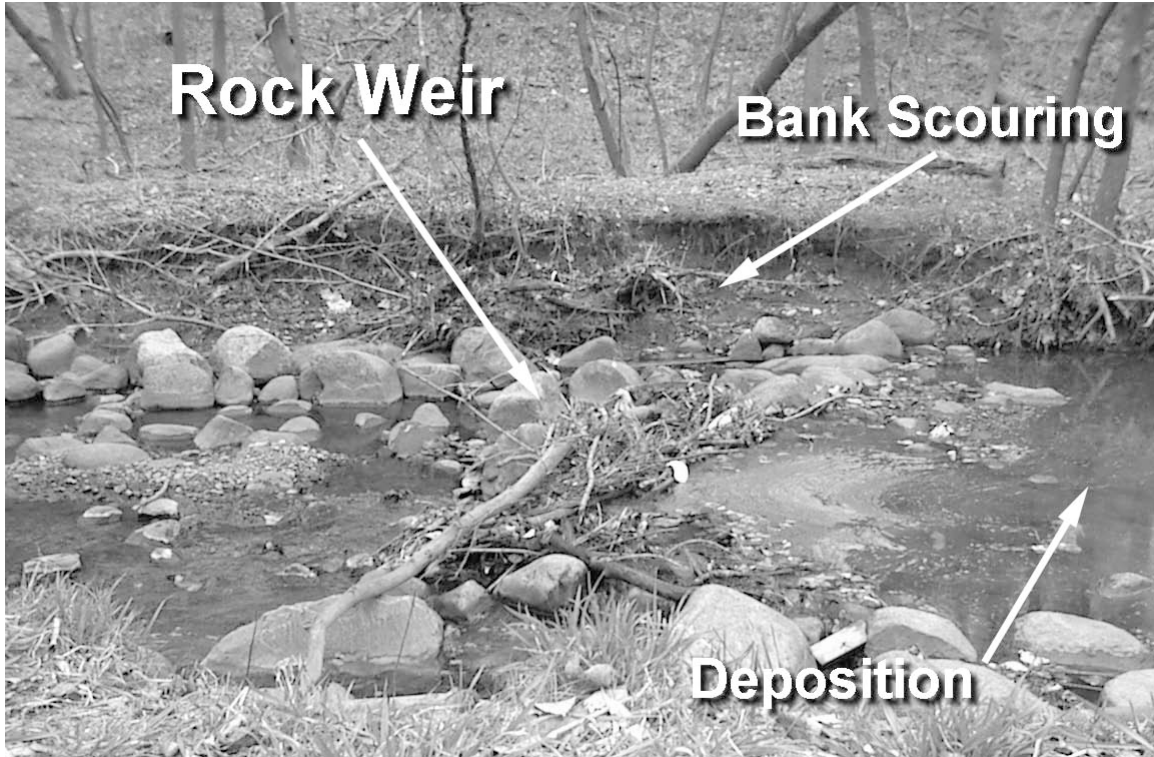
**Photo 4.16: Rock weir installation that resulted in upstream deposition and streambank scouring. Note accumulation of debris on top of weir.**

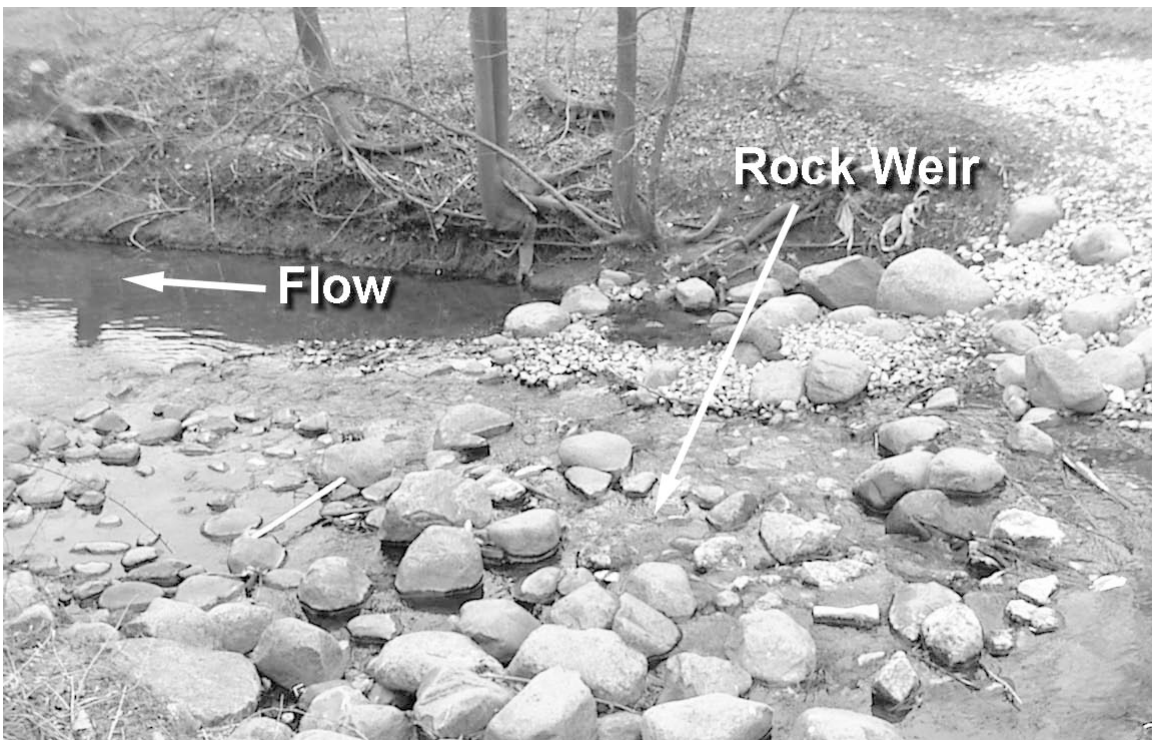
**Photo 4.17: Low profile rock weir experiencing only minor upstream sediment deposition and bank scouring.**

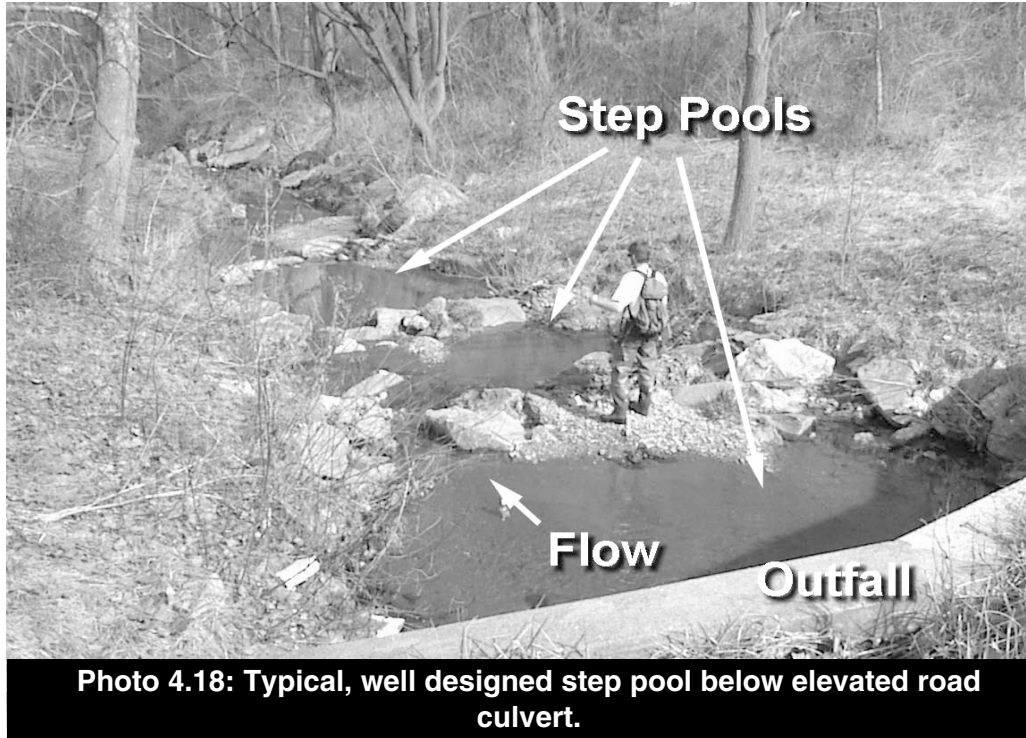
**Photo 4.18: Typical, well designed step pool below elevated road culvert.**

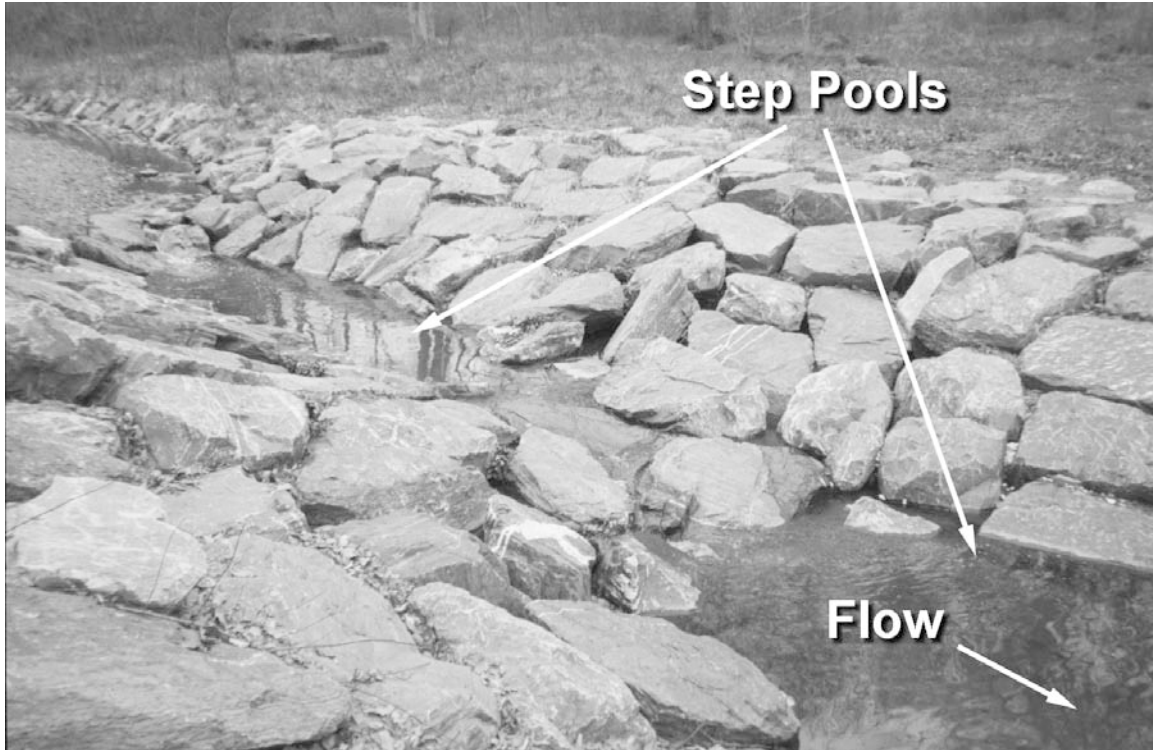
Photo 4.19: Large step pool installed to arrest active channel degradation.

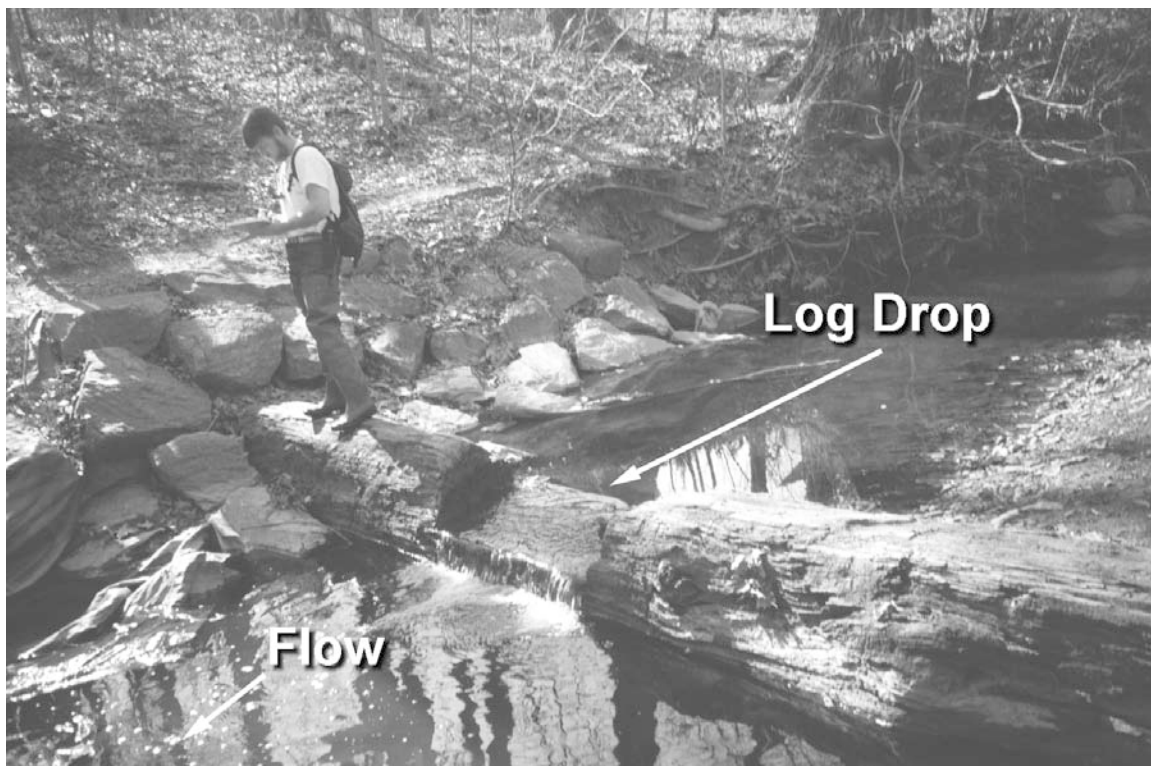
Photo 4.20: Log drop structure.

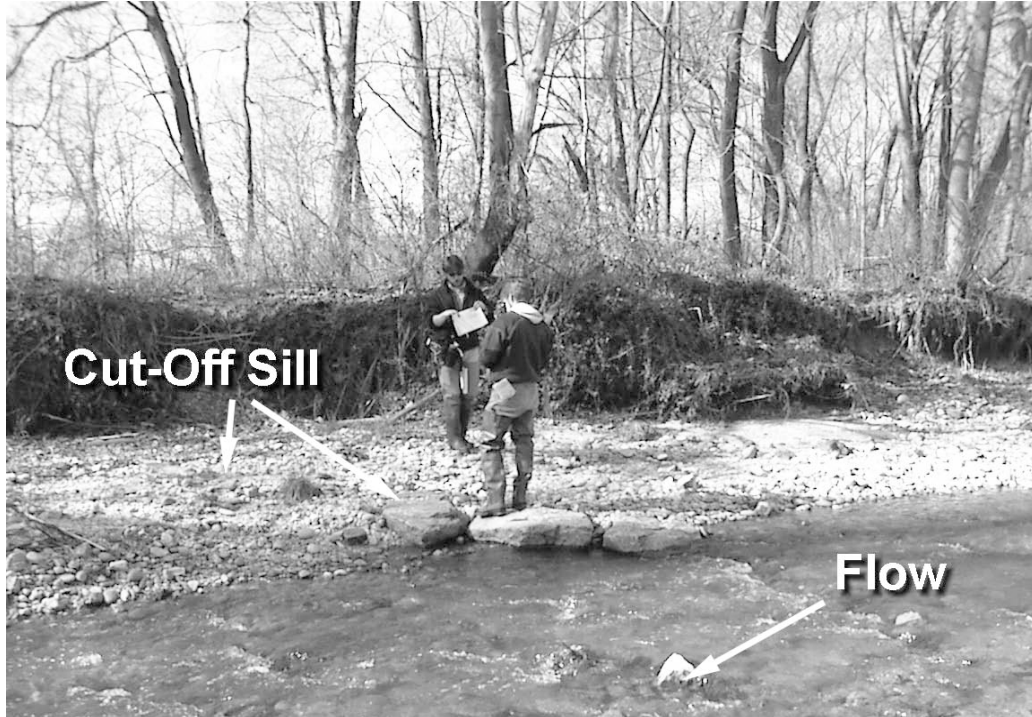
Photo 4.26: Cut-off sill installation that has caused sediment deposition along channel margin.

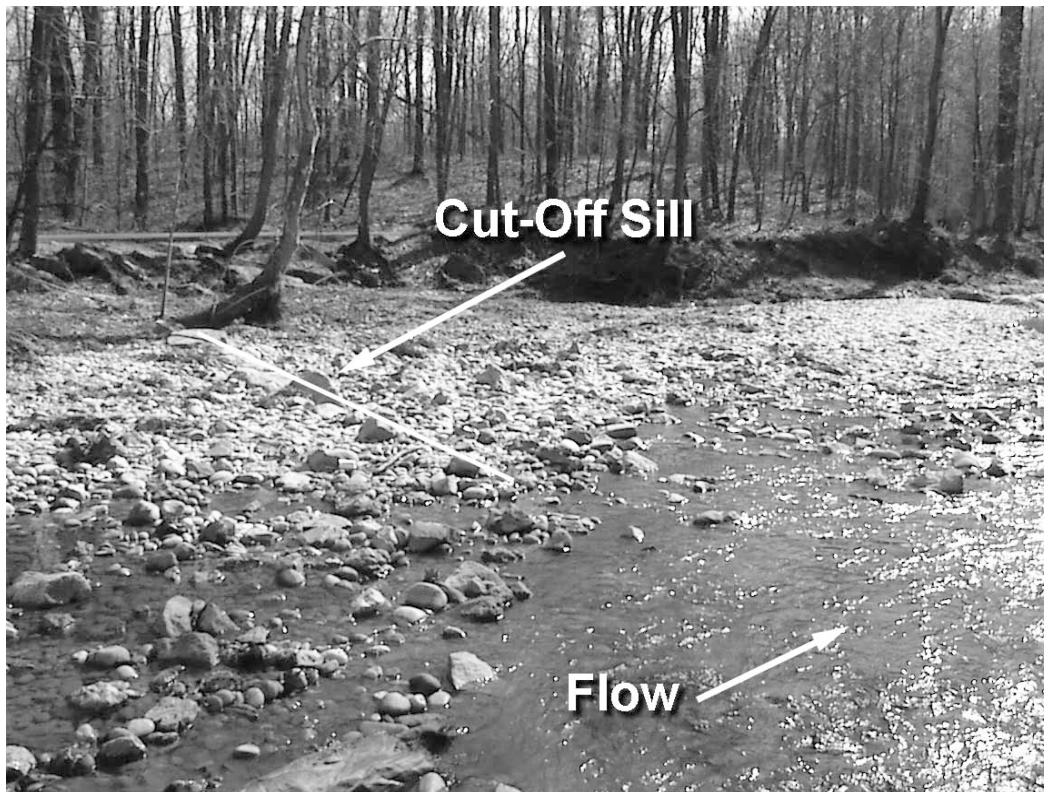
Photo 4.27: Cut-off sill within new lateral bar.

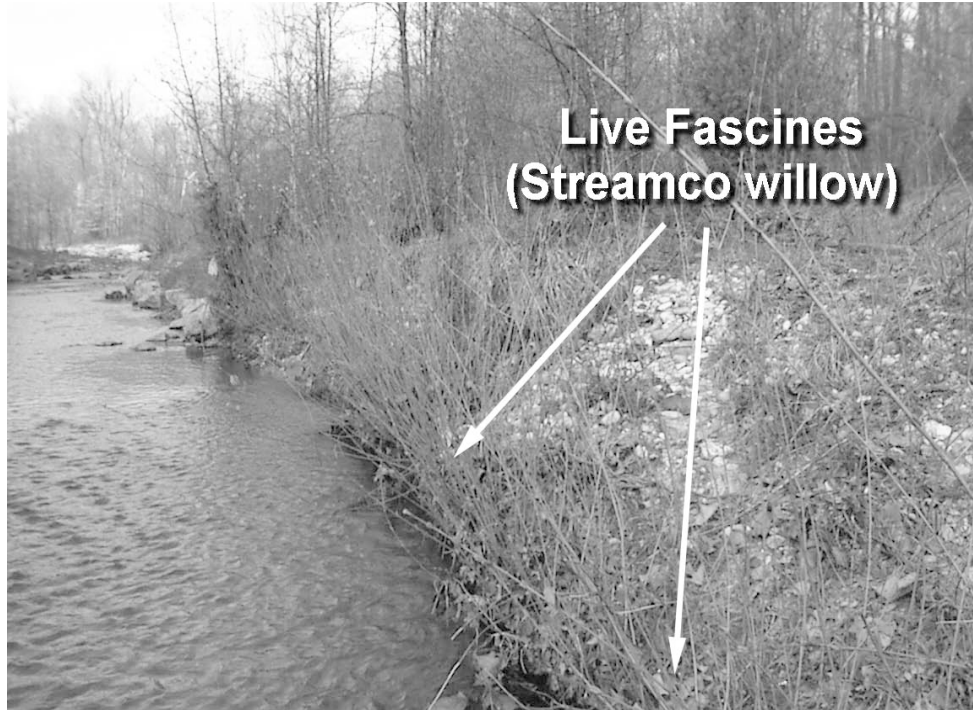
**Photo 4.32: Live fascine installation along streambank toe with excellent branch sprouting (Streamco willow).**

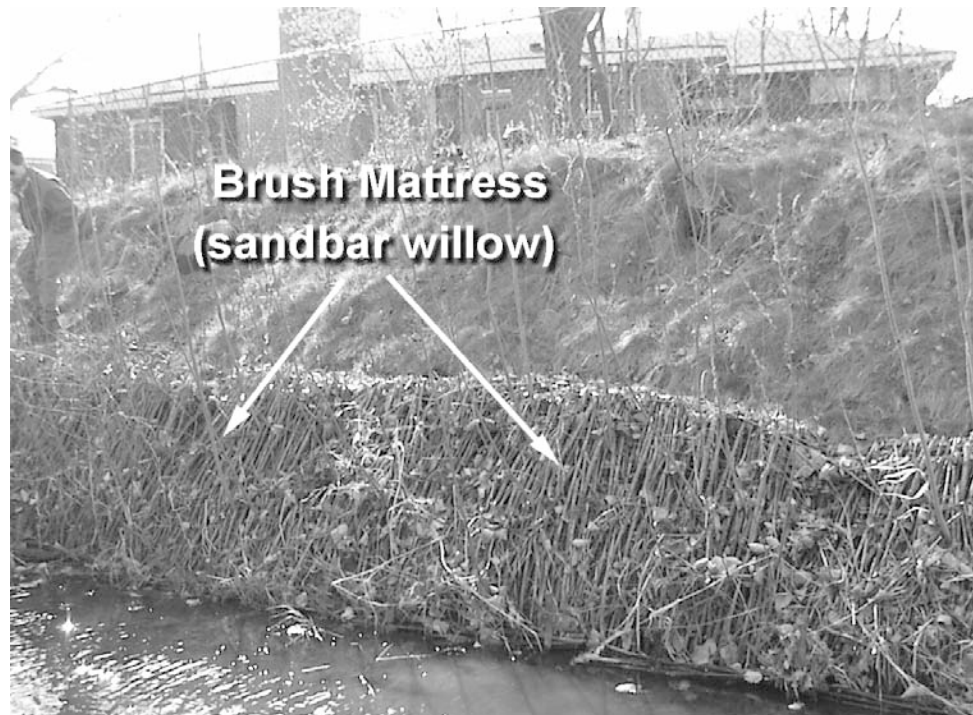
**Photo 4.33: Brush mattress installation using sandbar willow cuttings.**

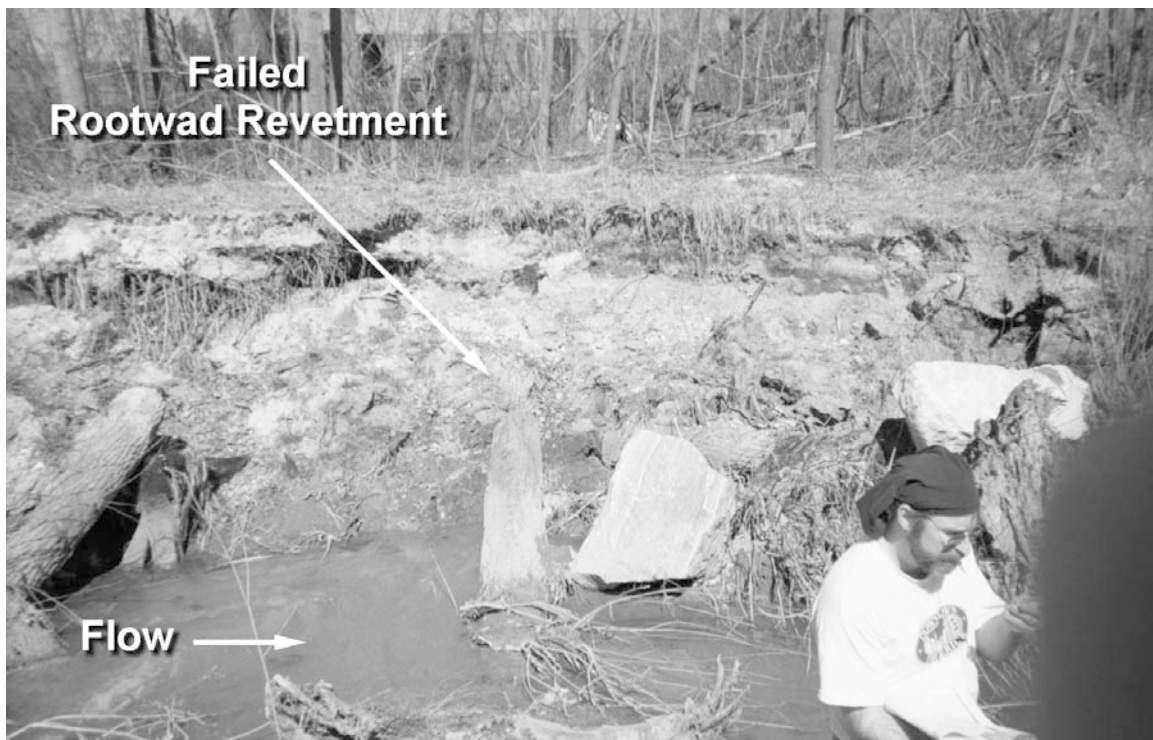
**Photo 5.1: Rootwad failure due to incorrect meander geometry. Meander radius was too small for existing stream conditions.**

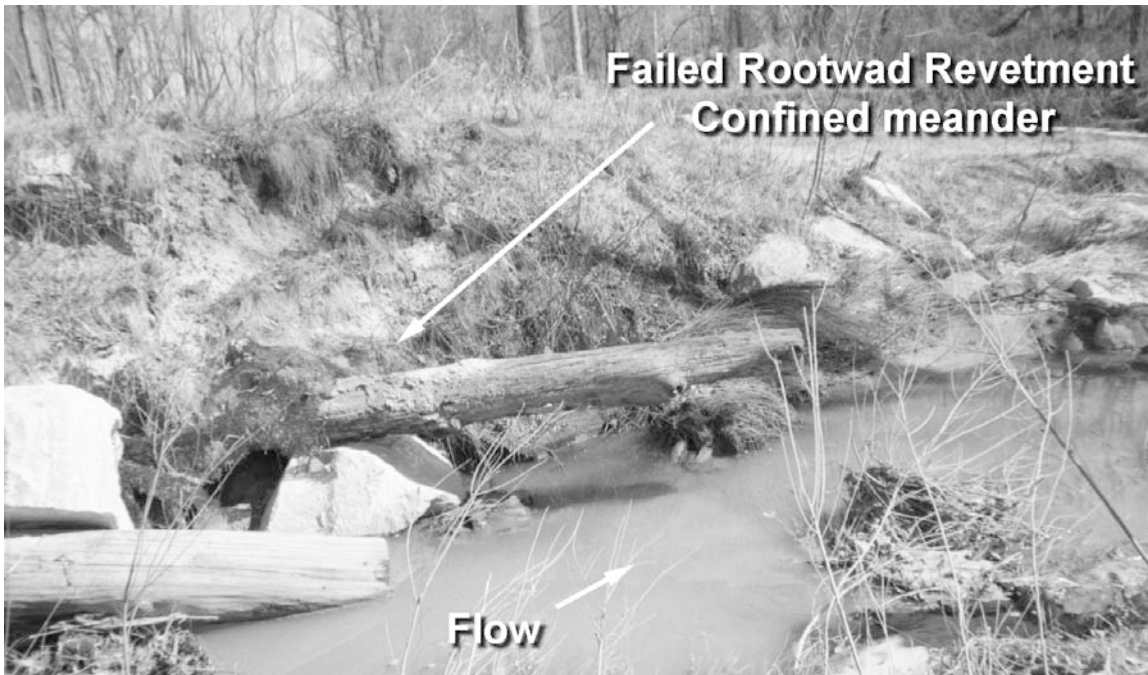
**Photo 5.2: Rootwad failure due to channel confinement in meander bend. Lack of access to the floodplain resulted in highly erosive conditions and failure of rootwad revetment.**

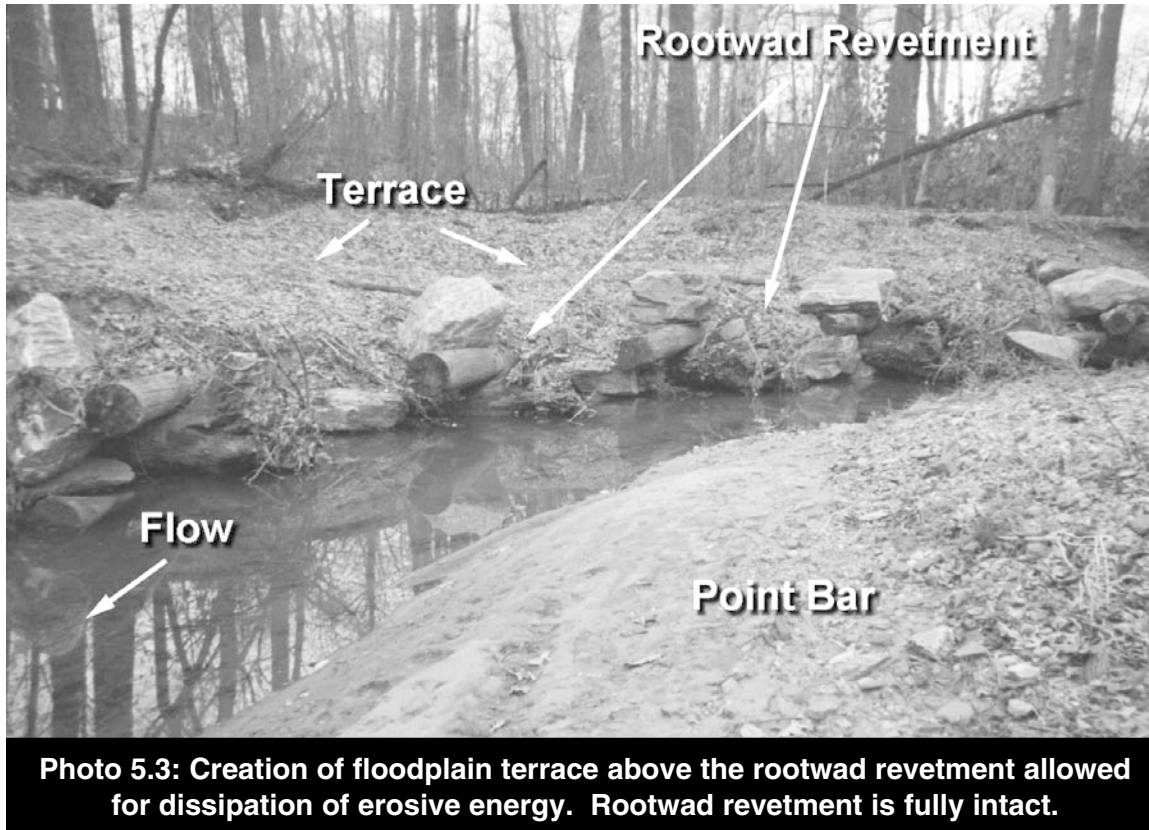
**Photo 5.3: Creation of floodplain terrace above the rootwad revetment allowed for dissipation of erosive energy. Rootwad revetment is fully intact.**

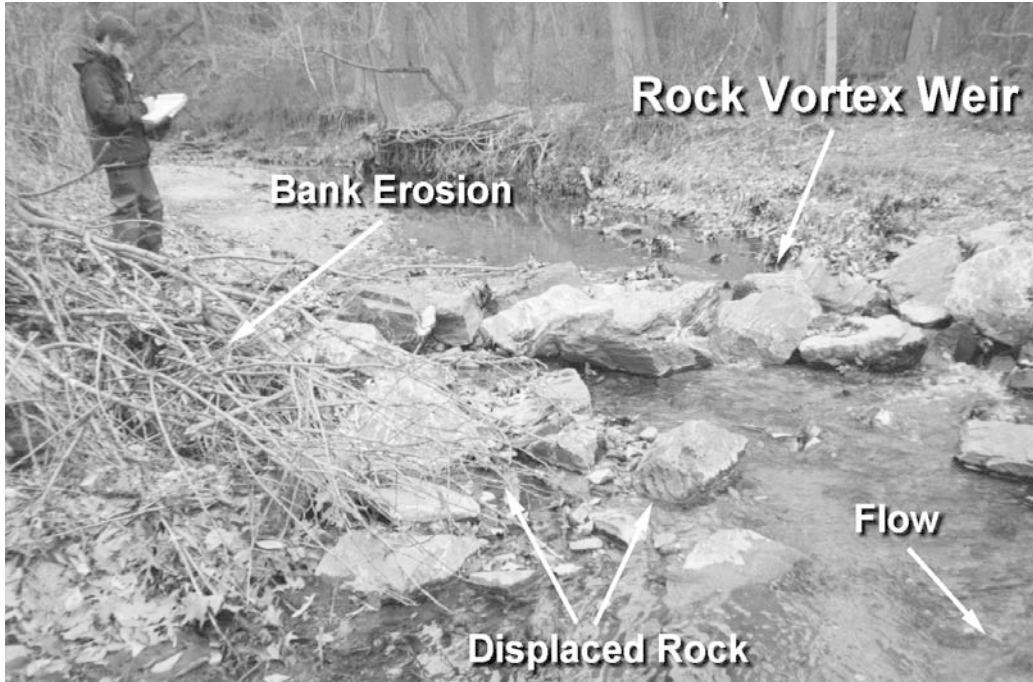
**Photo 5.7: Reduction in channel cross section at this rock vortex weir caused channel widening and practice failure.**

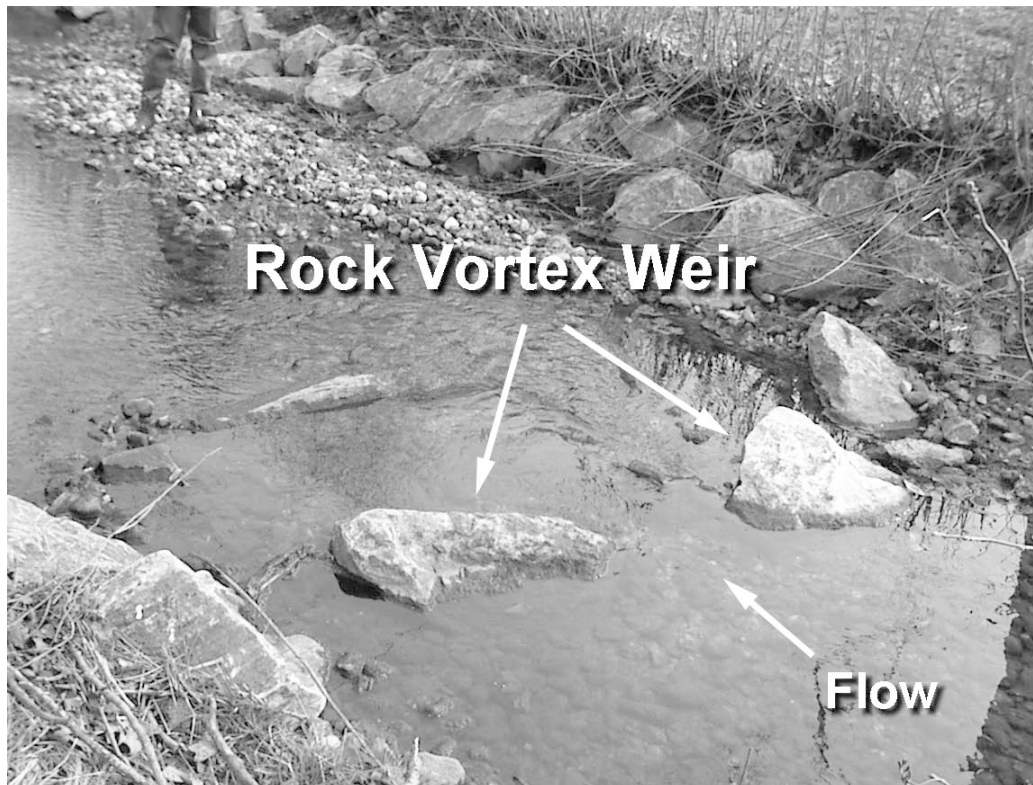
**Photo 5.8: Properly designed and built rock vortex weir. Note distance between weir rocks.**
