# **Urban Stream Restoration Practices: An Initial Assessment**

## **Final Report**

Kenneth Brown  
Center for Watershed Protection  
8391 Main Street

**October, 2000**

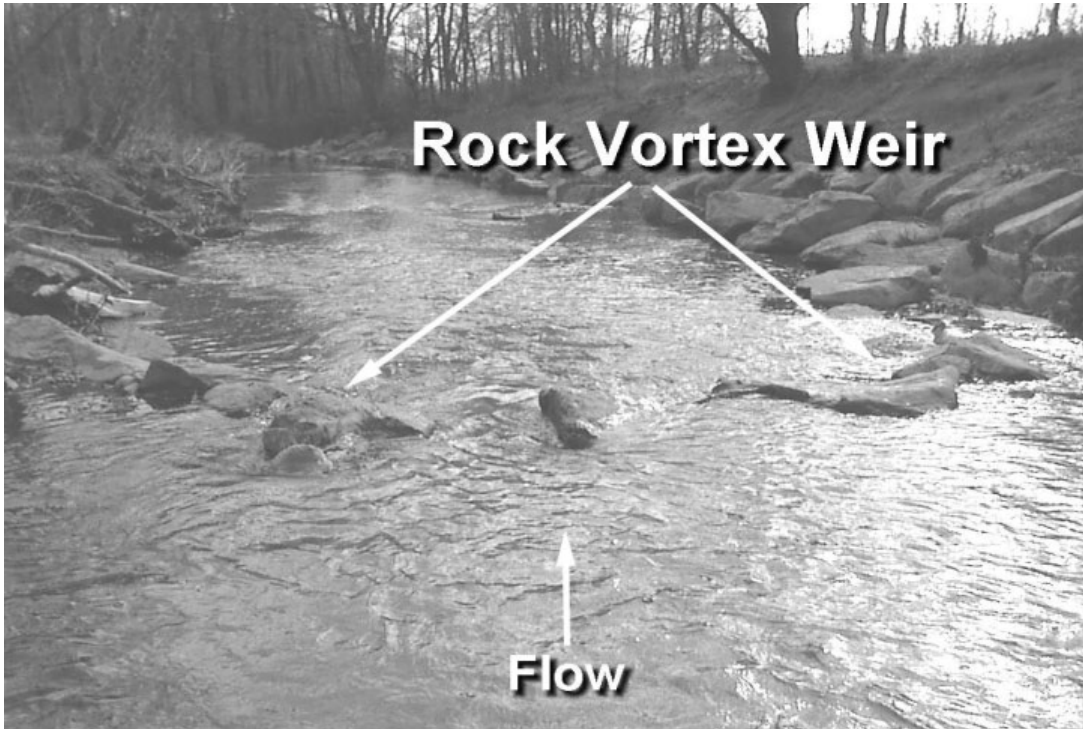
**Photo 5.9: Properly designed rock vortex weir on large stream. Proper height and distance between weir rocks are shown.**

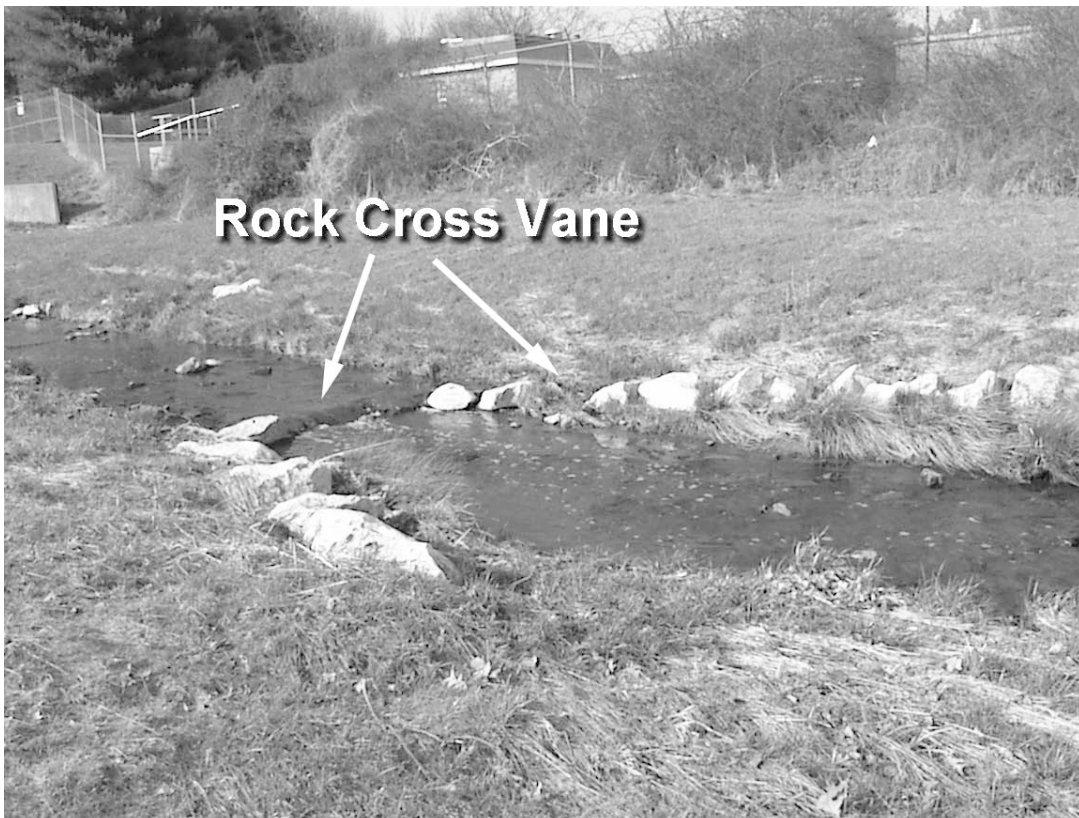
**Photo 5.10: Well designed and built rock cross vane.**

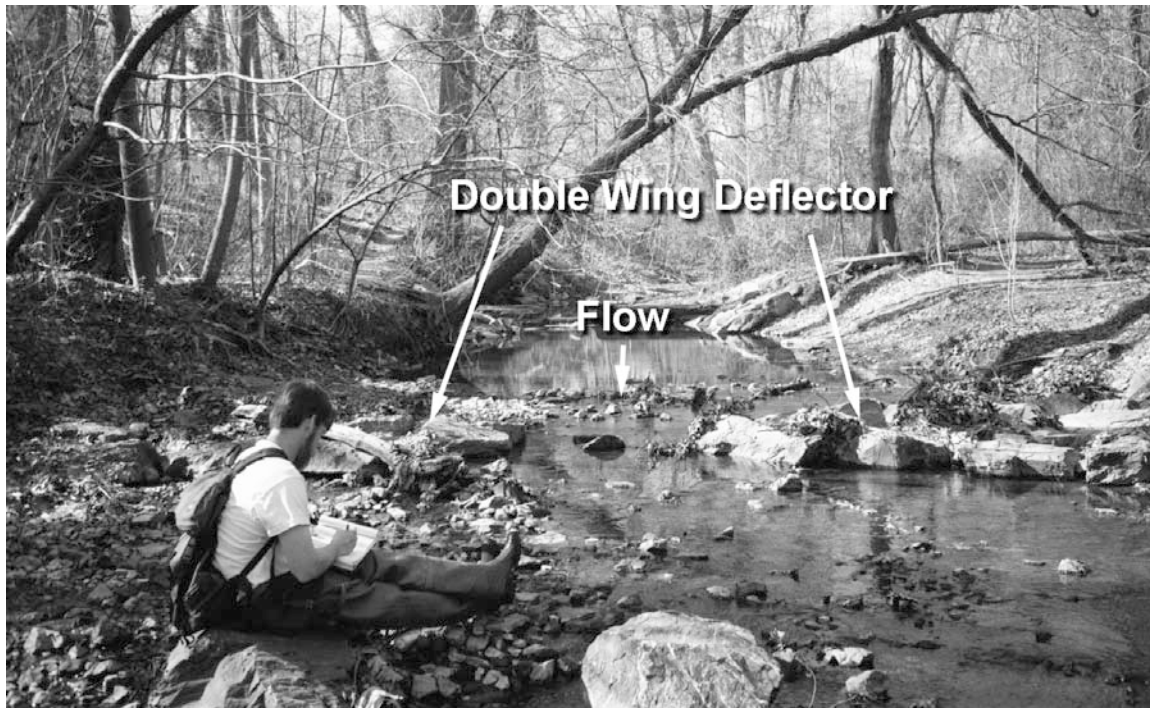
**Photo 5.11: Double wing deflector constructed low in profile. Note lack of pool formation downstream of structure.**

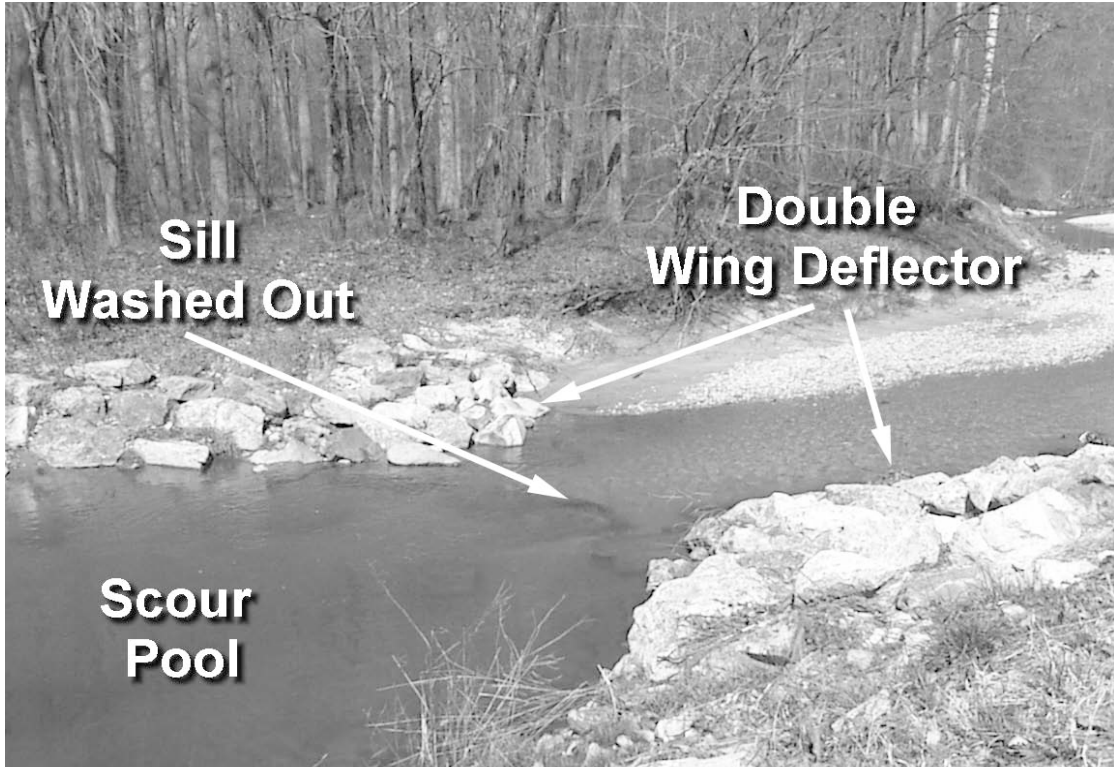
Photo 5.12: Double wing deflector with washed out connecting sill. No upstream sedimentation is evident.

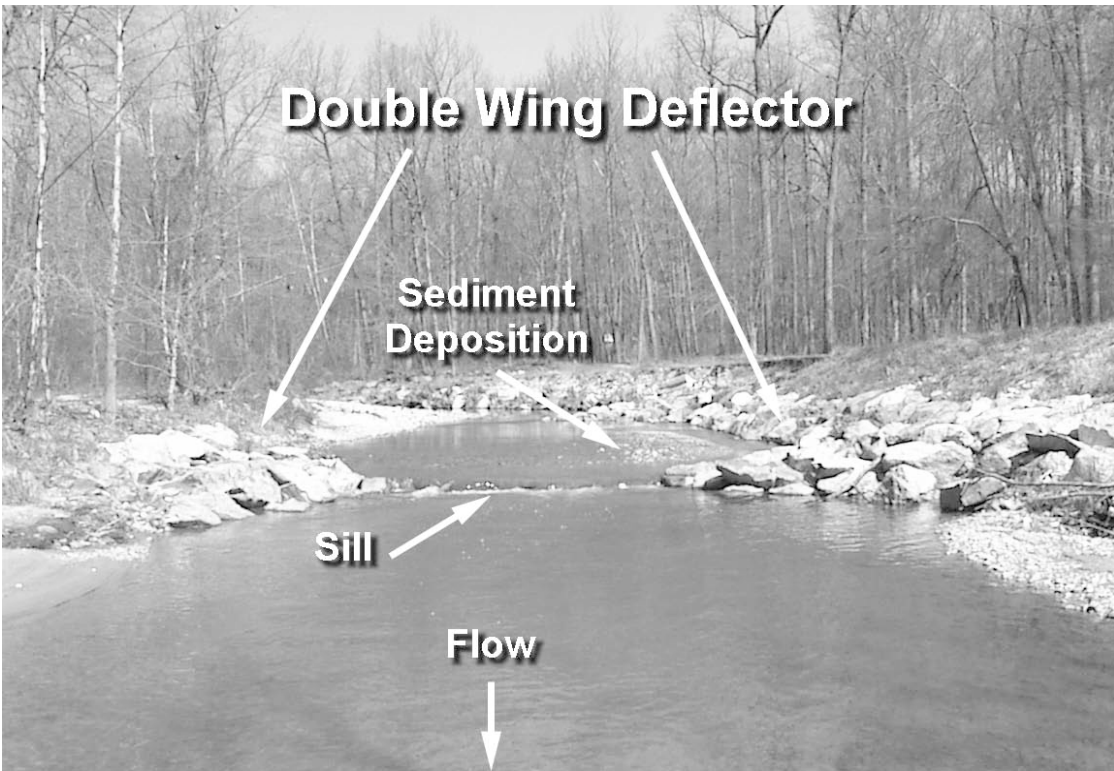
Photo 5.13: Double wing deflector with intact connecting sill. Upstream sedimentation is evident.

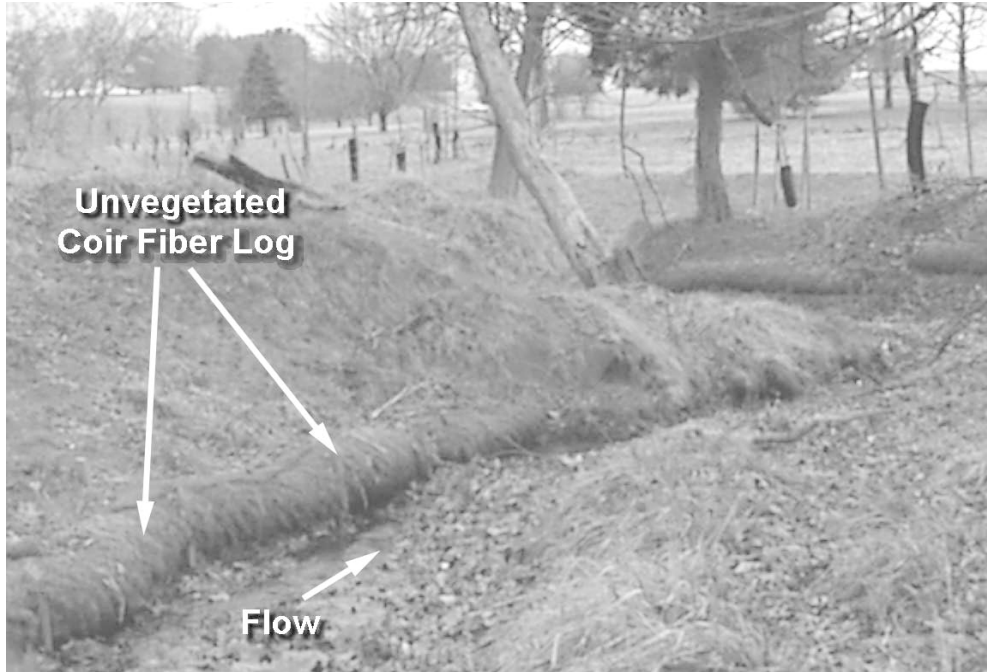
**Photo 5.15: Unvegetated coir fiber log installation. Note lack of contact with streambank and baseflow.**

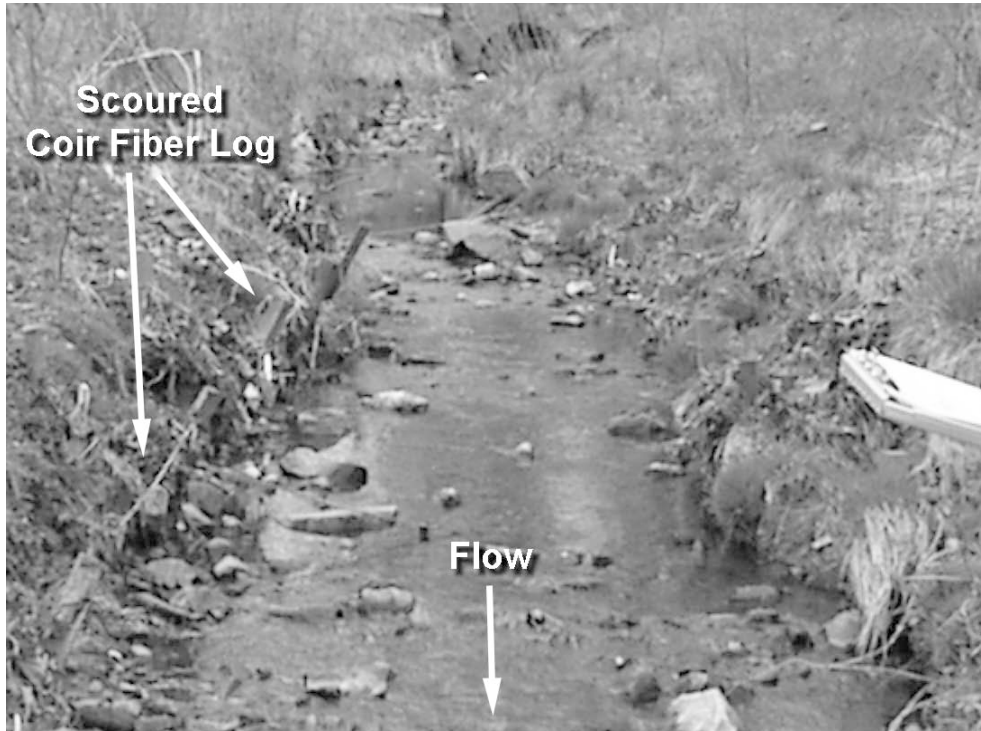
**Photo 5.16: Coir fiber log installation that narrowed channel and resulted in scouring and failure of the practice. (Stakes mark former location of coir fiber log.)**

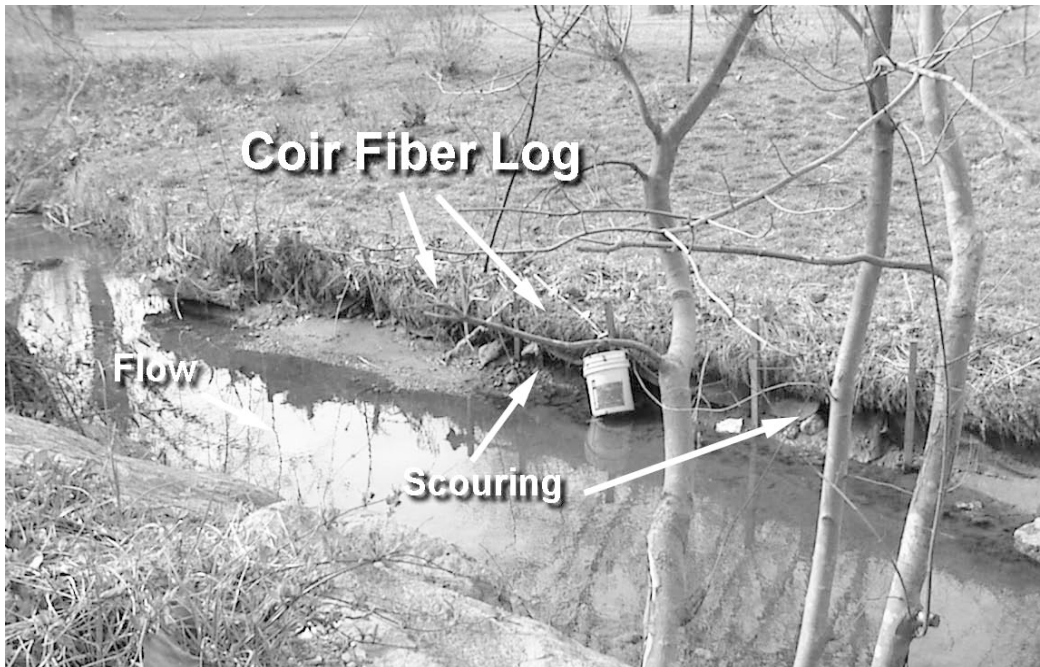
**Photo 5.17: Toe scour resulting in the undermining of coir fiber log installation.**
