KARST VOID MITIGATION FOR WATER QUALITY AND QUANTITY PROTECTION IN AUSTIN, TEXAS

By Sylvia R. Pope, Senior Environmental Scientist

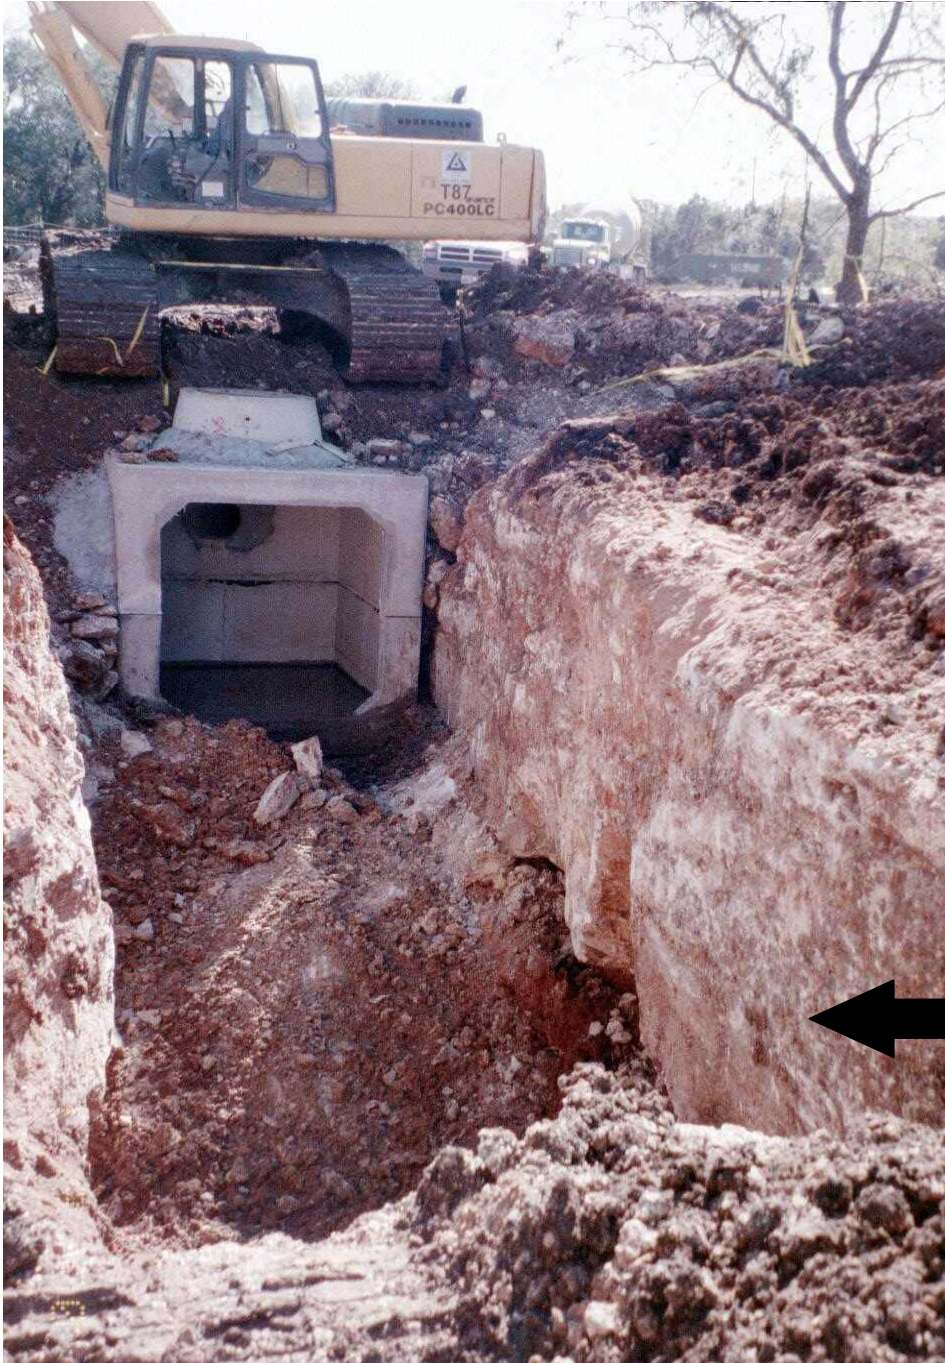
Lodge
Cave
prior to
sealing

Cave entrance,
west side

Lodge Cave was discovered on September 29, 2000, during trenching for a 1.8-m (6-ft)-diameter reinforced concrete pipe (RCP) stormsewer. The cave is an isolated feature ("interstitial void") that developed vertically along a fracture and horizontally along a fossiliferous, vuggy, friable horizon within the limestone. The "footprint" of the cave is approximately 21.4 m (70 ft) by 6.7 m (22 ft). The cave roof was intercepted by trenching equipment at a depth of approximately 3.1 m (10 ft) below grade. The cave interior was fairly dry, as evidenced by the abundant cave coral and popcorn formations, yet stalactites were dripping on September 29, 2000. Lodge Cave is considered a Type 2 void. Two-thirds of the cave will be beneath a future roadway.

Photographs of Lodge Cave are shown in the Appendix.

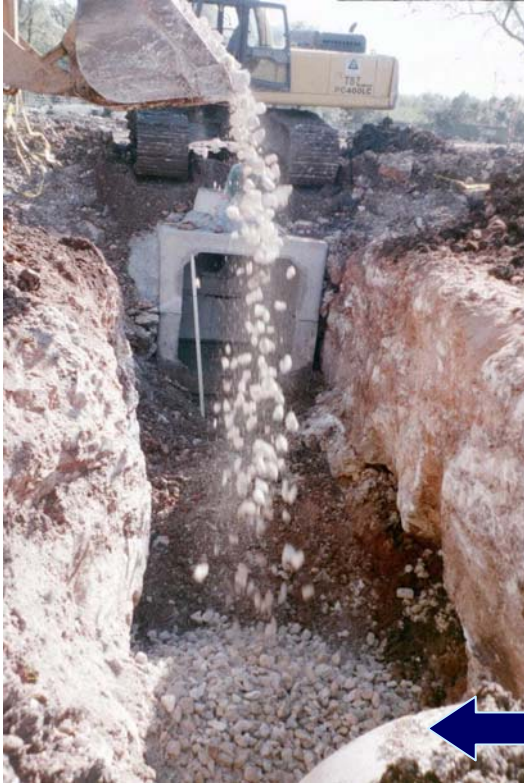
Backfill floor
of cave with
7 to 12-cm (3
to 5-inch)
gravel

1.8 m (6 ft) diameter
RCP stormsewer

- **Backfilling** 7.6 to 12.7-cm (3 to 5-inch) diameter rock at the base of the trench to support the 1.8-m (6-ft)-diameter RCP and to allow fluids to migrate along the cave floor;
- **Sealing off** the cave opening at the trench face with sand bags; and
- **Pouring a concrete slab** over the rock base that extends above the cave ceiling and for 1.5 m (5 ft) on each end of the cave opening. Dirt from the sidewalls of the excavation was removed by hand to ensure a strong bond between the limestone and the 17,237-kPa (2,500-psi) compressive strength concrete.

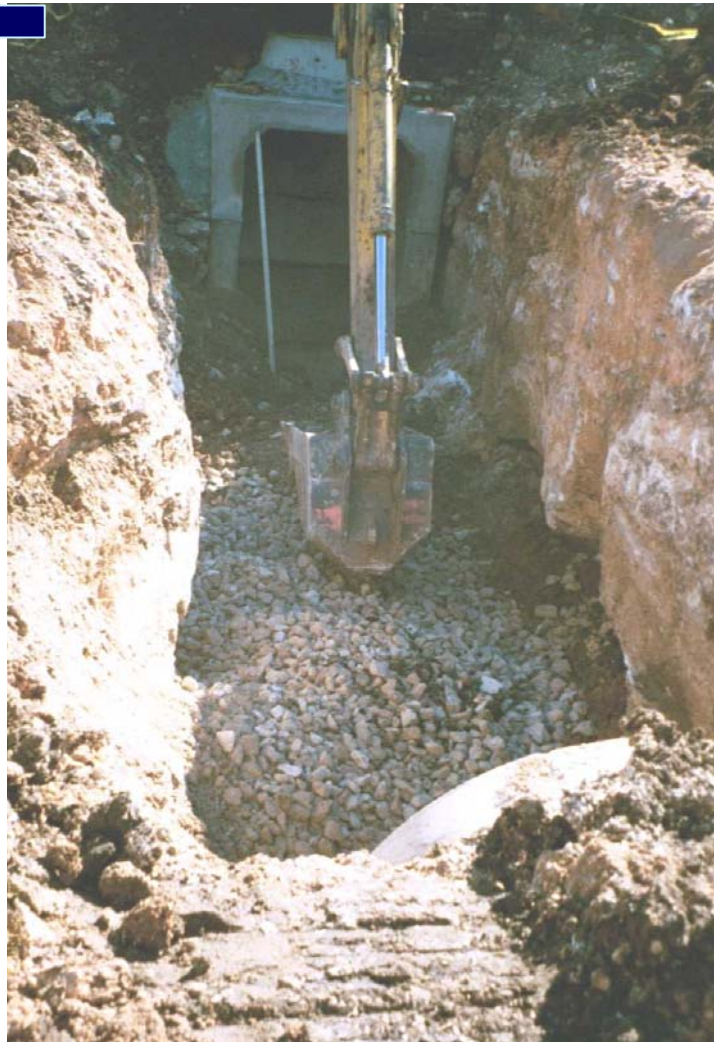
Tamp gravel
with trackhoe

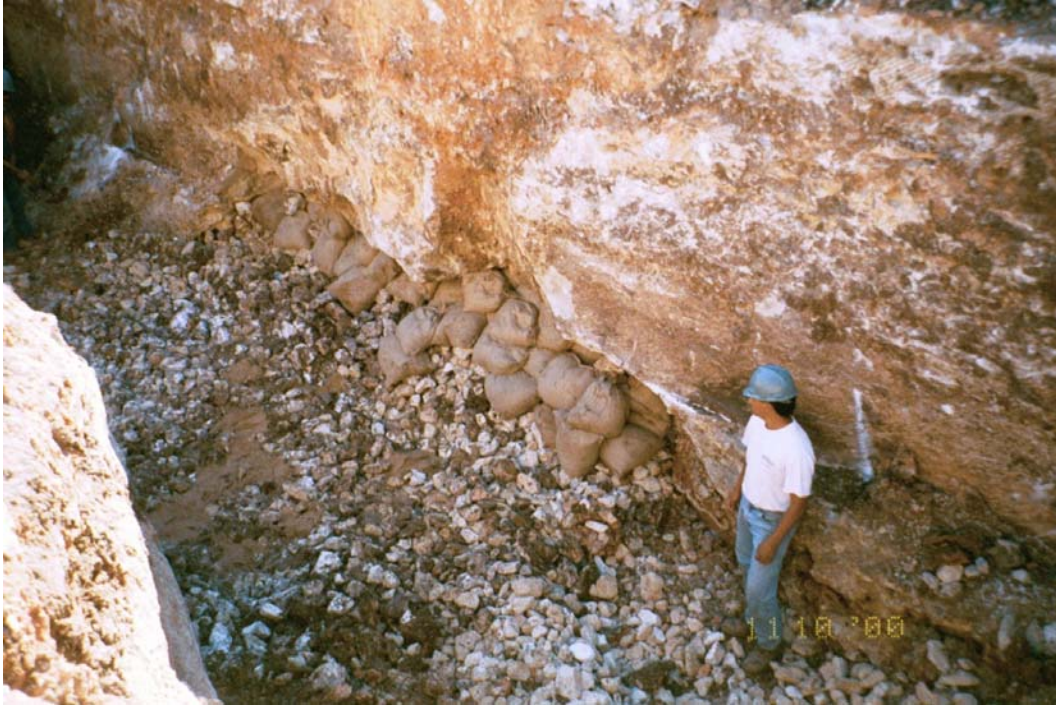
Sand bags placed inside cave opening.

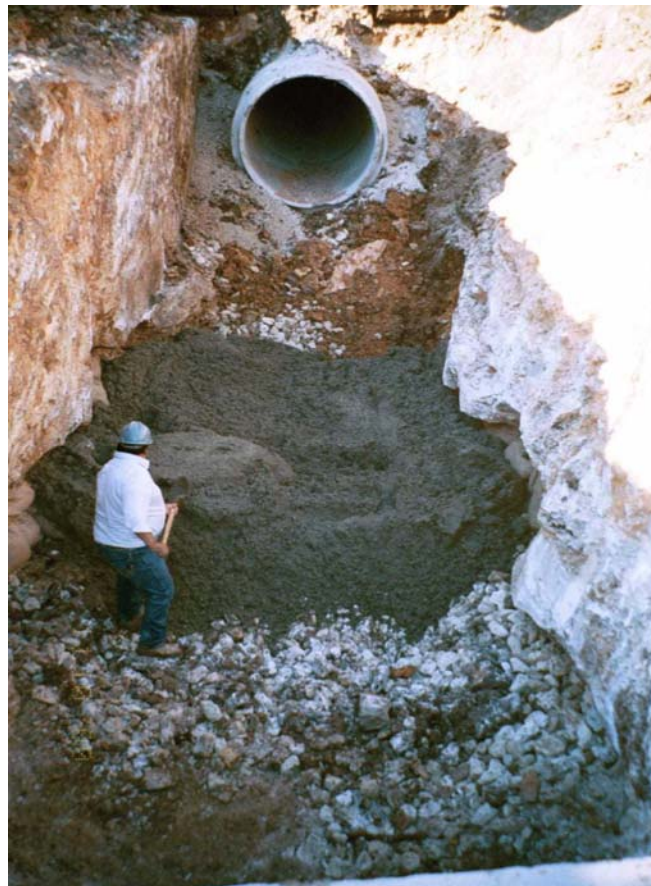
Concrete poured over gravel backfill

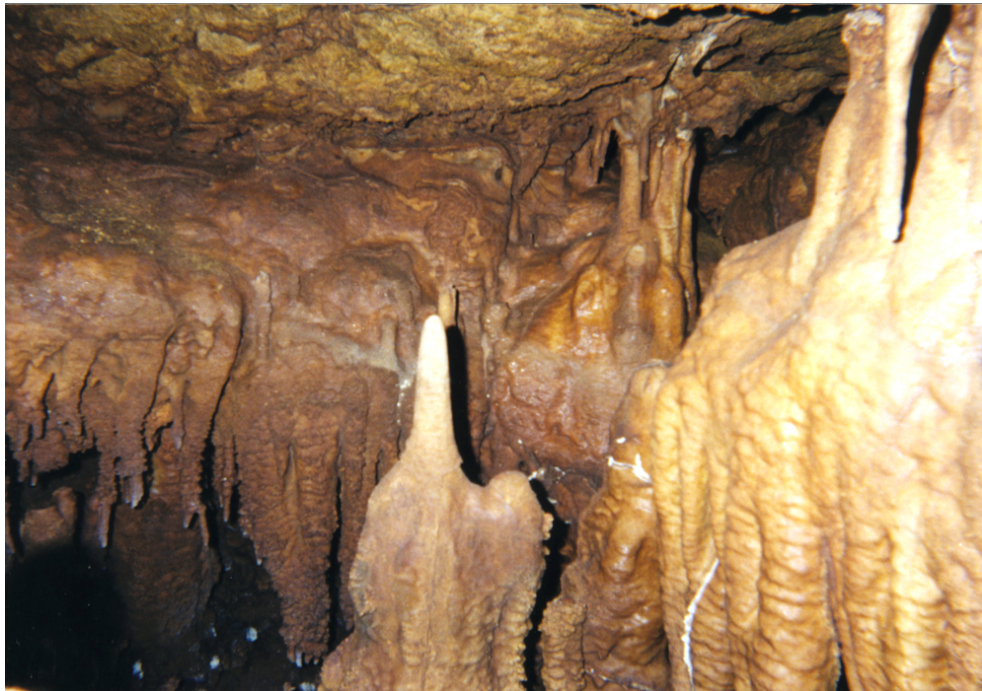
Void
interiors had
active
speleothems

A total of seven voids were intercepted along the trench for a 0.5-m (18-inch)-diameter RCP stormsewer. These ranged in size from 0.5 to 1.5 m (1.5 to 5 ft) in height and approximately 1.2 to 2.1 m (4 to 7 ft) in length and 0.3 to 1.4 m (1 to 4.5 ft) in width. The voids probably developed under phreatic conditions at or near the water table and are now active vadose zone features. Stalactites, stalagmites, flowstone, and cave popcorn were found in all of the voids (see example photographs in the Appendix). Tree roots, dark brown organic material, and spider webs found within one of the caves prompted a biological investigation, but no endangered karst invertebrate species were found.

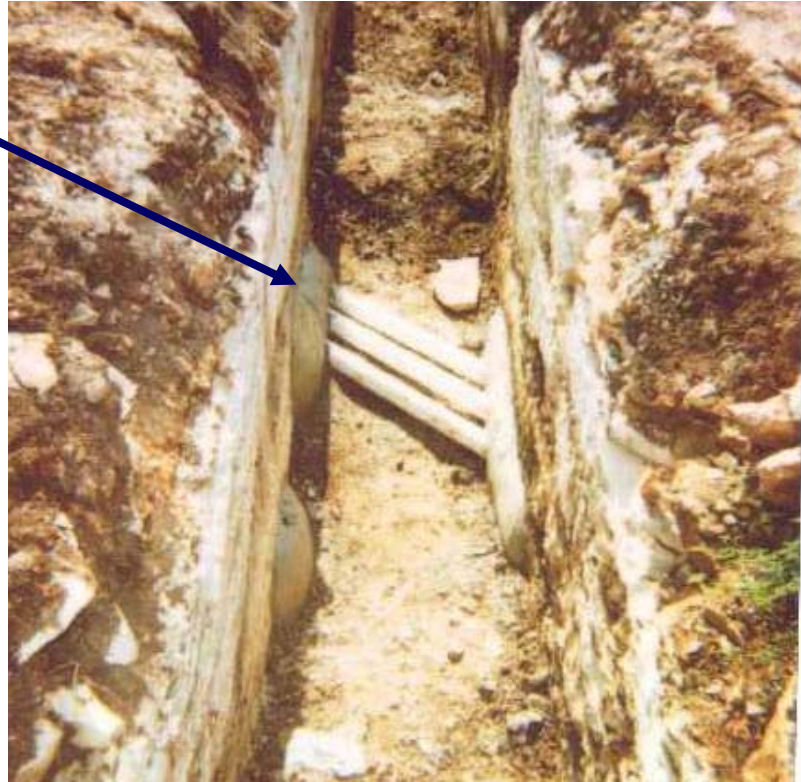
PVC pipe placed
below natural gas
pipeline to maintain
hydrologic
connection of void

Void closure,
Lonestar Gas Pipeline,
Parmer Lane,
Austin, Texas

- **Sealing** the openings along the face of the trench with rocks and mortar;
- **Installing PVC pipe** encased in concrete across the base of the trench to allow air, moisture, and fauna movement between voids intercepted by the trench;
- **Constructing small clay dams** within the trench to prevent fluid migration along the floor of the trench;
- **Encasing the gas pipeline** with 0.4-m (**16-inch**) diameter polyethylene pipe for the entire length of the void horizon (732 m or **2,400 ft**); and
- **Sealing** the encasement pipe and venting it to the atmosphere to prevent below ground releases of a future gas pipeline leak or rupture.

Figure 1 in the Appendix provides a photograph taken during the mitigation installation and an illustration of the mitigation strategy used for voids intercepted on one side of the trench.

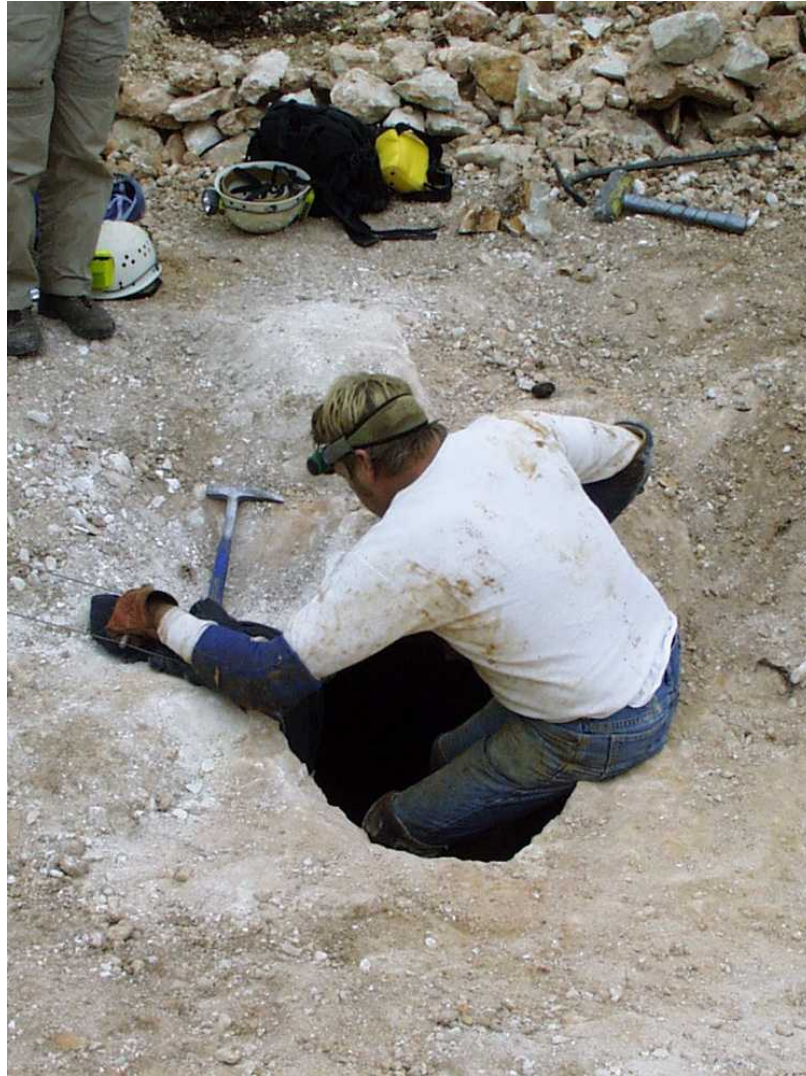
Millennium Cave
was found during
excavation of a
water quality
pond, January
31, 2000.

Mike Warton
entering the
skylight opening
in order to map
the cave and to
look for karst
invertebrates.

Millennium Cave was discovered on January 31, 2000, during excavation of a stormwater treatment sedimentation/filtration basin in the Village at Western Oaks subdivision. The trackhoe operator noticed a 0.4-m (15-inch) diameter opening in the rock and stopped to inspect the opening. He immediately

moved the trackhoe back from the opening after seeing that it dropped approximately 4.3 m (14 ft) and widened out to the sides 4.6 m (15 ft) or more. A thorough inspection by a cave specialist revealed that the main chamber of a cave had been popped open. The chamber is approximately 16.2 m (53 ft) wide by 13.4 m (44 ft) long by 4.3 m (14 ft) deep. The cave contains many stalactites, stalagmites, and flowstone formations. No surface expression of Millennium Cave was present prior to its discovery, but two caves are located within 153 m (500 ft) in a designated karst preserve.

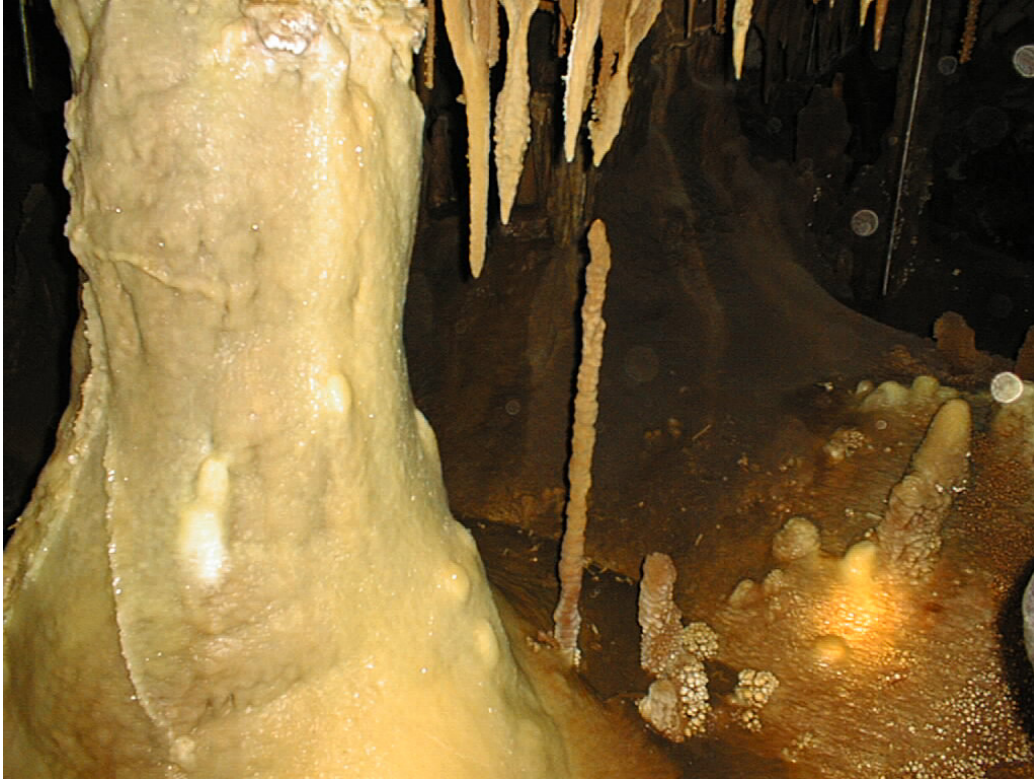
Interior of Millennium Cave: 0.9-m diameter column, stalactites, stalagmites and cave coral

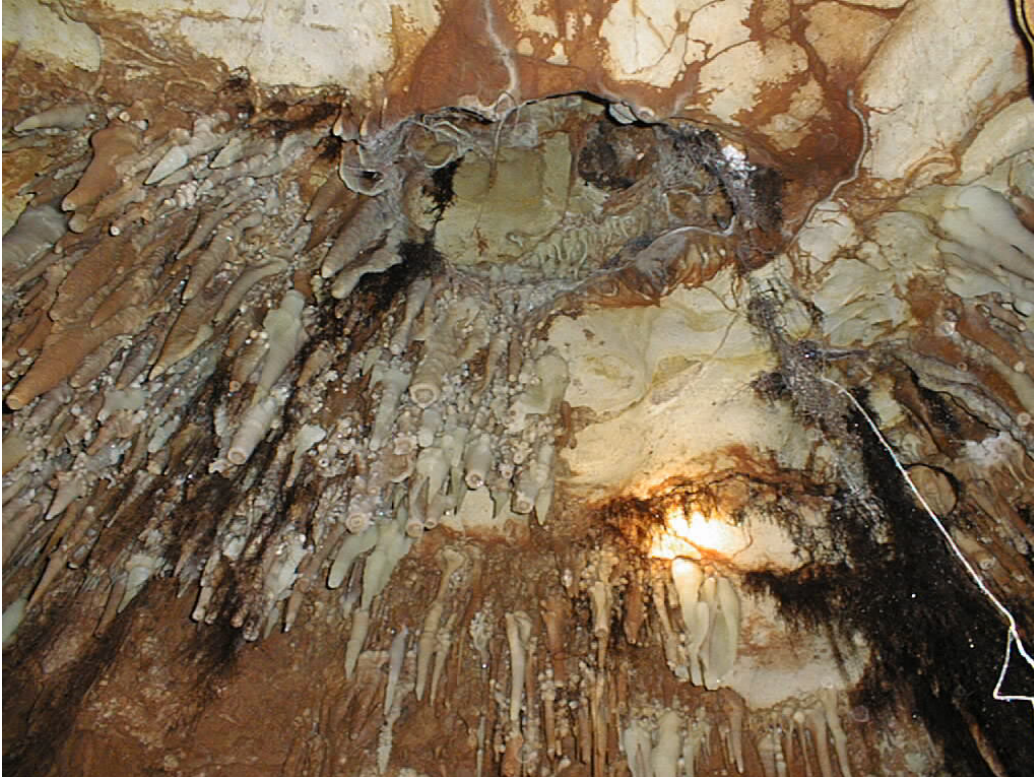
Millennium Cave is one of the largest and most “decorated” caves found during construction in Austin, Texas

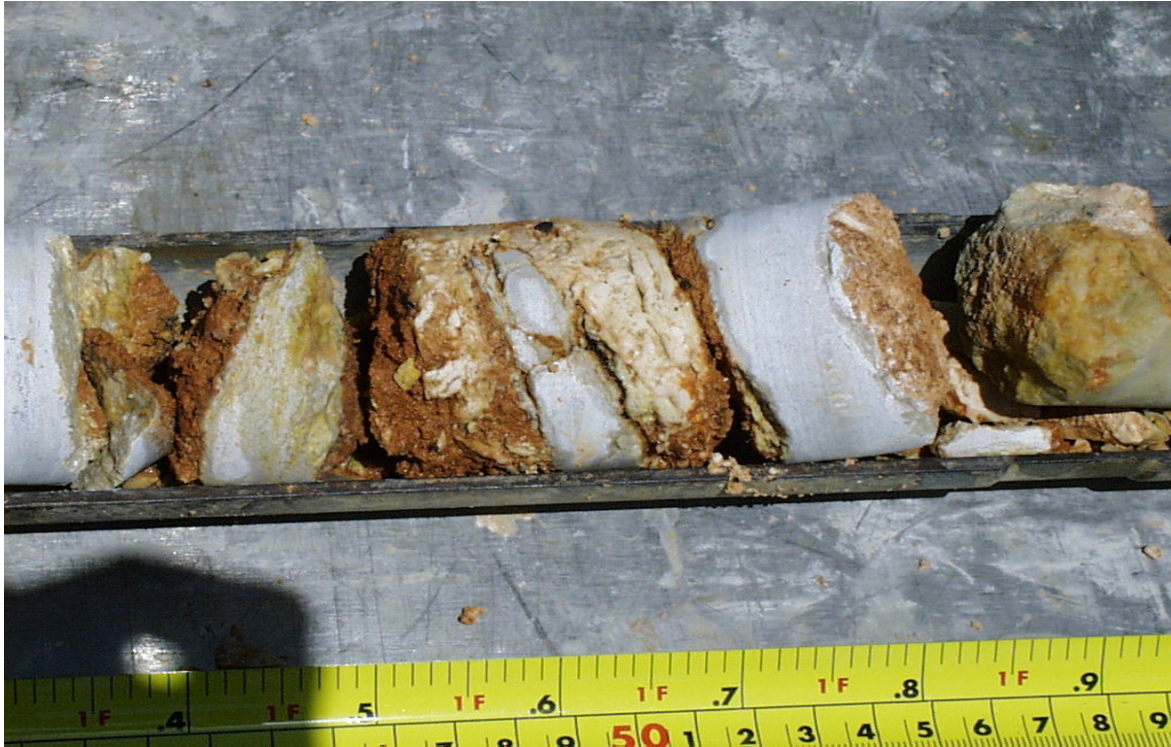
Coring was conducted in the water quality pond excavation to identify possible voids and passages connected to Millennium Cave.

Void mitigation for Millennium Cave was fairly complex due to the size of the cave and the proximity of the sedimentation/filtration basin. City of Austin WPDRD staffers were concerned that construction of the sedimentation/filtration basin adjacent to the cave and over undetected voids would lead to future failure of the structure and that the WPDRD would have to repair the structure. The owner was concerned that a proposed wet pond, to be constructed within 762 m (2,500 ft) of the sedimentation/filtration basin, would intercept a cave during excavation. The owner proceeded with exploratory geotechnical cores in the vicinity of the wet pond.

Preliminary discussions between the owner and the WPDRD to move the sedimentation/filtration basin were unsuccessful. Next, discussions focused on resizing the sedimentation/filtration basin, installing a structural wall adjacent to Millennium Cave, conducting void collapse analyses, and drilling geotechnical cores in the vicinity of the sedimentation/filtration basin. The void collapse analyses relied upon the calculations presented in Ford and Williams (1989) and White (1988) and the thickness of the limestone beds measured in Millennium Cave (Trinity Engineering, 2000). Several of the cores intercepted a friable/void horizon between depths of 3.7 to 6.1 m (12 to 20 ft), including a 1.2-m (4-foot) void detected in one of the borings. Photographs of Millennium Cave are provided in the Appendix.

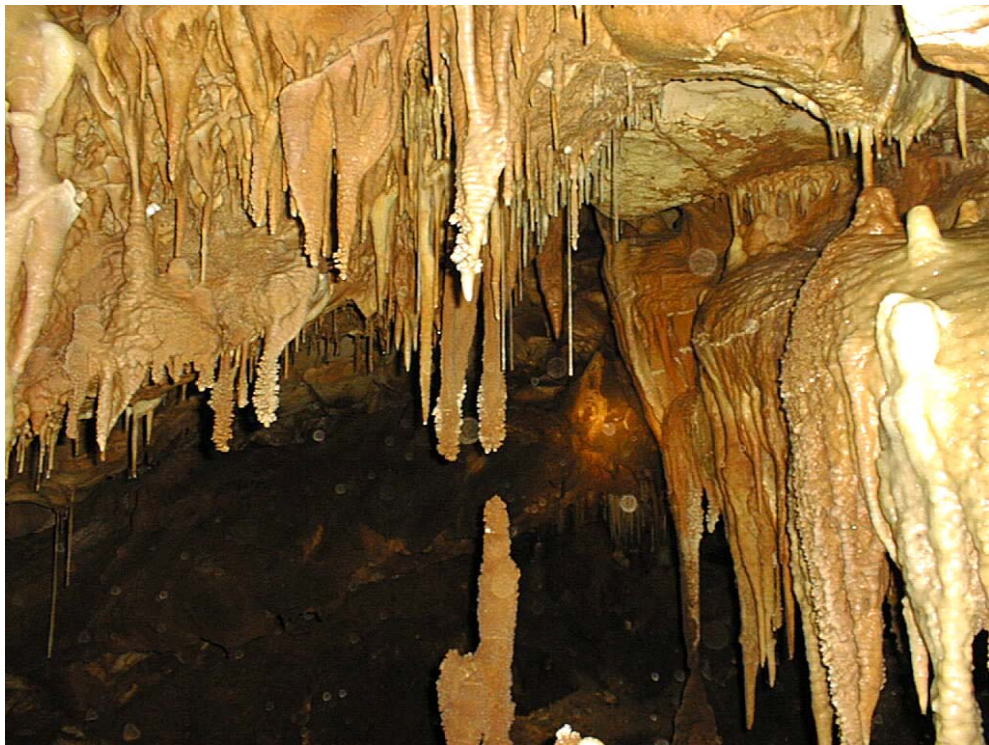
Interior of Millennium Cave
