Stormwater Quality Benefits of a Porous Asphalt Overlay

| CTR Technical Report: | 0-4605-2 |
| Project Title: | Stormwater Quality Documentation of Roadside Shoulders Borrow Ditches |

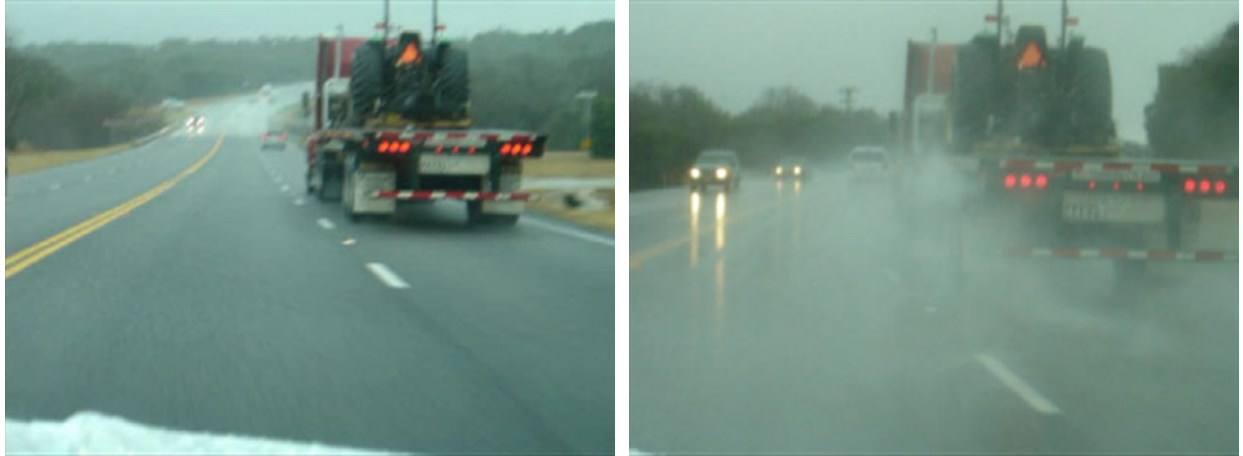
Figure 1.1: Difference in Spray from Conventional and PFC Pavements

Porous asphalt is an alternative to traditional hot mix asphalt and is produced by eliminating the fine aggregate from the asphalt mix. A layer of porous asphalt approximately 50 mm (2 in.) thick is placed as an overlay on top of an existing conventional concrete or asphalt surface. The overlay typically is referred to as Permeable Friction Courses (PFC), Open Graded Friction Courses (OGFC), Porous European Mixtures (PEM), or plant mix seal coats. The void space in a PFC overlay layer generally is 18–22 percent (1). Rain that falls on the friction course drains through the porous layer to the original impervious road surface, at which point the water drains along the boundary between the pavement types until the runoff emerges at the edge of the pavement.

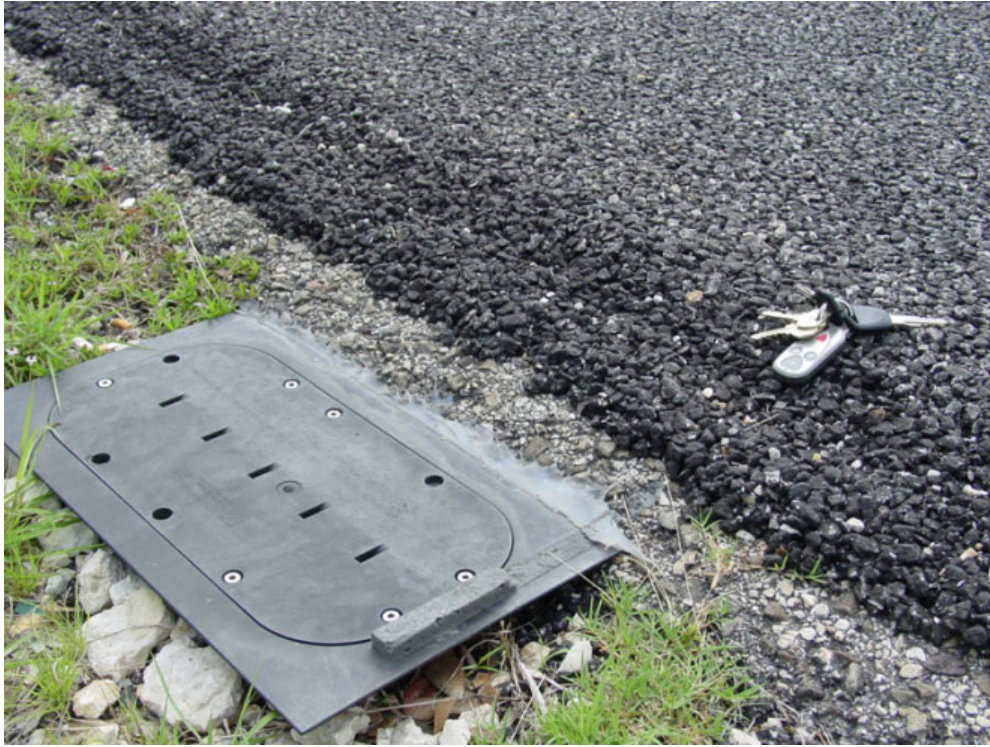
Figure 3.1: Photograph of installed sampler at edge of pavement.

The GKY sampler was placed in a test flume and several calibration tests were run at flow depths of less than 0.25 in. (6 mm) to depths of 2 in. (50 mm) at Texas A&M University (unpublished) before installation. The shallow sheet flows gave very good performance, requiring approximately 15–45 minutes to collect a 1.3-liter sample, depending on the number of openings unplugged. Although these are called *first flush* samplers, a substantial amount of rainfall was required to collect sufficient volume of runoff for analysis. The smallest event providing sufficient runoff volume was 0.5 in. (13 mm); consequently, this configuration allowed sampling of the entire storms for rainfall volumes less than about 1.5 in. (38 mm).

Prior to each event, a clean sampling container was also placed inside the sampler and the sampler ports and flaps inspected and cleaned to remove any collected mud or dirt. The rain gauge also was emptied and flushed of collected leaves and dirt. The plastic sampling container was removed and capped at the conclusion of each rain event. Occasionally, sites were visited during rain events to confirm that the sampler was accepting the runoff properly. The samples were transported to the laboratory for preservation and analysis when storms produced enough runoff volume to adequately collect in the samplers. Records were made during each site visit of rainfall volume, of volume collected in samplers, and of general site conditions.

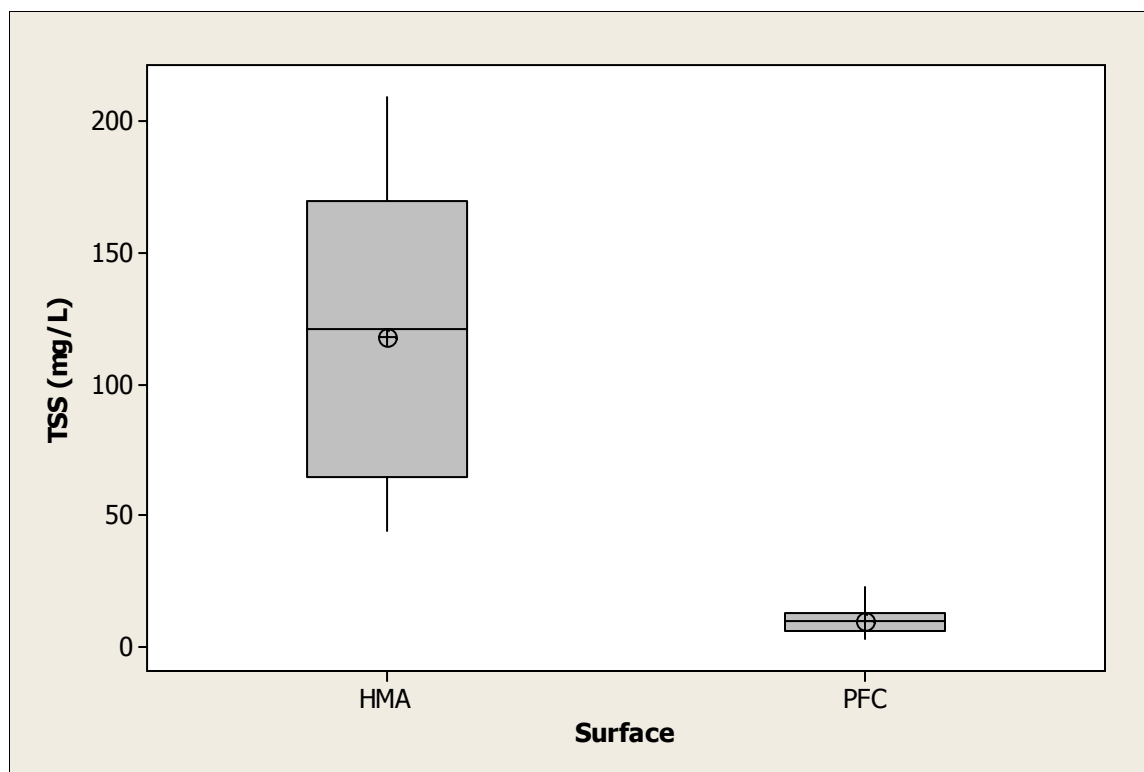
Figure 4.1: Boxplot of TSS EMCs for conventional HMA and PFC.

The data indicate that the runoff generated from the PFC surface has consistently lower concentrations of particles and particle-associated pollutants than that from the traditional asphalt surface. This difference in water quality also was noted upon visual inspection of the runoff samples collected at the edge of pavement. The concentrations of nitrate/nitrite, dissolved copper and zinc, and total and dissolved phosphorus did not exhibit a significant difference between the two road surfaces. These data indicate that the PFC has little to no effect upon the concentrations of dissolved constituents in the stormwater runoff. A boxplot demonstrating the differences between TSS concentrations in the runoff from the conventional hot mix asphalt (HMA) pavement and PFC is presented in Figure 4.1.

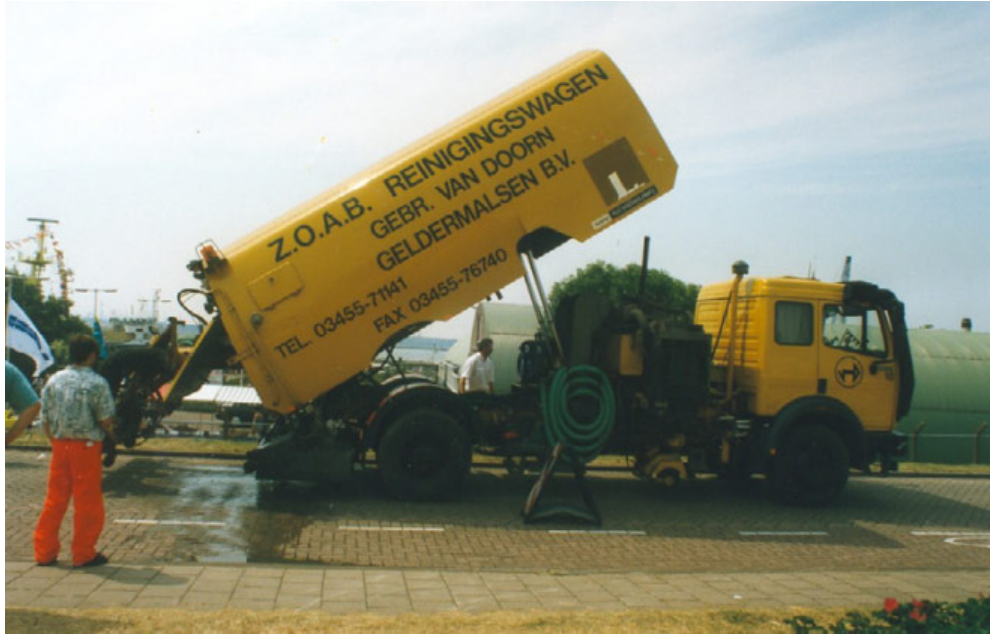
Figure 4.4: PFC (ZOAB in Dutch) cleaning machine.

It has been demonstrated that an aggressive maintenance program that includes specially designed vehicles for cleaning the pavement can maintain the performance of PFC for a considerable period (3). These vehicles contain both pressure washing and vacuum equipment to remove the accumulated pollutants (Figure 4.4). In the Netherlands, this type of street cleaner is used to wash the hard shoulders twice a year to maintain performance. It seems unlikely that the water quality benefits will persist without some effort of this type. A long-term monitoring project to document changes in performance and to evaluate different maintenance strategies is recommended for future research.

The type of equipment used for PFC cleaning in Europe has never been evaluated in the United States and its use might also improve the quality of runoff from conventional asphalt pavements. The problem with conventional sweepers is that they are substantially more effective for the larger particles and typically have had little impact on runoff quality (4). It is likely that street cleaning (as opposed to sweeping) would have to be conducted much more frequently on a conventional asphalt surface, because there is less room for storage of accumulated material in the surface roughness elements of conventional asphalt and this material is more subject to the forces of vehicle tires, which can remobilize the accumulated pollutants.
