BRONX RIVER WATERSHED MANAGEMENT PLAN (VOLUME 1)

BRONX RIVER WATERSHED ASSESSMENT AND MANAGEMENT REPORT WESTCHESTER COUNTY, NEW YORK

October 2007

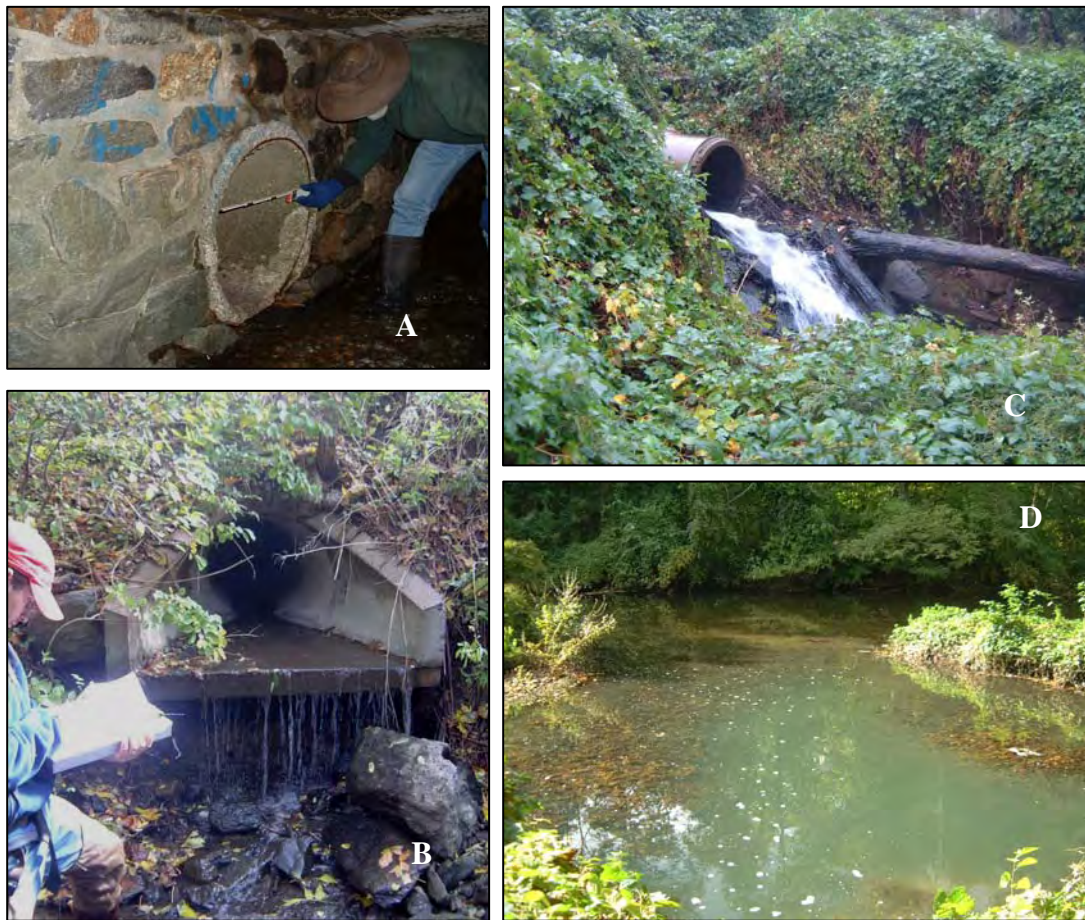
Figure 3-3: Field crews evaluated outfalls (A), looking for maintenance issues like undercutting (B) in Sprain Brook at reach SB-21 and suspected illicit discharges for further investigation like OT-1 discharge in Sprain Brook at reach SB-6 (C) and as evident with suds and murky/greenish discharge in Bronx River Middle Direct Drainage at reach BRM-1a (D).

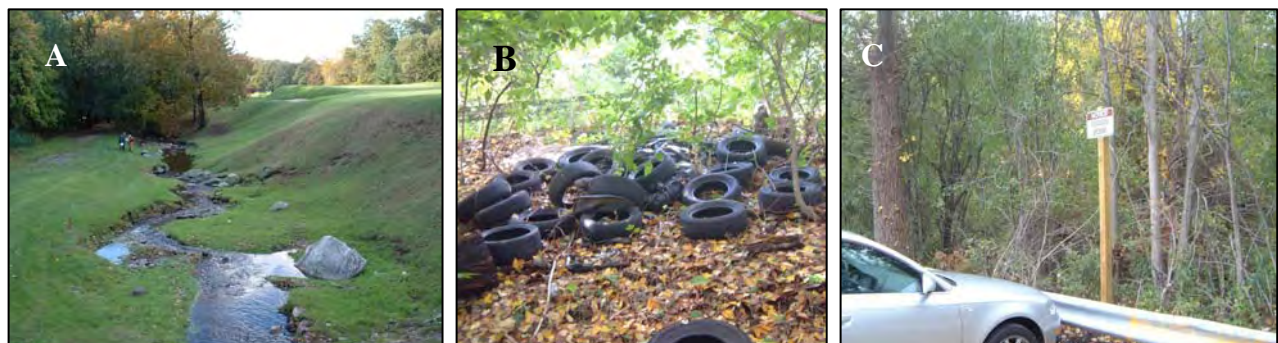
Figure 3-4: Examples of encroachment into stream buffers include (A) removal of riparian vegetation at a golf course in Manhattan Park Brook at reach MP-1; (B) dumping of waste materials in Sprain Brook at reach SB-17; and (C) encroachment of a parking lot in Bronx River Upper Direct Drainage at reach BRU-2.

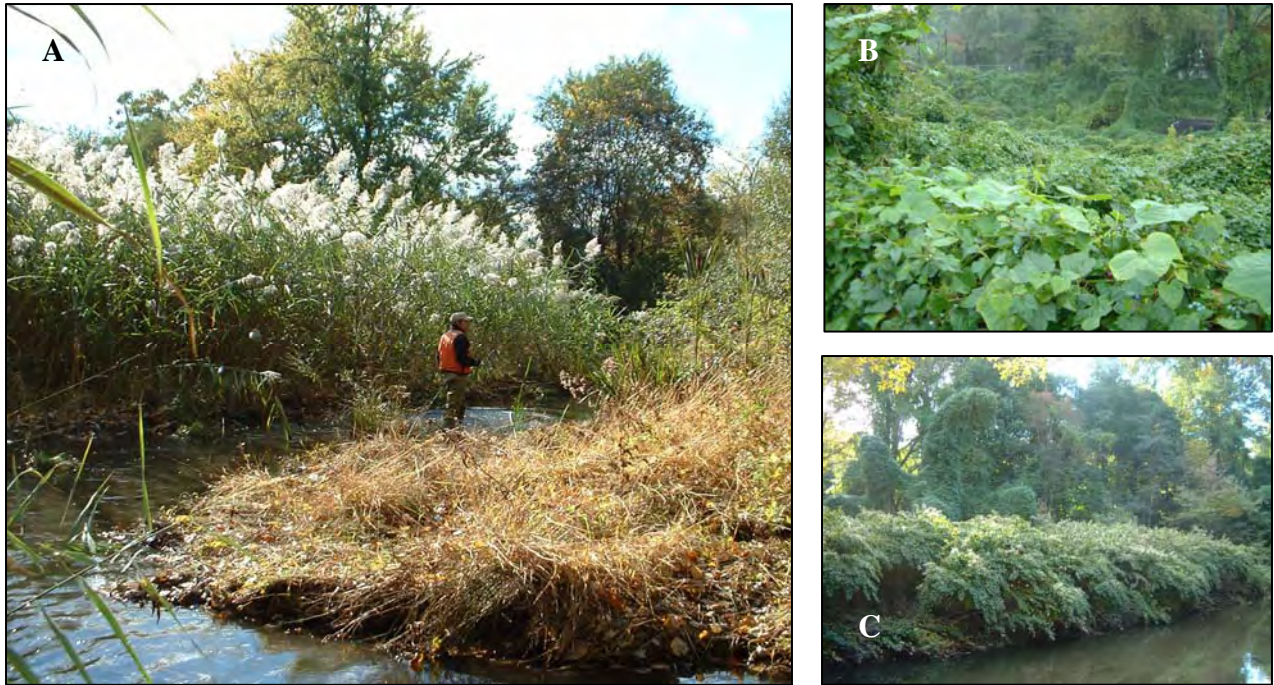
Figure 3-5: Extensive invasive plants were observed including (A) Phragmites in Manhattan Park Brook along reach MP-6; (B) Porcelain Berry at the Yonkers Waterworks in Sprain Brook along reach SB-3; and (C) Japanese Knotweed in Bronx River Upper Direct Drainage along reach BRU-5.

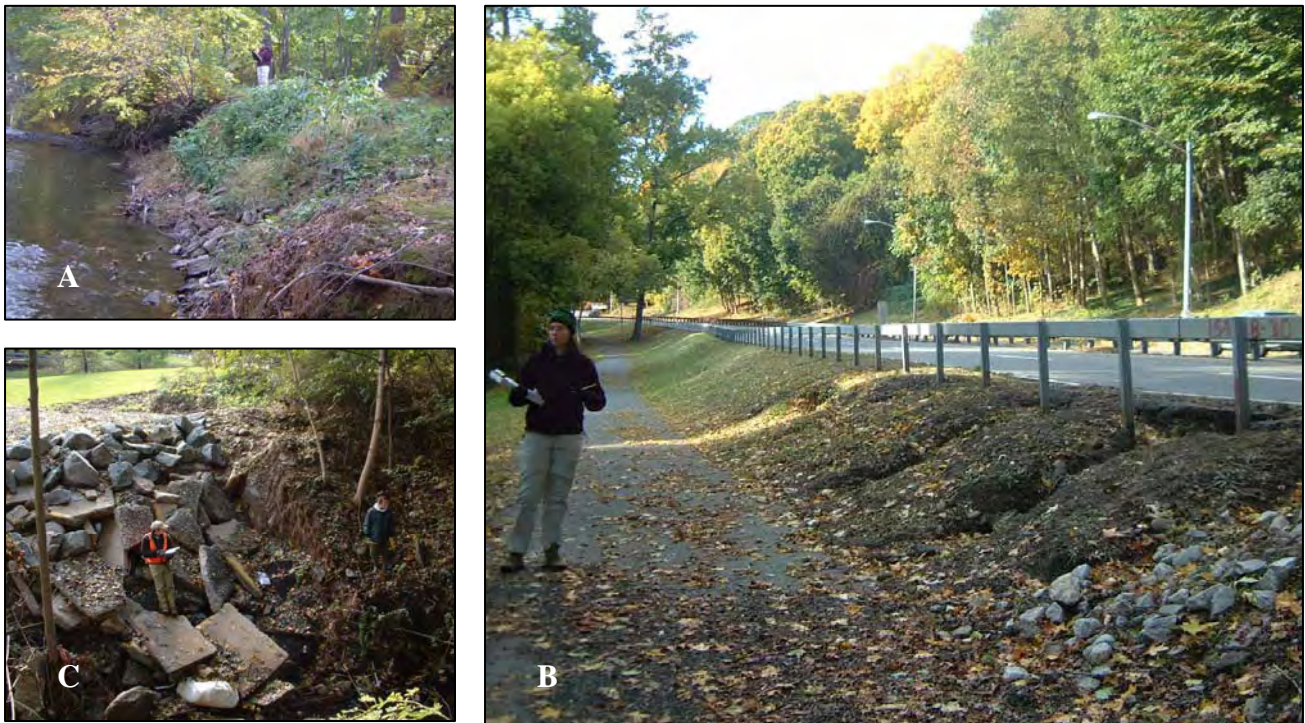
Figure 3-6: Problems with (A) stream bank erosion, (B) erosion in the upland corridor, and (C) head cuts were noted by field crews. These examples are from reaches in Bronx River Upper Direct Drainage (BRU-6 and BRU-5) and Manhattan Park Brook (MP-3), respectively.

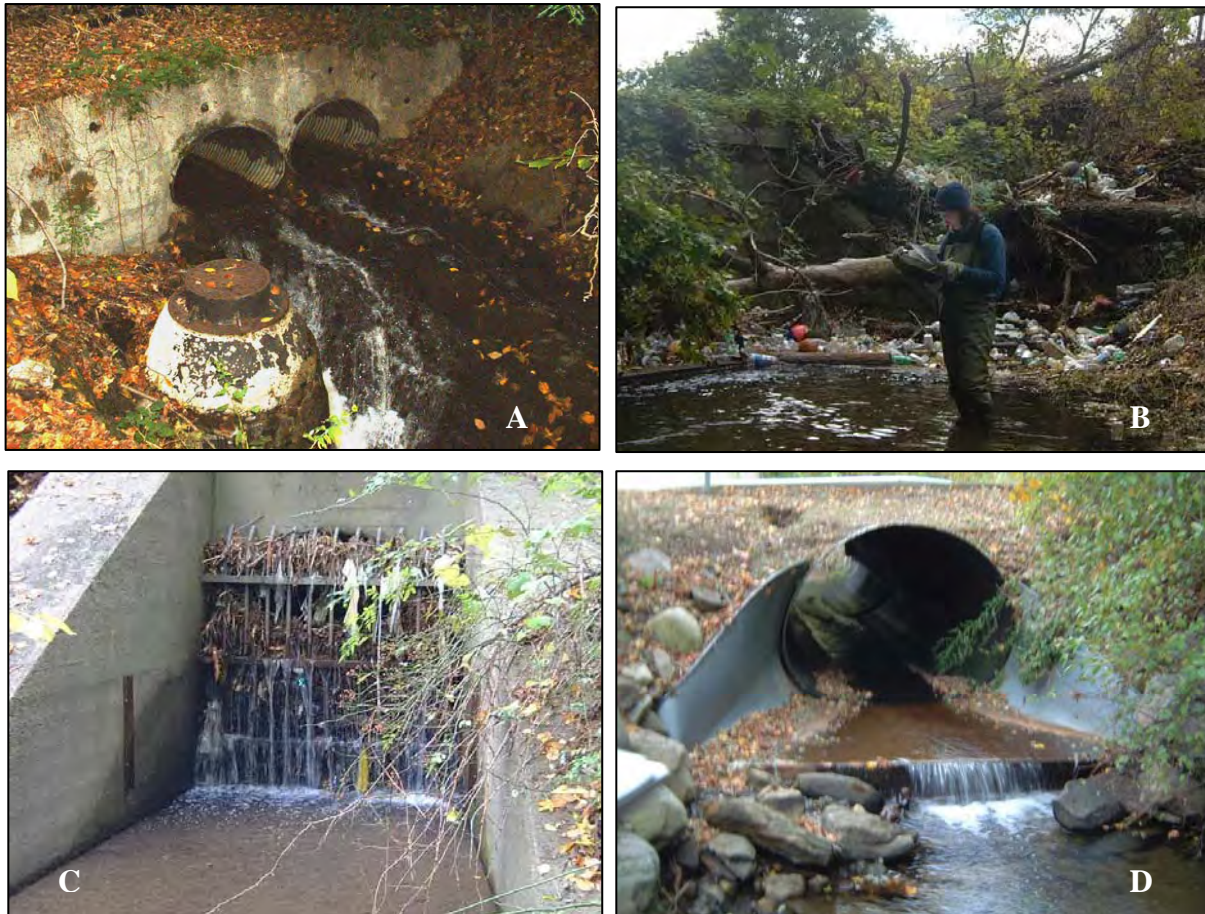
Figure 3-7: Field teams noted potential problems with utility crossings (A), and culverts that required debris or trash removal, such as (B) a debris jam and trash accumulation and (C) a blocked grated culvert in Davis Brook in reach DB-8. (D) Locations of potential fish barriers were also noted like the one here in Davis Brook in reach DB-2.

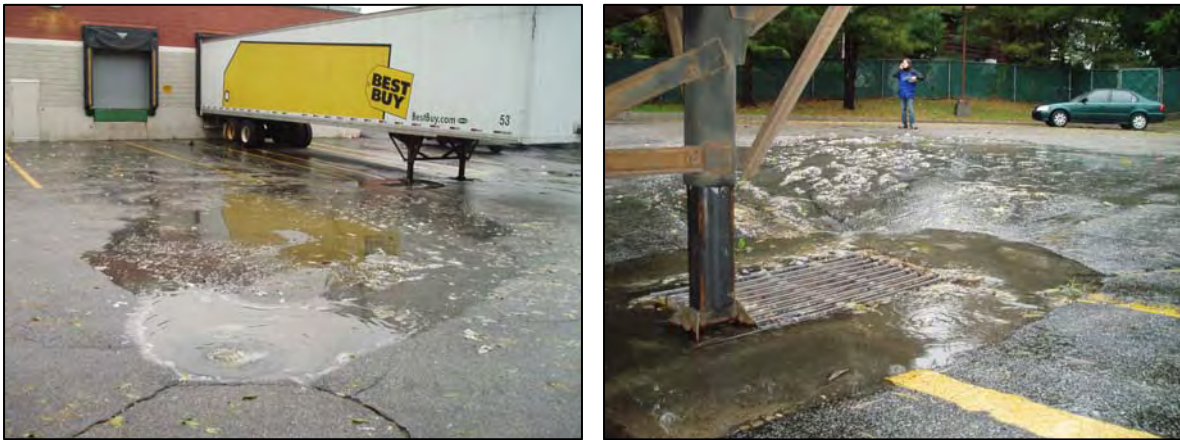
Figure 3-8: A sewer overflow was observed in the loading area in back of the Best Buy shopping center on Central Avenue in Fulton Brook Subwatershed (site ID FB-H2). Overflow drained into storm drain, which discharged directly into stream.

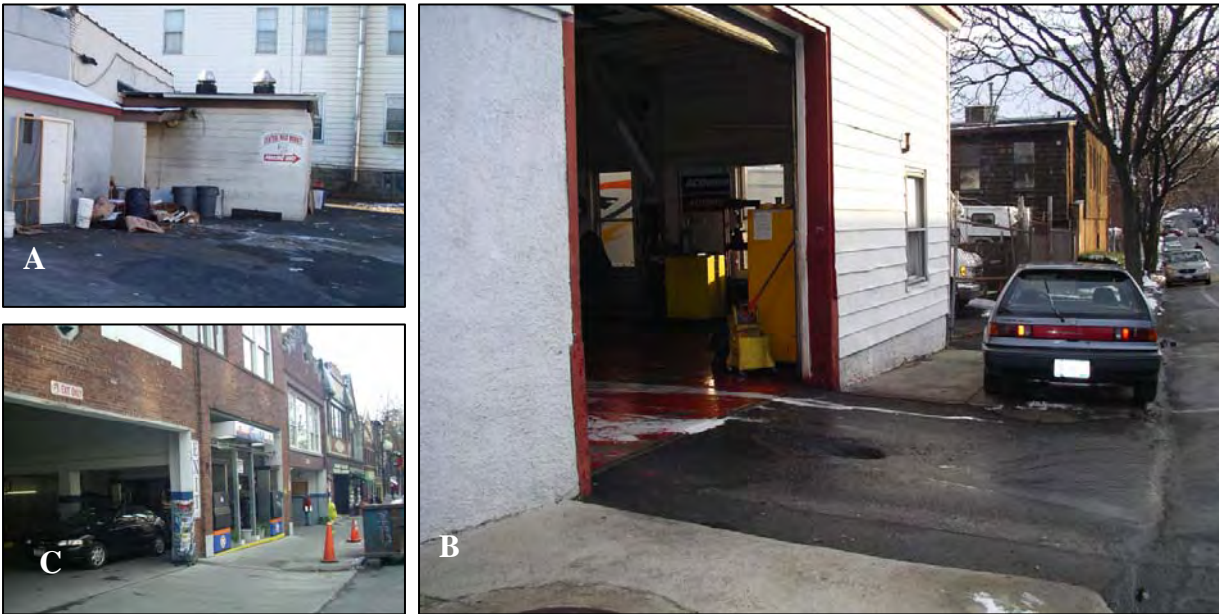
Figure 3-9: Other businesses such as restaurants, gas/service stations and car washes can also be potential stormwater hotspots. (A) poor dumpster management and waster storage practices, as the practice of (B) rinsing of garage floors out onto the street can contribute to polluted runoff. (C) Fueling islands at this gas station in Scarsdale were indoors and protected from rain.

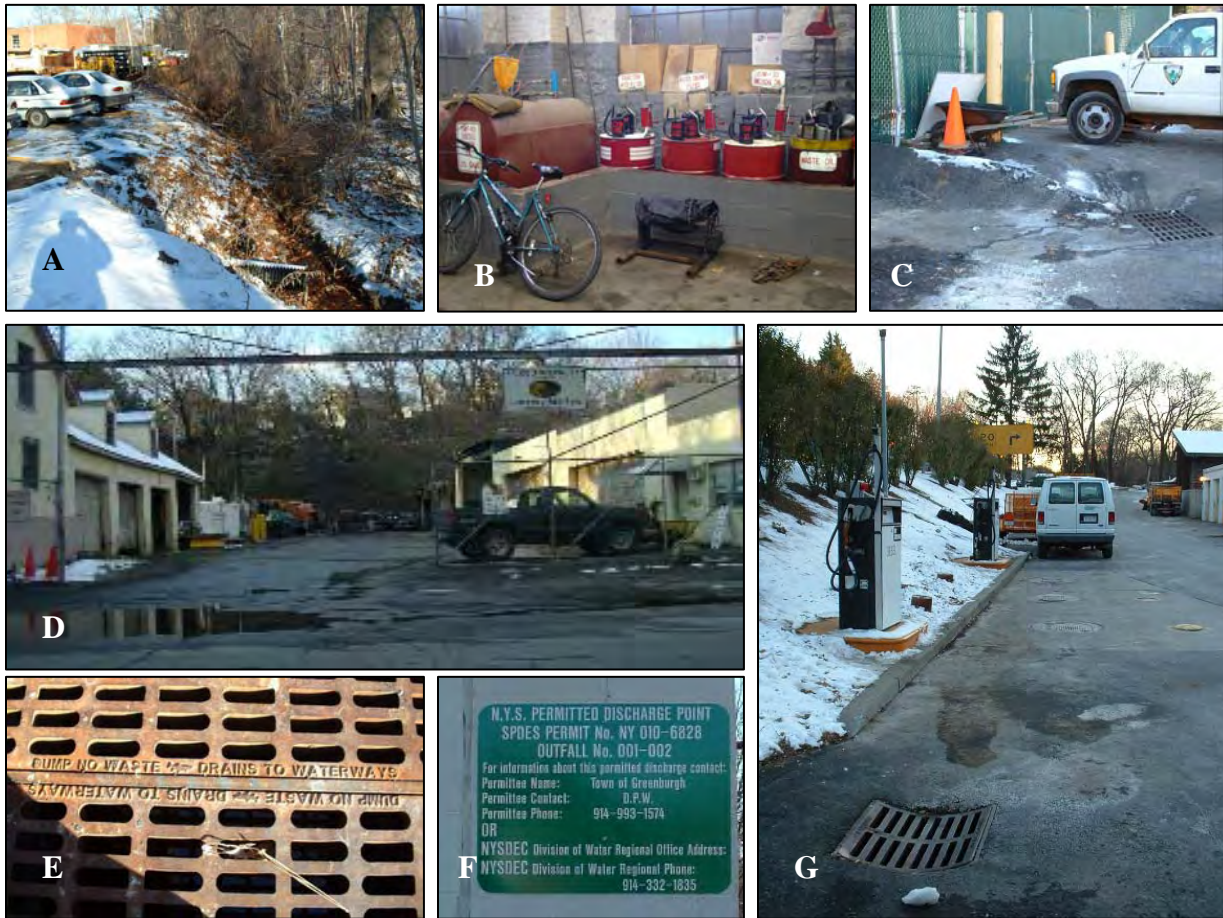
Figure 3-10: Municipal maintenance facilities were confirmed hotspots, though good practices were observed. Specific observations include: (A) stream and wetland encroachment; (B) secondary containment; (C and D) evidence of polluted drainage to storm drains; (E) drain stenciling; (F) posting of signage; (G) fueling islands draining directly to storm drains.

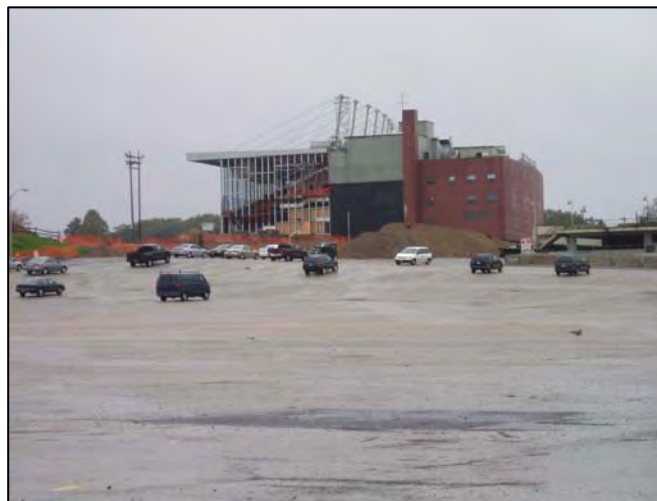
Figure 3-11: The racetrack in Yonkers provided stormwater retrofit, pollution prevention, and erosion and sediment control opportunities during construction.

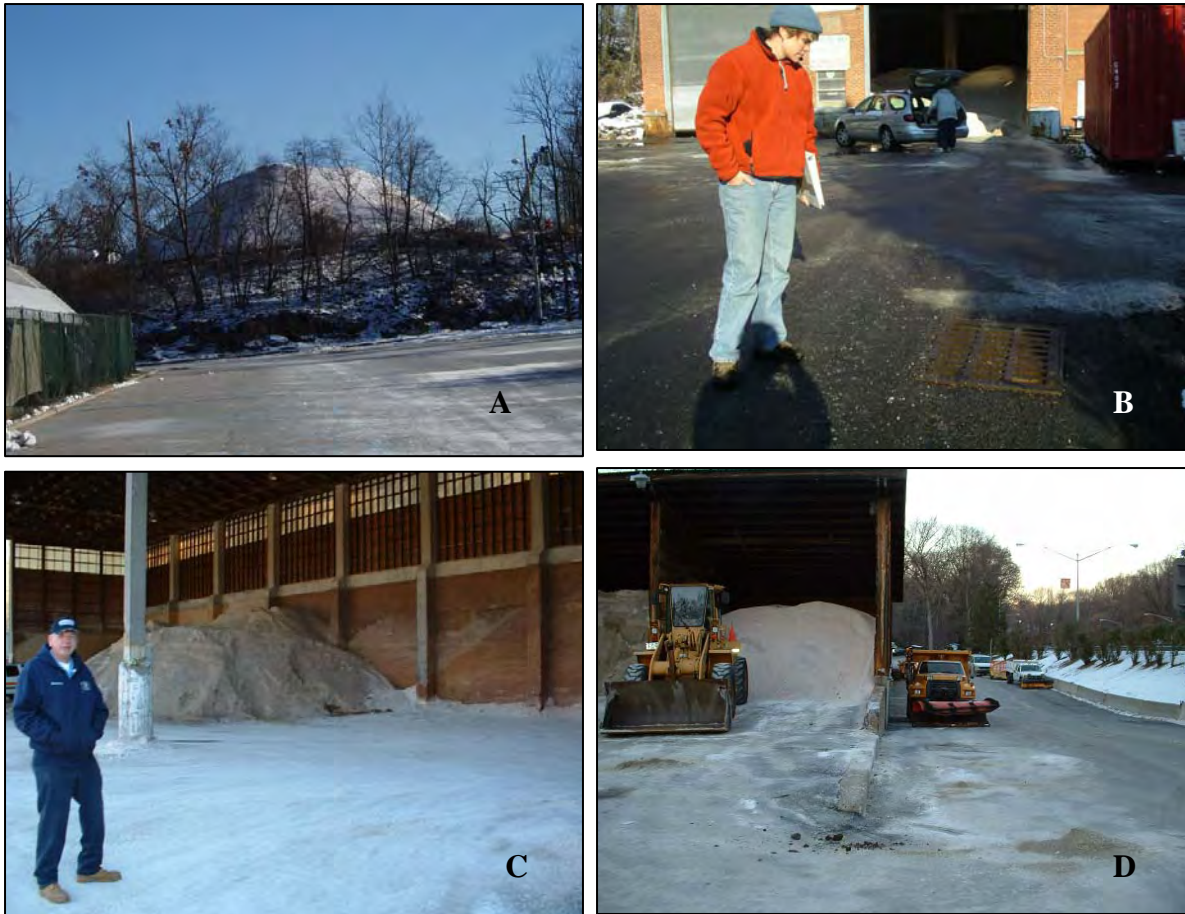
Figure 3-12: Salt storage practices ranged from (A) uncovered stockpiles in Yonkers, to covered storage areas that were (B and D) directly connected to storm drains in Eastchester and County Reservation Yard, or (C) were sloped to help contain salt in Greenburgh.

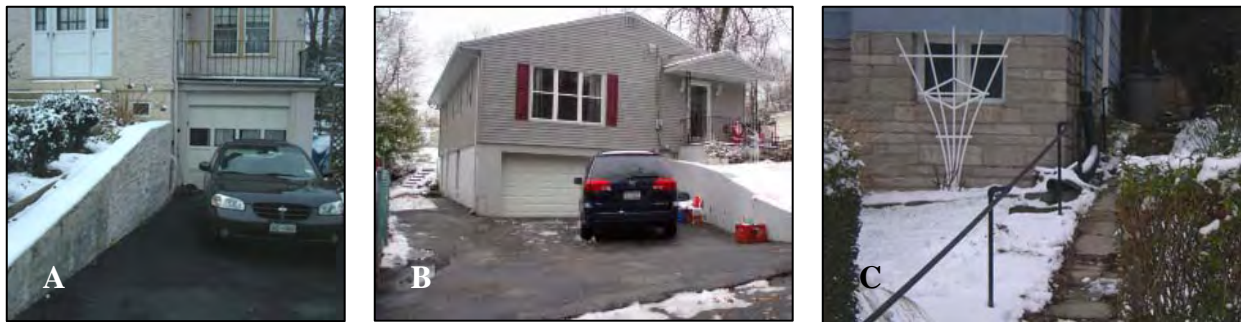
Figure 3-14: Opportunities for downspout disconnection in residential areas are plentiful. (A) shows a downspout directly connected to the storm drain system or to outlets on the street curb (B) shows a downspout draining onto driveway, which may subsequently drain to a pervious area or to the storm inlets on the street. (C) Shows a diverted downspout into a lawn area or landscape feature, which is preferable where feasible.

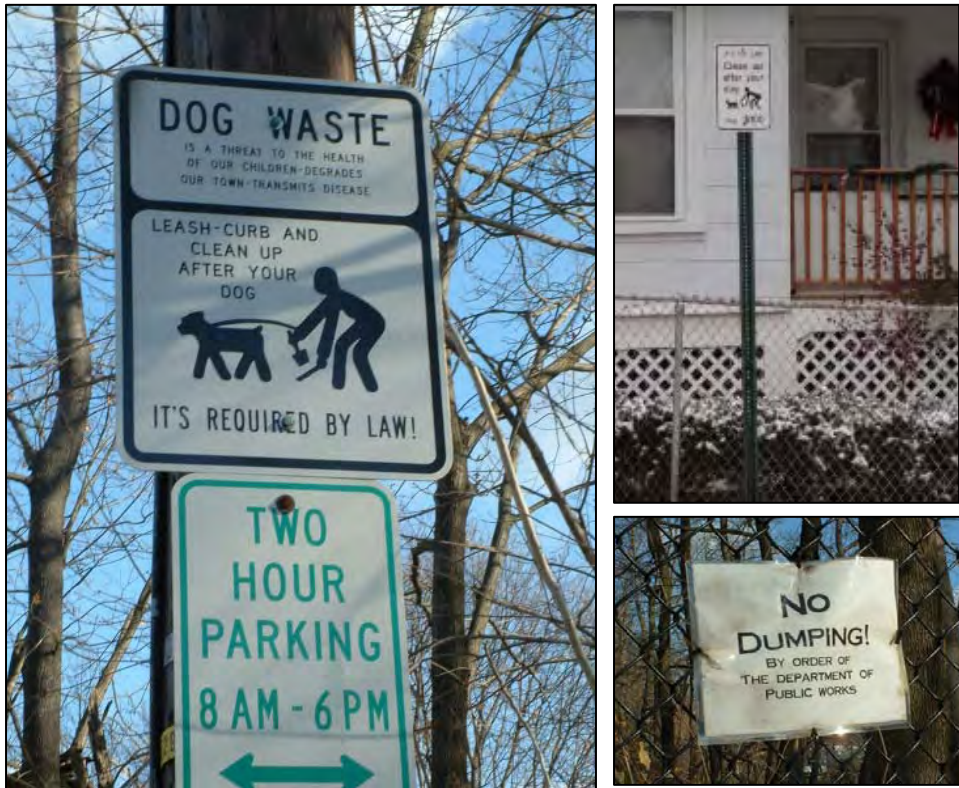
Figure 3-15: Relatively little signage was seen in residential areas touting pollution prevention behaviors.

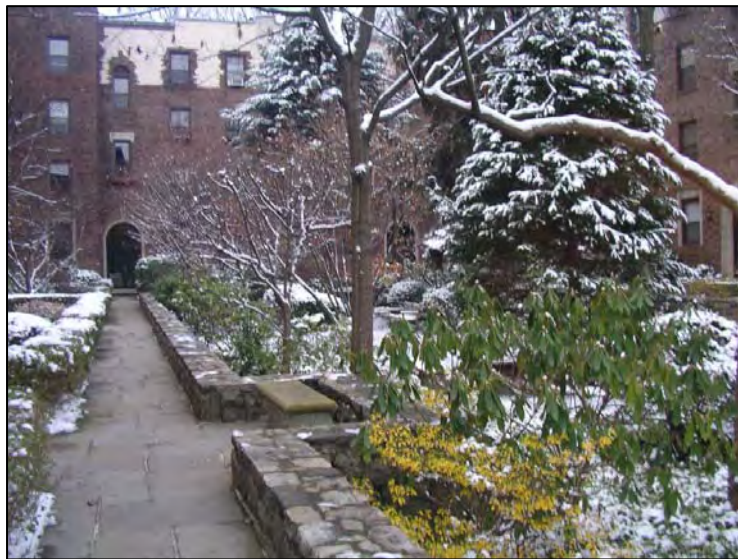
Figure 3-16: Apartment complexes with courtyards and common space offer opportunities for downspout disconnection. This courtyard in Bronx River Middle Direct Drainage (site ID BRM-N4) at Sangamore Rd. apartments offers an interesting landscape, however downspouts are internal to the building.

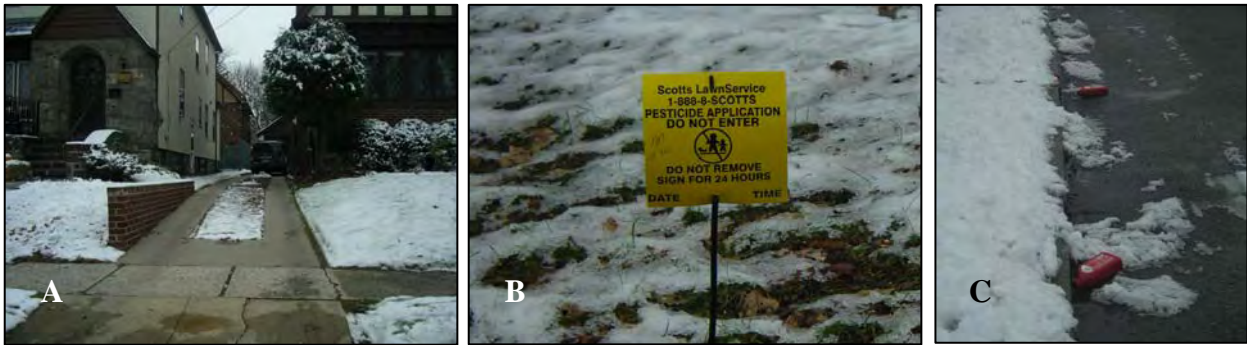
Figure 3-17: Other notable features in residential areas included (A) two-track driveway designs that help reduce impervious cover, (B) evidence of lawn chemical application in the winter, and (C) evidence of homeowner car maintenance with a potential for oil and grease to enter stormdrain.

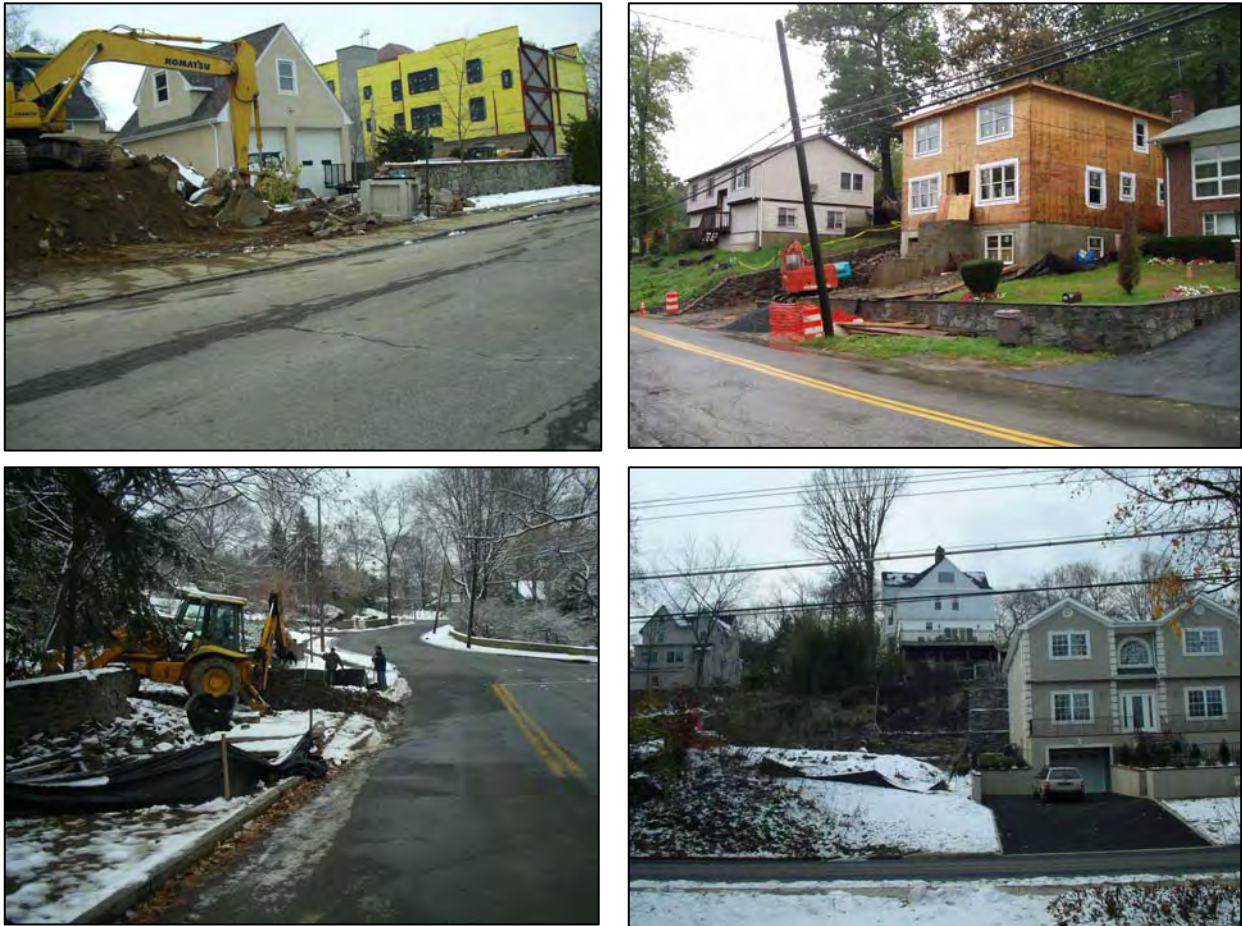
Figure 3-18: Construction in residential areas was mostly single lot infill and redevelopment with poor erosion and sediment control implementation.

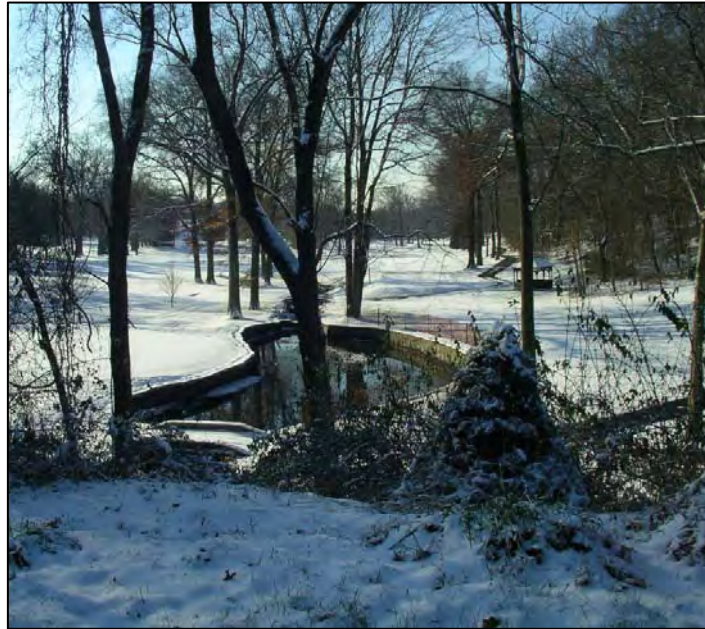
Figure 3-19: Golf course, such as the Leewood course pictured here, may provide a good opportunity for restoration via perimeter tree planting and stormwater retrofits in partnership with upstream municipal maintenance yard.

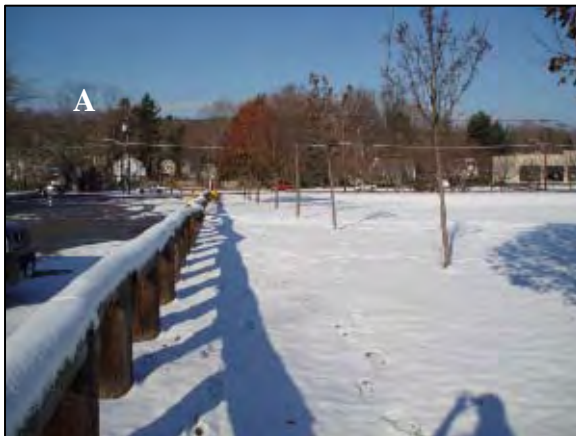
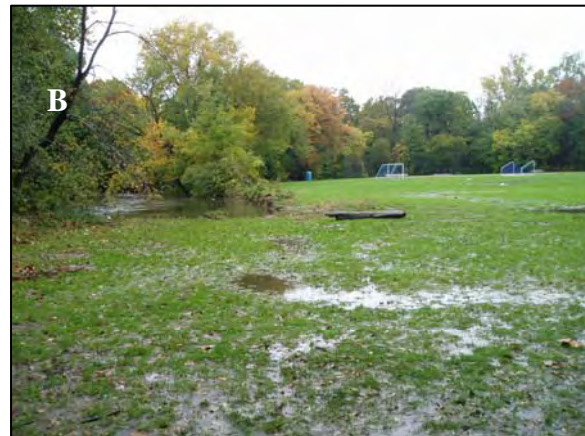
Figure 3-20: Public parks offer high visibility for restoration projects. (A) Webb Park on Central Avenue in Fulton Brook (site ID FB-P1) has a potential for reforestation along the north and east boundaries of the park and a native plant demonstration site along the parking lot. (B) At this site near the confluence of Laurel Brook and the Bronx River, wetland restoration may be a potential project.

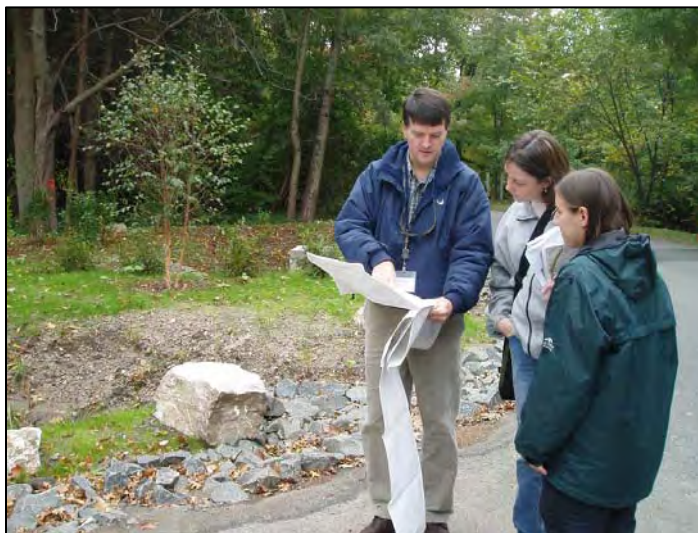
Figure 3-23: A few demonstration retrofits like the pocket wetland at the Crestwood Maintenance Facility in the Bronx River Parkway Reservation shown here exist in the watershed.

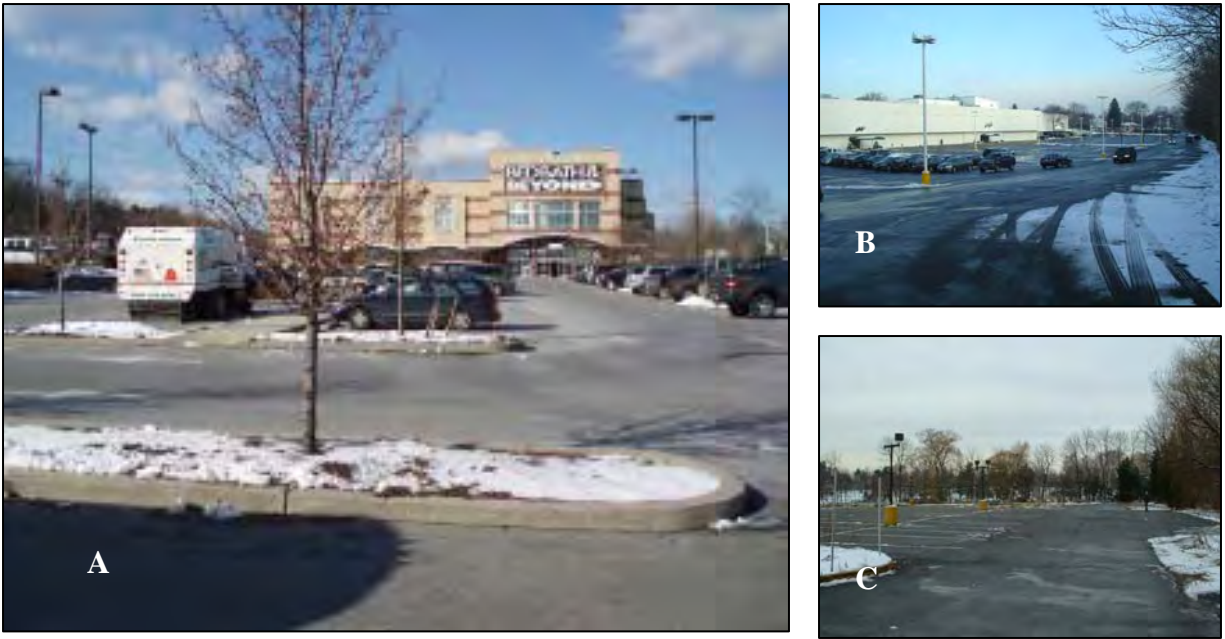
Figure 3-24: Parking lots at commercial shopping centers and businesses offer many opportunities to collect and treat stormwater runoff. (A) This shared parking lot at the Bed Bath & Beyond in Manhattan Park Brook (site ID MP-R2) is a potential candidate for underground sand filters. (B) The Lord and Taylor in Bronx River Middle Direct Drainage (site ID BRM R2) and (C) Frank's Nursery in Grassy Sprain Brook (site ID GSB-R1) offer bioretention, porous pavement and vegetative swales options.

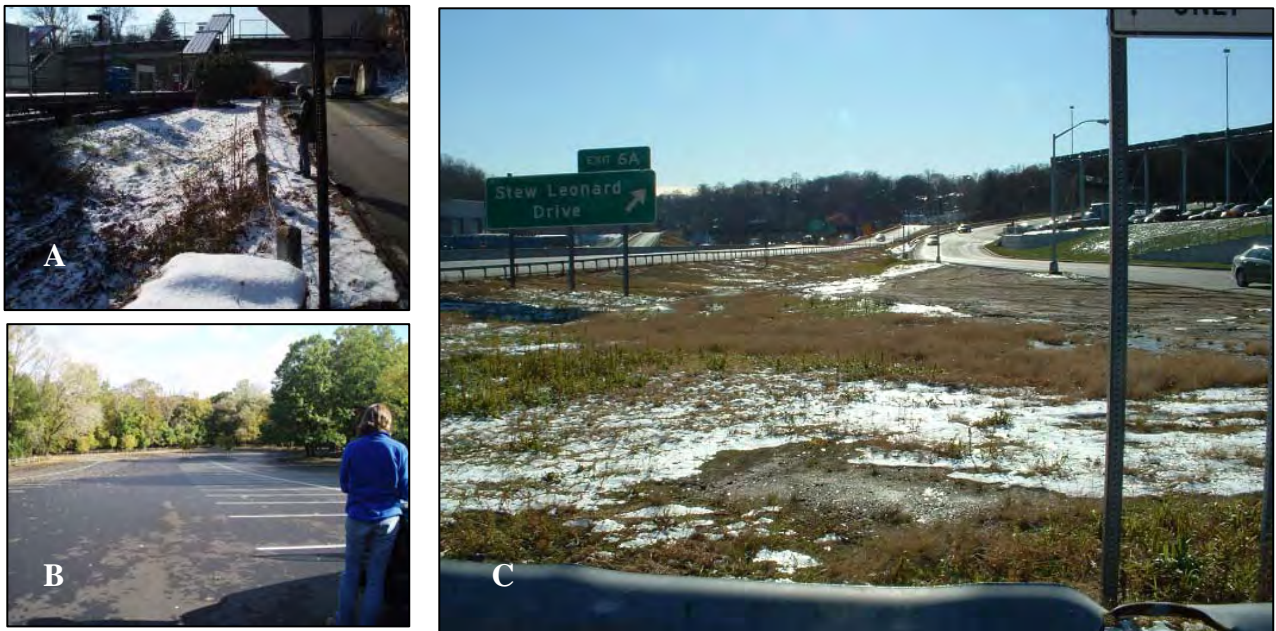
Figure 3-25: Retrofit concepts were developed at transport-related locations like (A) the Hartsdale train station in Hartsdale Brook (site ID HB-R1); (B) the Park and Ride in Sprain Brook (site ID SB-R4); and (C) the right of way between the toll plaza and Home Depot on Sprain Brook Parkway (site ID SB-R3).

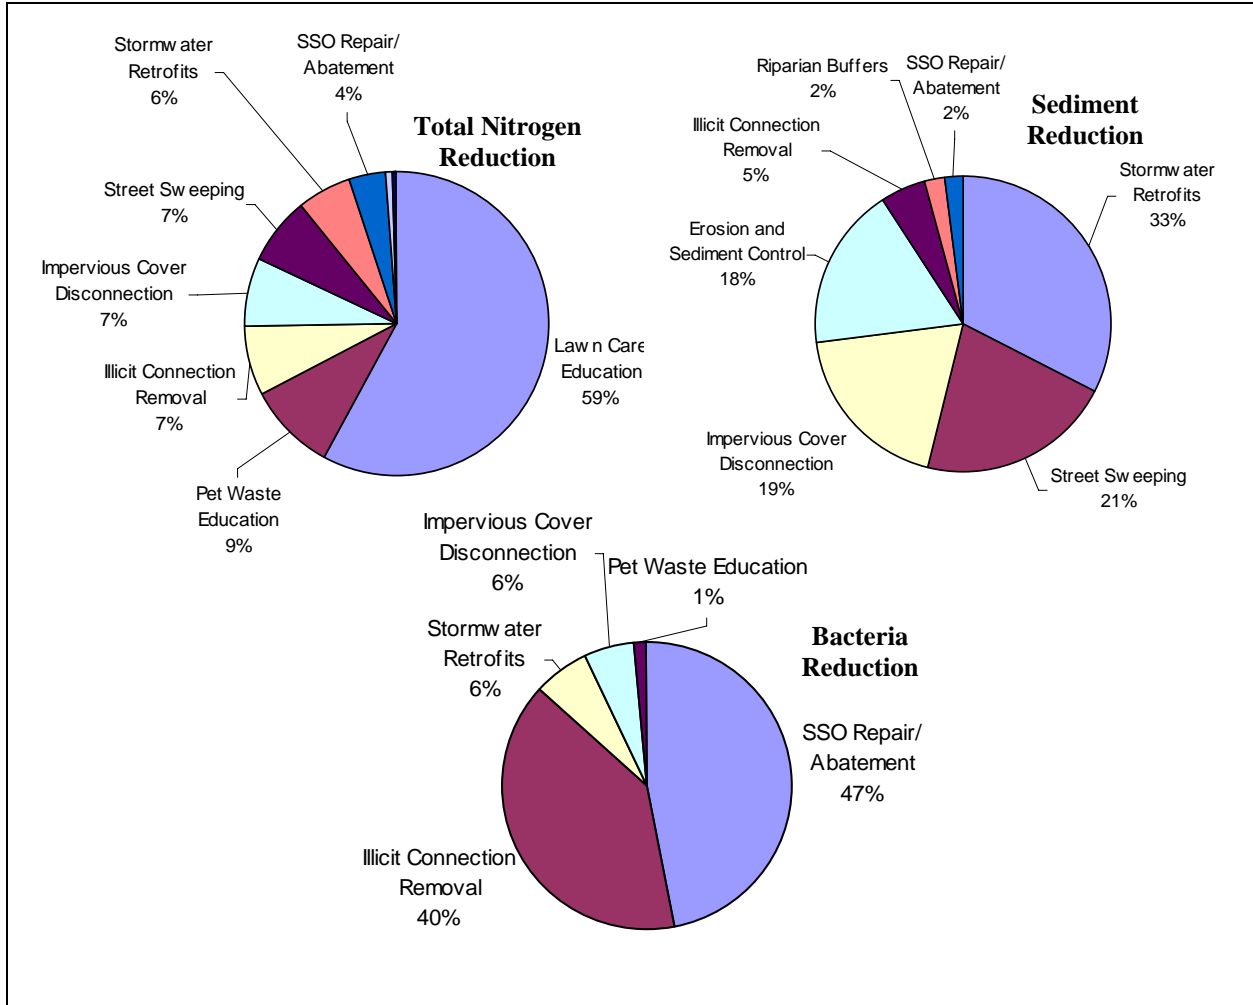
Figure 6-5: Potential Effect of Different Treatment Practices on Pollutant Load Reduction in the Manhattan Park Brook Subwatershed

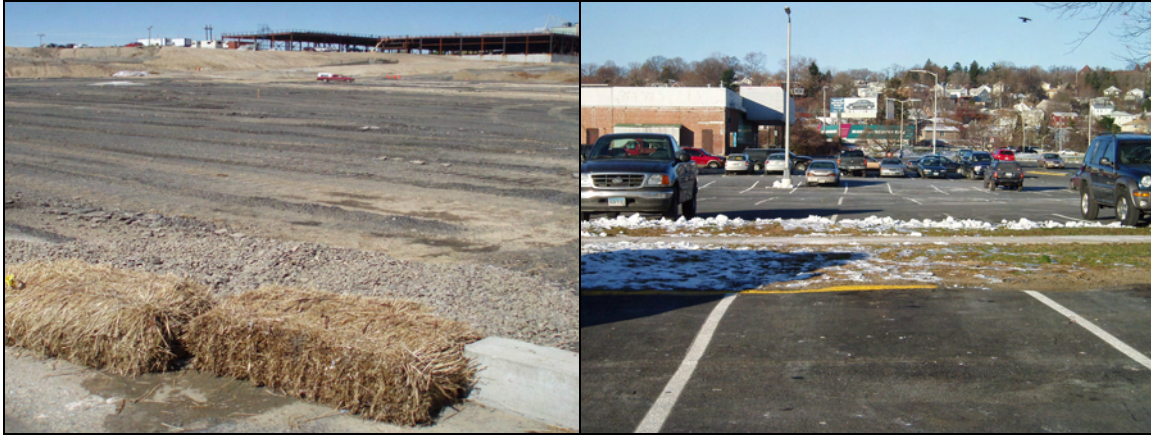
Figure 7-1: Development activity at the Yonkers Raceway (left) and the Cross County Mall with dense residential development in the background (right).

Approximately 2% of the subwatershed is forested. This subwatershed contains very dense development; 54% of the land use is residential. Current impervious cover for the subwatershed is 43.7%, which is the highest of all subwatersheds. The estimated hotspot density is 14.4 hotspots per square mile, again the highest of all subwatersheds. The Yonkers Raceway and Cross County Mall are two notable land uses in the subwatershed (Figure 7-1). Redevelopment activities are taking place at both locations.

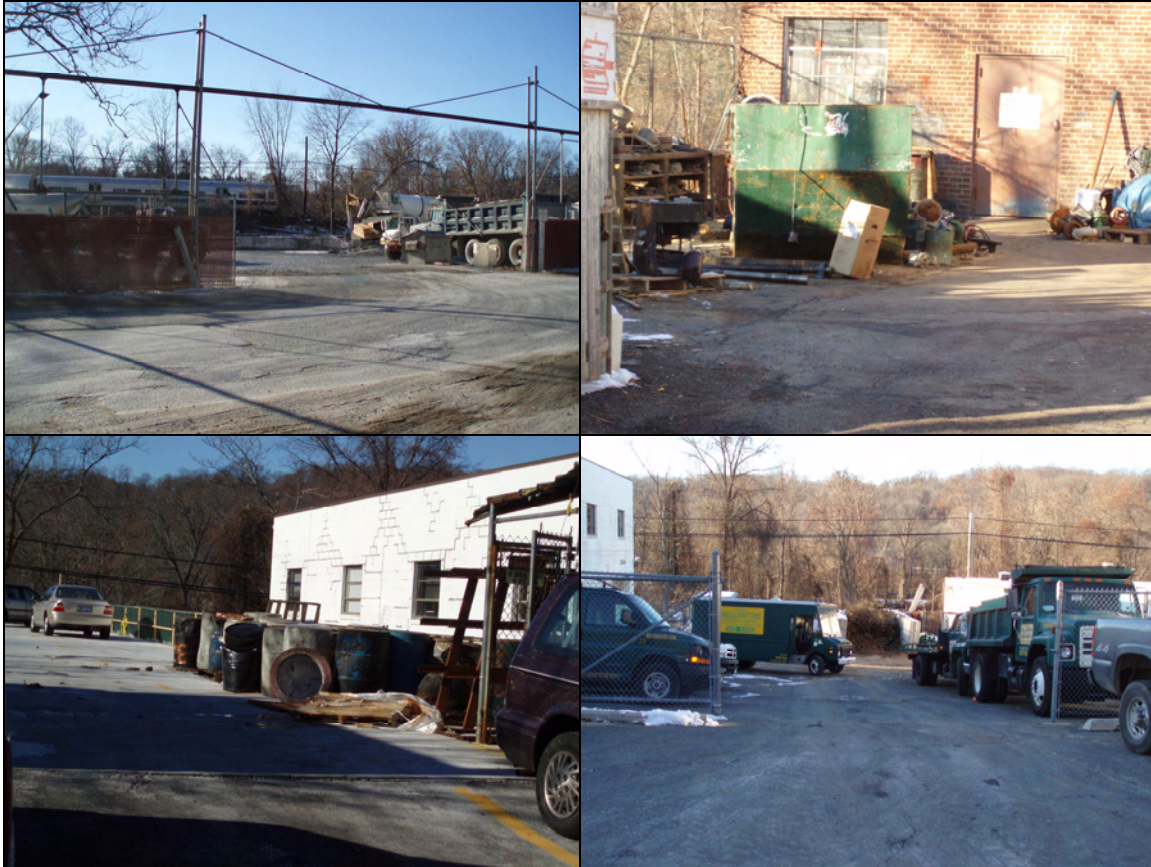
Figure 7-2: Typical land use and activities observed along Lafayette Avenue in the northern portion of the Bronx River Upper Direct Drainage subwatershed.

Invasive plant species are prevalent throughout the watershed; however, attempts to control them are evident in some reaches. Approximately 20% of the subwatershed is forested and 29.8% is impervious cover. The predominant land use in the subwatershed is residential. In the northern portion of the subwatershed, industrial and transport-related land use is adjacent to the stream corridor (Figure 7-2).

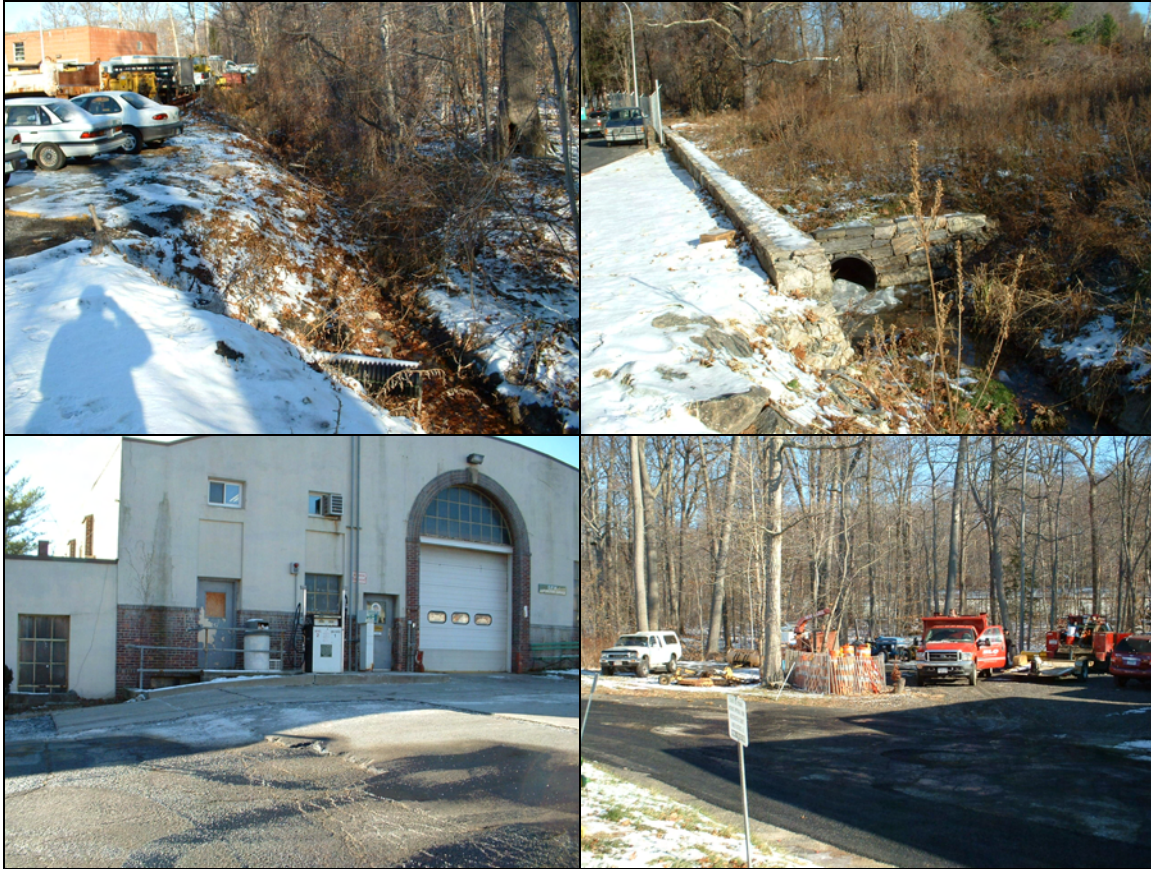
Figure 7-3: The County's Grasslands facility in the Davis Brook subwatershed

The current imperviousness of the subwatershed is 13.4%, and it has approximately 30% forest cover. The predominant land use is non-residential at 60.7%. A significant portion of the subwatershed is cemeteries and associated business enterprises. The County’s Grasslands facility is in the subwatershed (Figure 7-3), and both the New York Transit Authority’s railway and the Taconic Parkway parallel portions of the stream. Over 190 acres of undeveloped land still remains in the subwatershed.

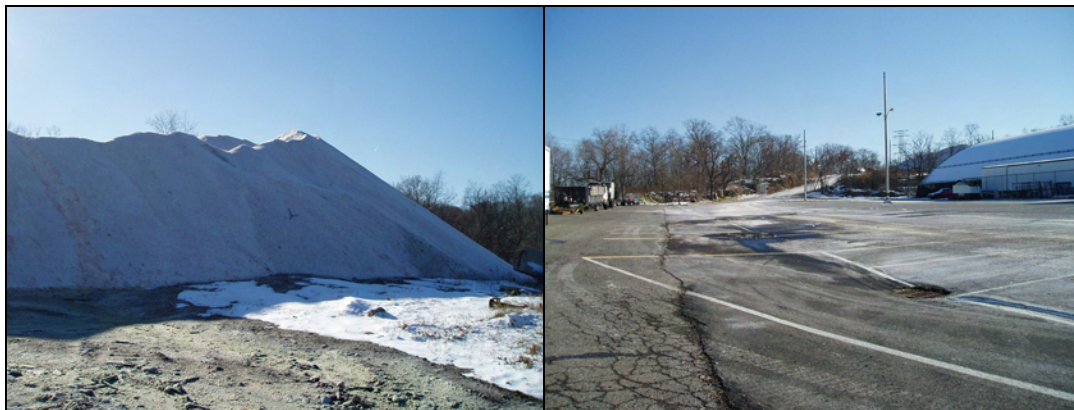
Figure 7-4: Salt storage area in City of Yonkers

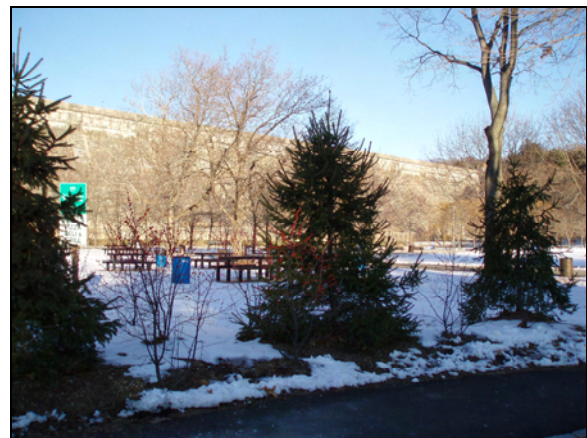
Figure 7-5: The Kensico Reservoir dam

The Kensico Reservoir subwatershed drains 12.4 square miles in North Castle, Harrison, Mount Pleasant, New Castle, and White Plains. The Kensico Reservoir is one of many components in the New York City water supply system. It has a capacity of 30.6 billion gallons, stores water from the Catskill and Delaware aqueducts, and supplies 85% of Westchester County residents and New York City with drinking water. According to Malcolm Pirnie, 1975, there is no hydraulic connection between the Kensico Reservoir and the downstream section of the Bronx River. There is, however, a connection between the reservoir and Davis Brook, a tributary to the Bronx River. Also, the large fountain pools in front of the Kensico Dam (Figure 7-5), when in operation, are filled with water drained from the Kensico Reservoir. This water circulates through the fountain pools and is discharged directly into the Bronx River (Doscher, 2005).

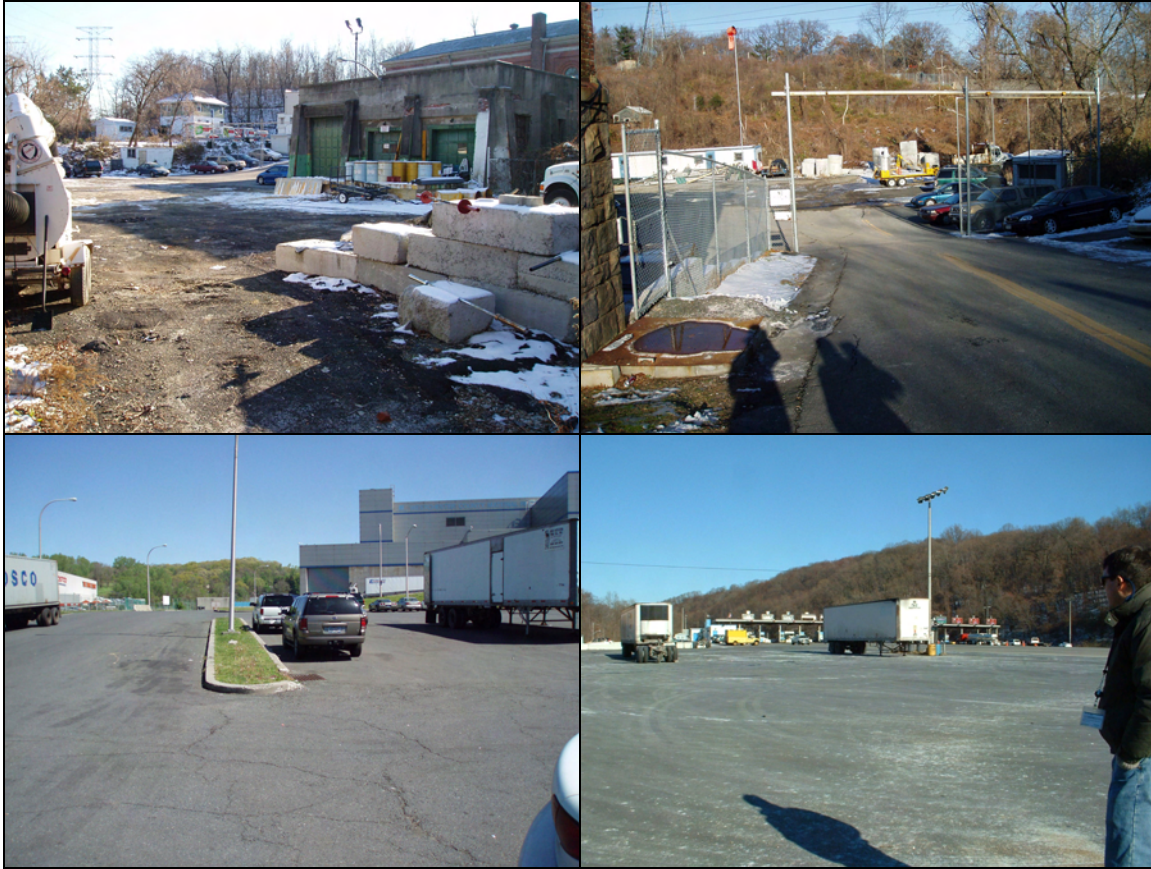
Figure 7-6: Publicly-owned location in the Sprain Brook subwatershed, including the City of Yonkers Water Works facility (top); the Westchester County Resource Recover facility (bottom left); and a toll plaza on the New York State Thruway.

About half of the land use in the subwatershed is residential, and about one-quarter is non-residential. Notable publicly-owned land uses in the subwatershed include the City of Yonkers Water Works Building / Sign Shop, the Westchester County Resource Recovery Center, and a toll plaza for the Thruway (Figure 7-6).

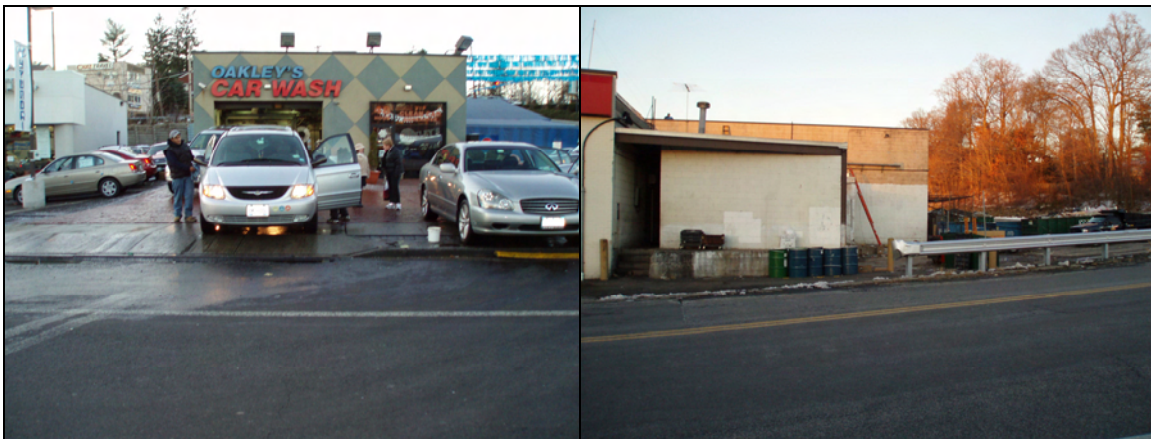
Figure 7-7: Commercial land uses observed along Central Avenue in the Troublesome Brook subwatershed included a carwash (left) and a restaurant with grease storage in the rear (right).
