Technical Memorandum

Subject: IDDE monitoring in Baltimore Watersheds

Prepared by:
Center for Watershed Protection, Inc.
8390 Main Street, 2nd Floor
Ellicott City, MD 21043

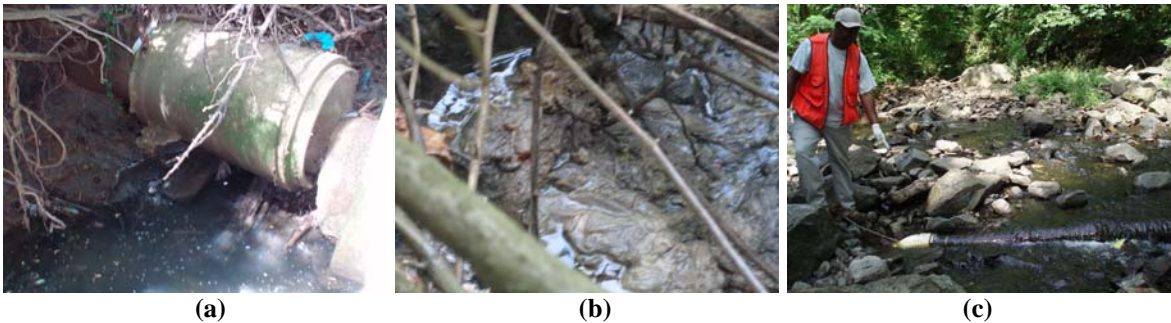
- WR702 (Figure 8) - Pipe was inaccessible by field crew but noticeably broken with sewage smell and discolored water; City followed up and found high ammonia; ammonia was traced upstream to school and the problem was fixed;

- WR256 (Figure 8) - Broken sewer pipe behind residential townhomes; City called in to maintenance for repair; inspection of sewer line that crossed stream revealed that plastic elbow on the other end of the pipe was also broken;

Figure 8. (a) WR702: Sanitary leakage into Western Run traced upstream to one of two private units. (b-c) WR256: Sanitary line broken in two locations behind residential townhome development.

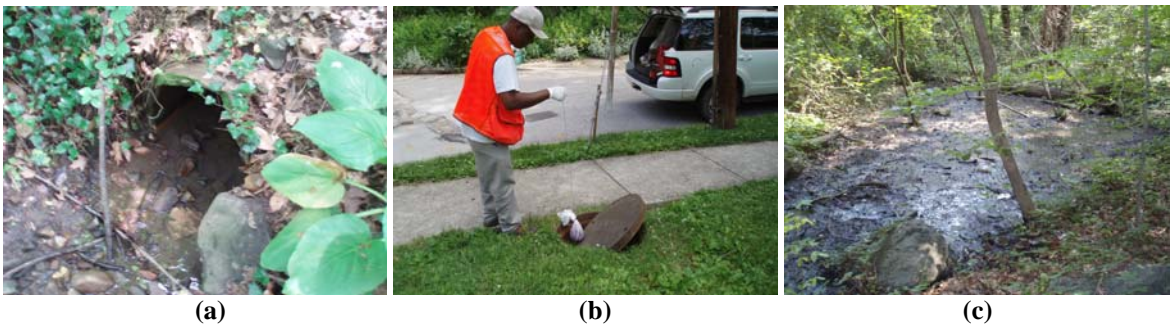
- WR254 (Figure 9) - Discharge determined to be a broken sewer line between the outfall and 300' wooded area to Uffington Rd; City staff used dye testing from Uffington Rd - came back several hours late and red dye was coming from outfall; will refer to engineering dept in the City to determine best course of action

- WRSEEP (Figure 9) – sewage seepage from a hillside reported in the past by Guy Holliday; City is relining sanitary lines in adjacent neighborhood as the source could not be located with dye testing and other means;
- WRB616 (Figure 10) – High ammonia; County referred to their Environmental Health Section for follow-up;
- MRC111 (Figure 10) - Obvious sewage contamination from odor and indicators; under Hwy 40; reported to City onsite; a number of re-visits indicates that this is an intermittent problem as flow is not always consistent;
- MR701 (Figure 10) – High ammonia, fluoride, detergents and bacteria; County followed up with another visit but outfall was not high for ammonia; and
- JF201 – High ammonia with sewage smell determined to be a sanitary sewer overflow west along a tributary; the same sanitary stack was observed overflowing about a month later.

Figure 9. (a-b) WR254: Dye testing revealed infiltration from a sanitary line into the storm drain system in an outfall behind a residential home. (c) Sanitary seepage from a hillside has not been successfully traced in an adjacent neighborhood.

and stormwater treatment practices. For example, the sanitary seep described in the illicit discharge source tracking section (WRSEEP) has been ongoing problem. The annual nutrient input from this one discharge has been estimated at approximately 239 lb/yr of total nitrogen and 85 lb/yr of total phosphorus. Treating this same amount of nutrient input with traditional bioretention would require the installation of 143 0.5-acre practices to treat the phosphorus or 49 to treat the nitrogen at a cost of between \$590,000 and \$1,700,000. This discharge along with several other confirmed sewage discharges was found on a small tributary of Western Run, which met the main channel just below an extensive stream restoration project. Fixing illicit discharges can be an inexpensive to a very expensive process for a local jurisdiction, depending on the problem. Likewise, tracking illicit discharges incurs expense from staff time to equipment and analysis of water samples. While the expense incurred from finding and fixing illicit discharges can be significant, it is logical that these problems be permanently remedied at the source before attempting to treat stormwater and nonpoint sources of pollution in the stream or through retrofitting stormwater treatment practices.

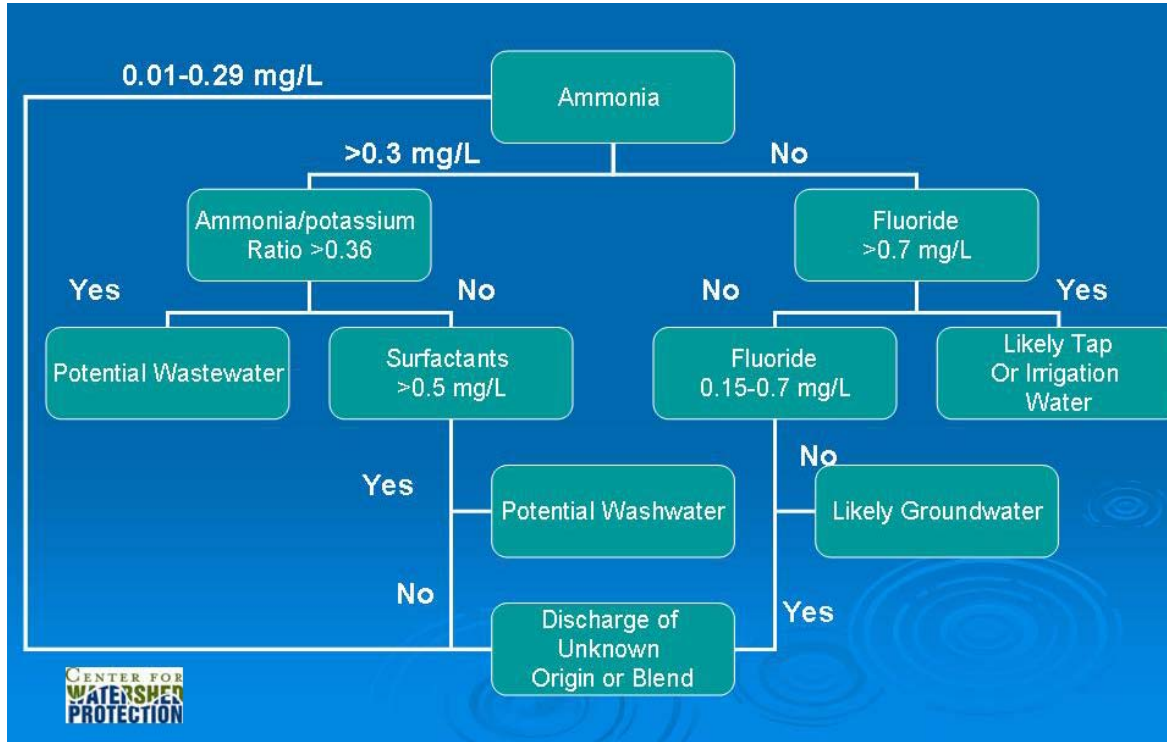
Figure 11. Modified IDDE flow chart for Baltimore waters.

Based on project results, a modified IDDE flow chart for source detection is suggested for Baltimore watersheds (Figure 11). E. coli or other bacteria can be used as a co-indicator for sewage contamination. The modified chart considers the following:

- Lower ammonia to potassium ratio threshold for sewage from >1.0 to >0.36 based on confirmed sewage discharges found in Baltimore.
- Increase surfactant threshold from >0.25 mg/L to >0.5 mg/L for washwater due to the seemingly high background level of surfactants in Baltimore waters
- Increase fluoride threshold from 0.25 mg/L to 0.7 mg/L for tap water and 0.15-0.7 for a smaller tap water leak that may be blended with groundwater or other sources. Fluoride is present naturally in Baltimore waters and, based on in-stream samples collect by Baltimore City Water Quality Management staff, the average level detected is 0.14 mg/L.
- An additional source is added, “Discharge of Unknown Origin or Blend” for instances of high ammonia, without high surfactants and/or fluoride levels between 0.15-0.7 mg/L. Ammonia levels between 0.01 and 0.29

mg/L are likely also indicative of a problem and may indicate a discharge of unknown origin or blended flow and, if resources allow, should be investigated as well.
