# Field Findings

**Date:** July 13, 2011

**Subject:** Pollution Detection & Elimination in Sligo Creek, Montgomery County, MD

Prepared by:  
**Center for Watershed Protection, Inc.**  
8390 Main Street, 2<sup>nd</sup> Floor  
Ellicott City, MD 21043

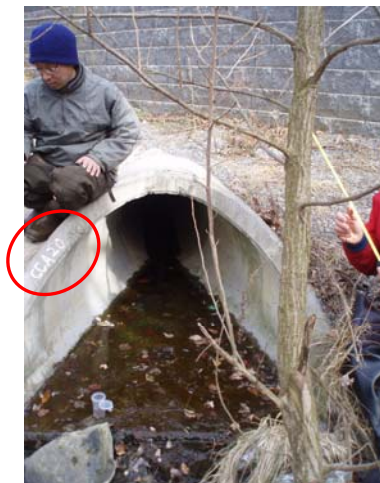
Figure 4. Outfall CCA20 marked in the field.

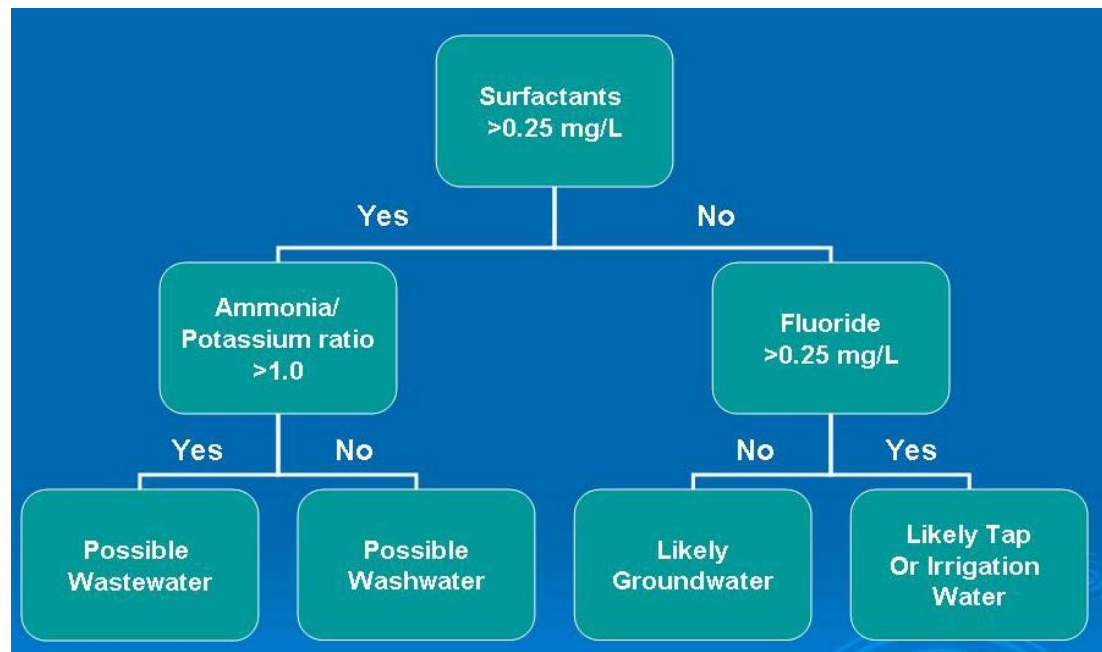
A variation of the Flow Chart Method (Brown et al, 2004, Figure 6) was used to distinguish between three major types of illicit discharges: wastewater, washwater and tap water discharges from groundwater, which is not considered to be an illicit discharge.

**Figure 6. Flow chart method used to distinguish potential illicit discharges (Brown et al, 2004).**

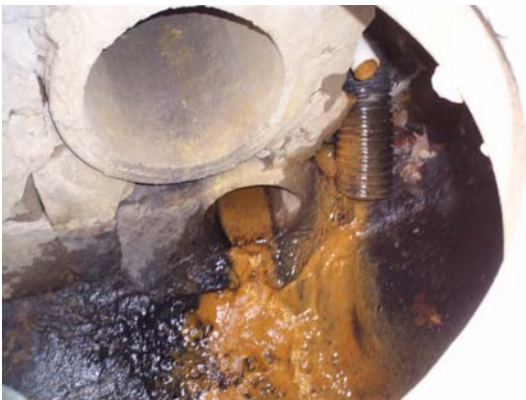
- Upon investigation of the drainage area, the team discovered a potential illicit discharge in a manhole at Glazewood and Devonshore coming from a black, plastic PVC pipe (Figure 12). Ammonia concentrations from this pipe were elevated. The other pipes had no ammonia but did have fluoride, indicating a potable water source.

**Figure 12. Four pipes enter a stormwater manhole at Glaisewood and Devonshire. Ammonia was elevated from the flow being discharged from the black, corrugated pipe (0.25 mg/l in field, 0.14 mg/l checked with spectrophotometer later in the day).**

- o It is unclear where the piping for this outfall originates. It may be connected to the system on New Hampshire Ave (unmapped) and did not appear to be connected to the tributary system running parallel to New Hampshire.
- o A sewer line runs along northwest New Hampshire Ave as well. Since no connection could be found between the outfall and upstream drainage area, there could be a cross connection or sewer break that is allowing sewage to get into the storm drain system and then Sligo Creek along New Hampshire Ave.
- o Dye should be placed in the sewer system up-pipe of the outfall to determine if there is a connection.
- o The outfall should continue to be monitored for ammonia.

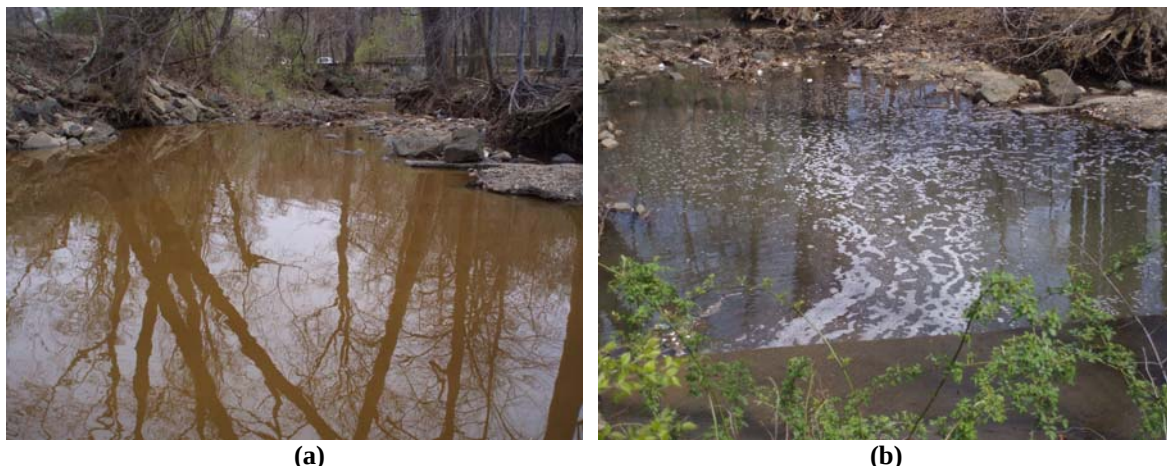
- This outfall was not surveyed during the original field work in January.
- On 3/28, the team noticed a severe sediment discharge coming from the double 72" outfalls (Figure 13). A water sample showed elevated ammonia (0.14 mg/l) and very high fluoride (1.15 mg/l).
- Team visited a nearby construction site but did not detect any water leaving the site. Team went to a location suspected by the County but did not find anything.
- During the inspection of a manhole at Lincoln and Maple, a dry weather discharge was discovered (see investigation for KE02).
- Upon return to the outfall ~2 hours later, the sediment was observed to have stopped discharging.
- A site visit to the outfall on 4/4 found the outfall discharging severe suds (Figure 13). Detergent levels measured 3.0 mg/l.

**Figure 13. (a) Sediment discharge at outfall KE01 on 3/28/2011 and (b) suds discharge at outfall KE01 on 4/4/2011.**

- o Transitory discharges evident at this outfall.
- o Enforcement measures should be increased in the drainage area to decrease the frequency of problems observed (e.g. suds).
- o The County should engage in a targeted education effort in the drainage area, focused on car washes, auto dealers and others that may be suspect for large scale washwater discharges. Develop, maintain and update a list of potential generating sites in the drainage area for both washwater and sediment sources.
- o The County may want to seek assistance from a local watershed group to assist in this education effort. Friends of Sligo Creek and the Anacostia Watershed Society may be able to assist.
- o Continuous discharges are also a problem at this outfall (see below regarding site KE02) and require a different strategy and tracking mechanism.

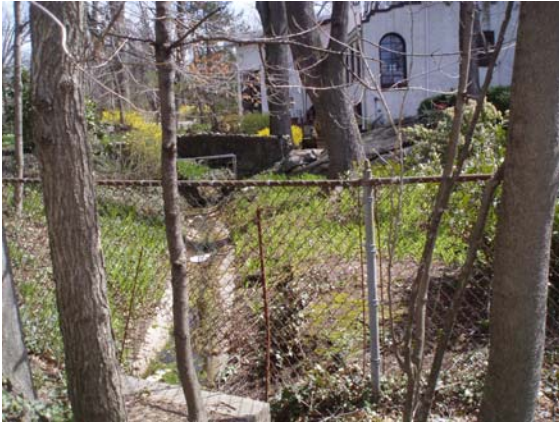
- Initial field screening found high ammonia at this outfall (0.54 mg/l).
- Re-sampled outfall and found high concentrations of ammonia in the pool (1.39 mg/l) and in the flow (2.23 mg/l).
- Opened manhole at Franklin and Hamilton. Found flow emanating from two different pipes – a pipe coming from Franklin St. and another coming from a conveyance on private property (Figure 15).
- Checked ammonia from both sources – the private residence flow had an ammonia concentration of 0.5 mg/l and the pipe coming from Franklin had an ammonia

concentration of 0.38 mg/l. Algae was noted in the concrete conveyance by the private residence and the water seemed to originate from a spring behind the house.

**Figure 15. Nutrient rich flow as evidence by algae originates from behind a private residence. High ammonia detected in this discharge.**

- o Team appeared to observe a “spike” in the discharge (1.34 mg/L) at the beginning of the site visit and less observed at the end (0.17 mg/L). The discharge appeared constant but pollutant loading may be intermittent.
- o The private residence should be dye tested to see if there is a connection between the house and the nutrient rich waters originating in the stormwater conveyance.
- o The County may want to video the other pipe with high ammonia to determine where the flow is coming from.

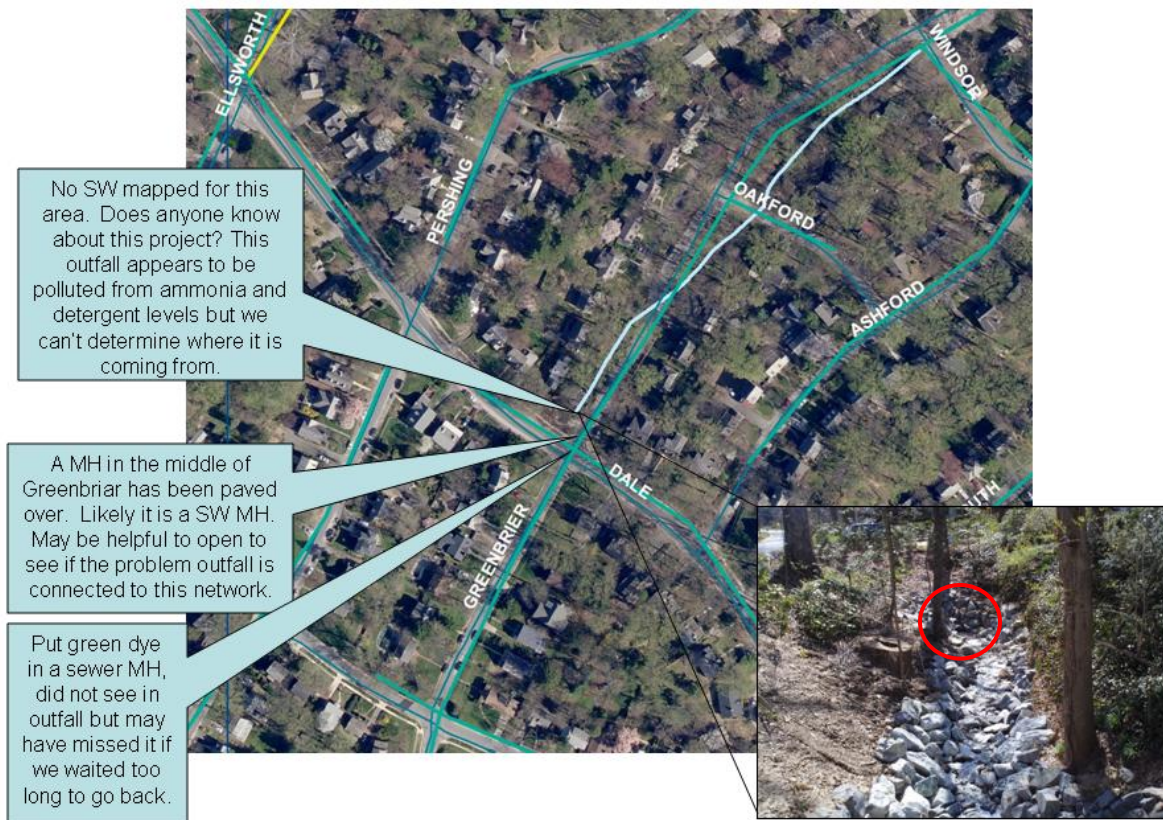
- Initial field screening found high ammonia, potassium and very high detergents (1.5 mg/l) at this outfall.
- A sample was collected at Greenbrier and Windsor; ammonia was 0.3 mg/l and detergents were 0.5 mg/l.
- Flow was tracked to where it daylighted at an outfall at Greenbrier and Dale in what seems to be a newly constructed stream stabilization project (Figure 16).
- Could not find flow in any nearby stormwater manholes or inlets. One nearby inlet on Greenbrier was paved over.
- Dropped dye in an adjacent sewer line. Checked outfall several hours later but did not observe dye in flow.

**Figure 16. Outfall at Dale and Greenbrier circled in red.**
