## Field Findings Report

**Subject:** Pollution Source Reduction in Baltimore Watersheds

Prepared by:  
**Center for Watershed Protection, Inc.**  
8390 Main Street, 2<sup>nd</sup> Floor  
Ellicott City, MD 21043

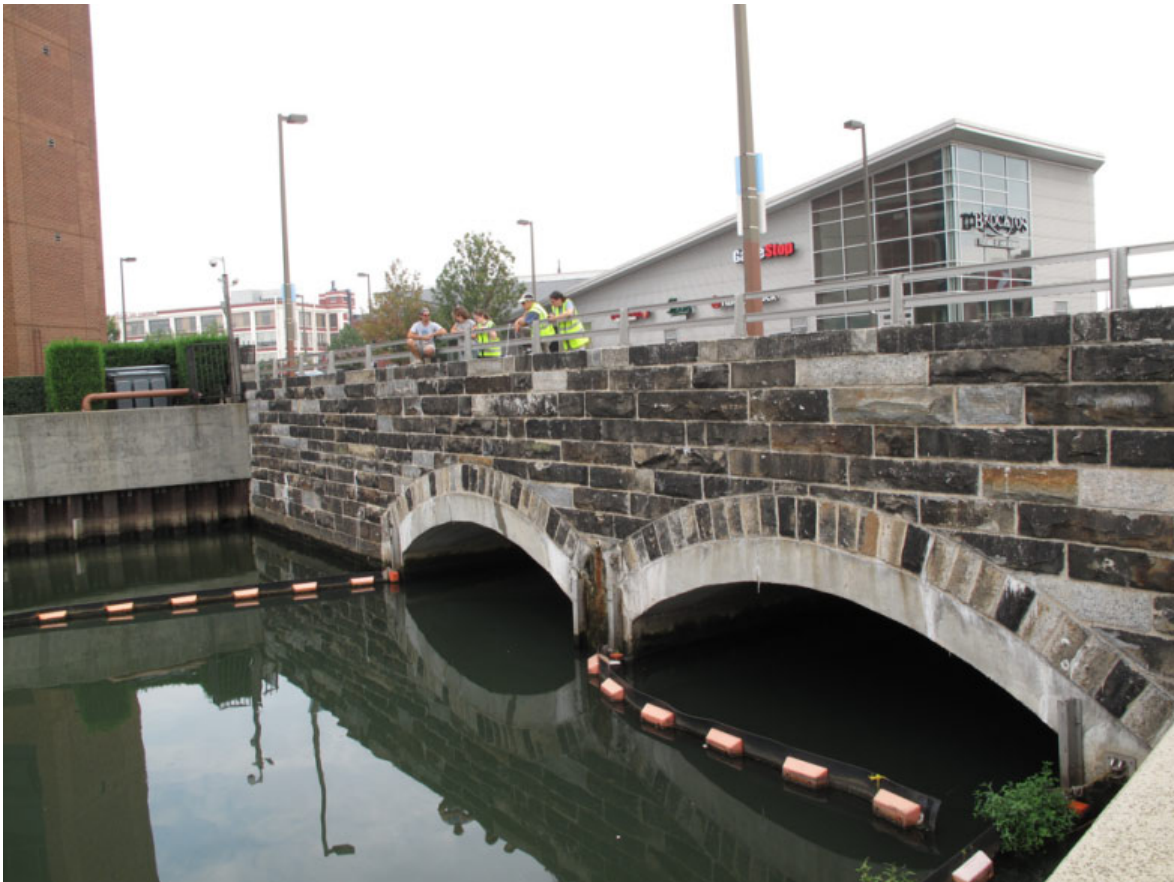
Field staff prepare to take a water sample from the Harris Creek outfall located at Boston Street in Canton.

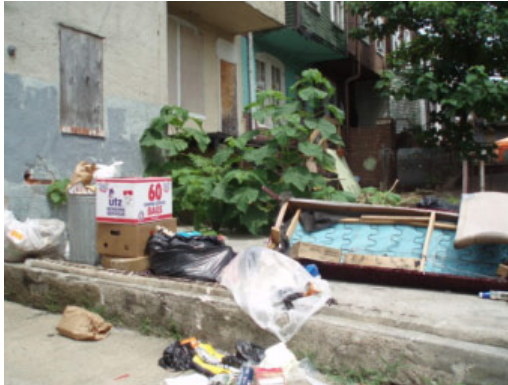
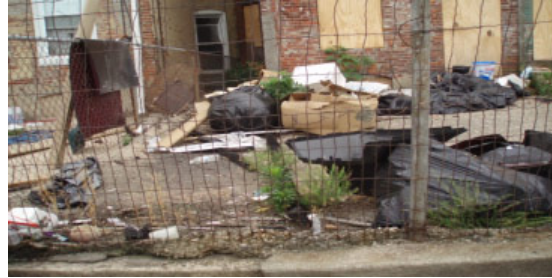
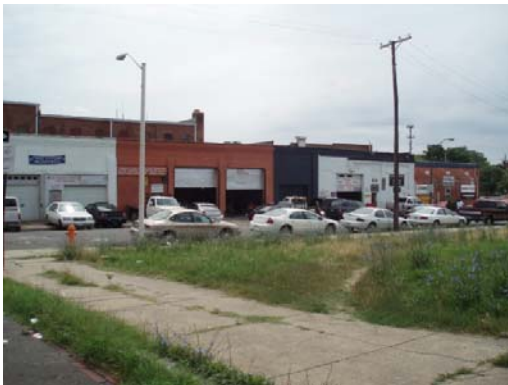
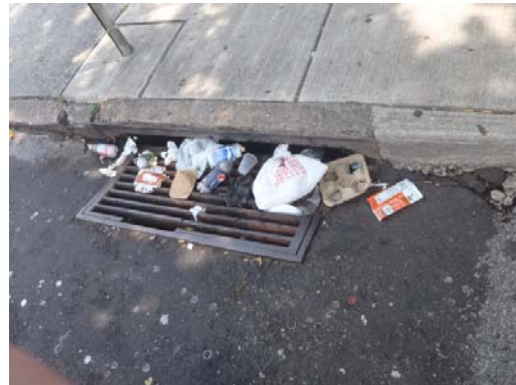
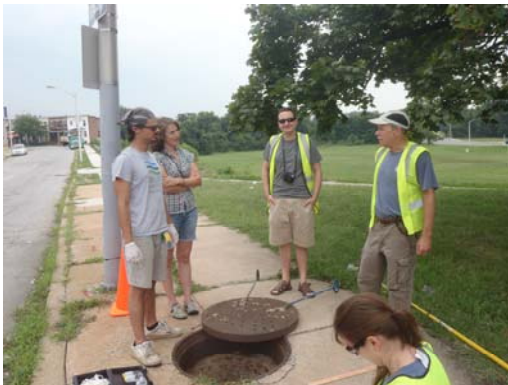
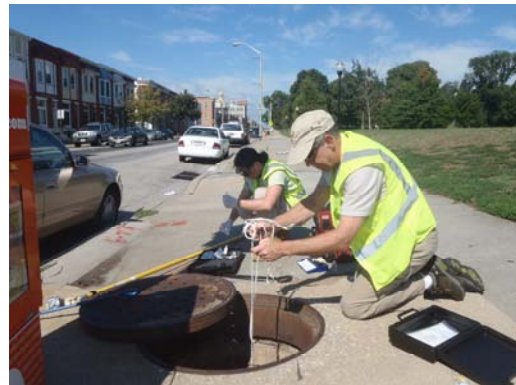
**Figure 2. Representative field photos. Illegal trash dumping sites (top left and right), potential hotspot facilities (middle left), clogged stormdrain inlet (middle right), illicit discharge sampling (both bottom photos).**

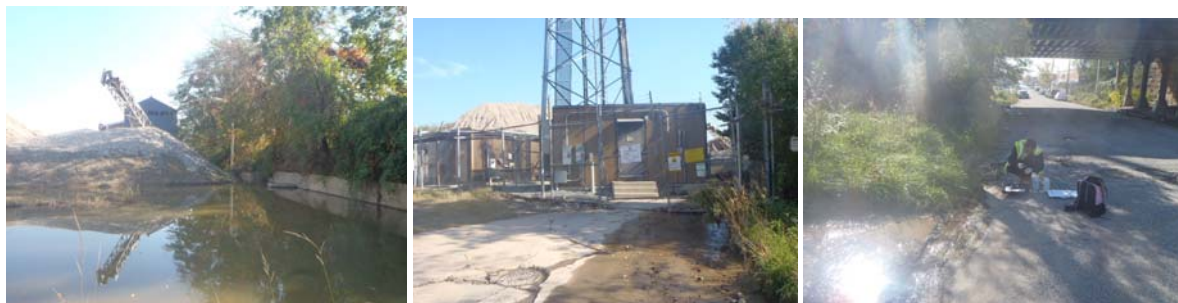
of the Bocek Playfield (Figure 5). One transitory discharge was observed at Eager-Ashland and North Lakewood where a homeowner was washing down his lot. Another discharge, H2-2, was determined to be coming from a semi-permanent car wash station set up on Patterson Park Ave (Figure 6). This resulted in a discharge that was detected in a manhole at Chester and Eager. See Appendix E for the Harris Creek illicit discharges data.

**Figure 5. Water collecting in a back corner of the recycling plant (left), drains off-site through a cell phone tower facility (middle), and exceeds industrial and sewage benchmark values based on water quality testing (right).**

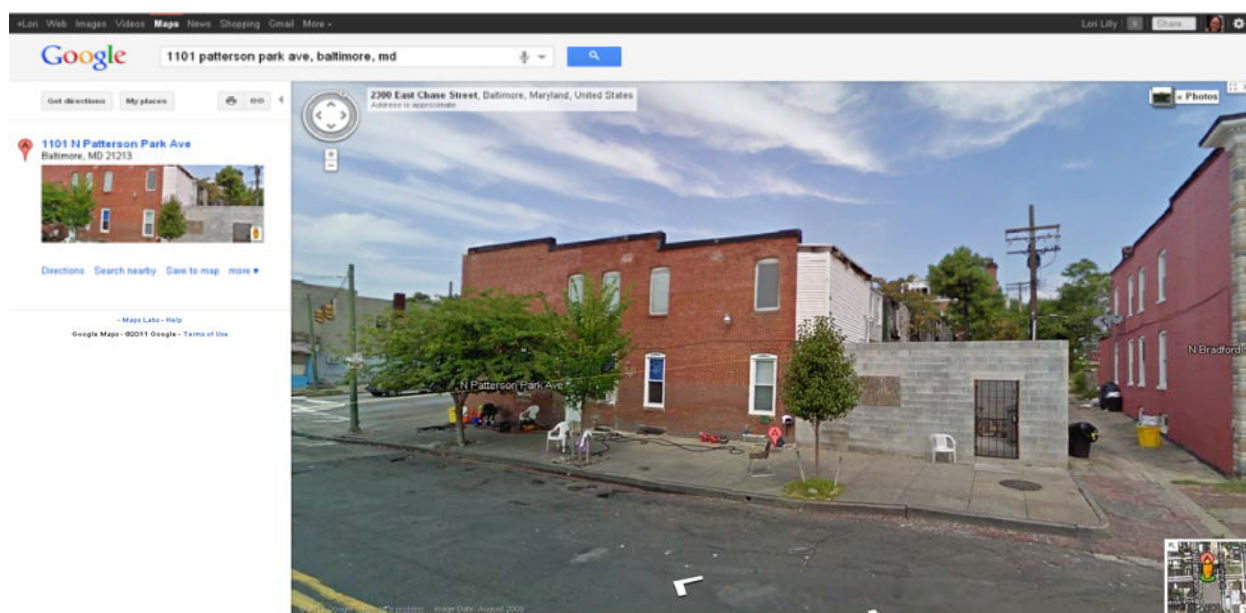
**Figure 6. Semi-permanent car wash station at 1101 Patterson Park Ave is visible from Google Maps. Washwater from the car wash leaves the site untreated and enters the stormdrain system. The discharge was detected from excessive detergent concentrations found in a manhole three blocks away. Image from Google Maps.**

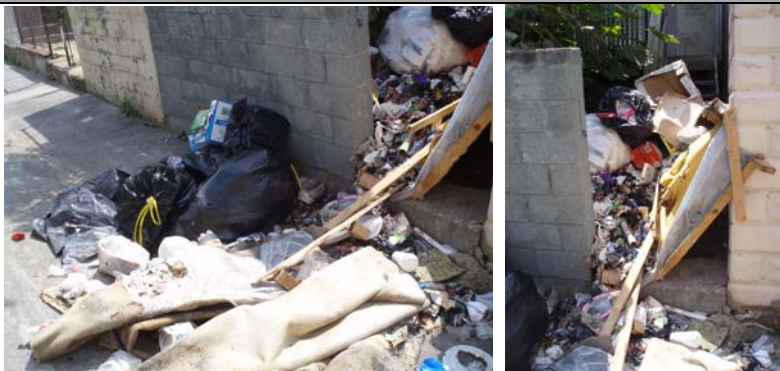
<p>Site ID: HC-TR-232 (alternative ID: HC-TR-B-502)          Neighborhood: McElderry Park, N. Rose/N. Luzerne Alley and McElderry Street          Site visits: 6/20/11 and 8/23/11</p>	
<p><u>Problem</u> Legacy dumping site behind house and in alley (trash present both times), potential hazardous wastes, rats, evidence of trash encourages others to dispose of trash in this area</p> <p><u>Follow Up</u> 311 results for 6/20/11 were: 1) Housing Code Enforcement Official referred to another agency and 2) closed as of 6/22/11. The Center site visit on 8/23/11 found site was not cleaned up. 311 results for 8/23/11 were: 1) HCD-Illegal Dumping---Alley and 2) closed 9/15/11.</p>

<p><u>Pollution Reduction Strategies</u></p> <ul style="list-style-type: none"> <li>• Education for bulk trash pick up, education for trash program, education for recycling program City to contact owner for action(s)</li> <li>• City to contact owner for action(s)</li> <li>• Neighborhood Watch</li> <li>• Volunteer clean-up</li> <li>• City clean-up</li> <li>• Neighborhood group continue to report to 311 and track investigation until resolved</li> <li>• Future strategies needed to deter continued dumping in the area (e.g., signs, surveillance camera, physical barrier(s), lighting)</li> </ul>

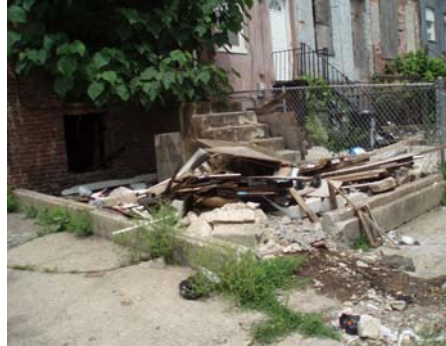
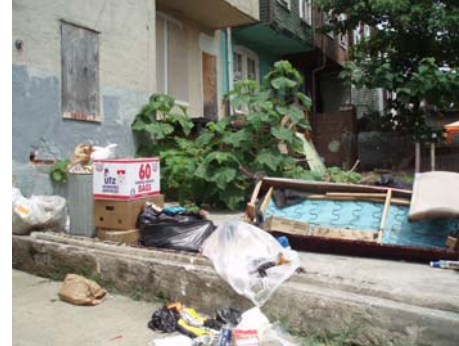
Site ID: HC-TR-312

Problem Two dumping sites behind houses and in alleys, both household and construction dumping, potential hazardous wastes, and rats

Follow Up 311 results were: 1) dispatched investigator and 2) unfounded.

- Education for bulk trash pick up, education for trash program, education for recycling program
- City to contact owner for action(s)
- Neighborhood Watch
- Volunteer clean-up
- City clean-up
- Neighborhood group continue to report to 311 and track investigation until resolved
- 311 Service Type could include: "Dirty Alley Cleaning," "Housing Inspection - Trash and/or Weeds," or "Housing Inspection – Rodent"
- Remove weeds and shrubs
- Future strategies needed to deter continued dumping in the area (e.g., signs, surveillance camera, physical barrier(s), lighting, etc.)

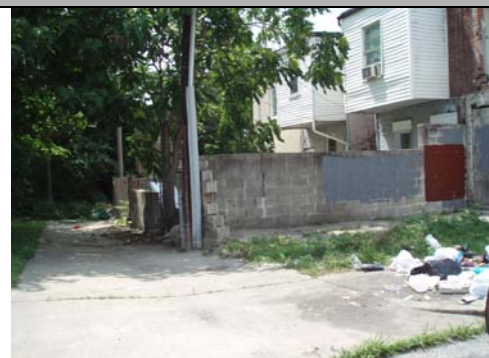
Site ID: HC-TR-322

Problem Legacy dumping site behind house in back yard and in alleys nearby, potential hazardous wastes, and rats

Follow Up 311 results for 6/20/11 were: 1) Referred for removal and 2) cleaned. The Center site visit on 8/23/11 found the site had trash again.

- Education for trash program and education for recycling program

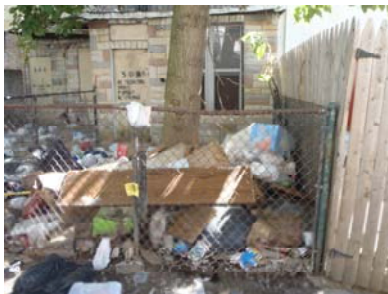
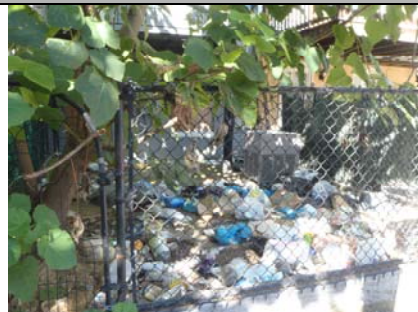
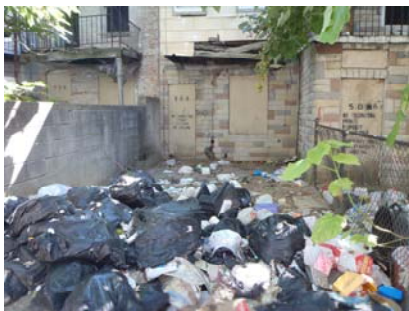
Site ID: HC-TR-B-503

Problem Legacy household trash dumping site behind 4 to 6 houses and in alleys, potential hazardous wastes, rats, and Code Enforcement Official acknowledged that 500 block of Glover was a problem area during field site visit.

Follow Up Reported to Code Enforcement Official onsite 8/23/11. 311 results were:  
1) HCD-Illegal Dumping and  
2) closed 9/15/11.

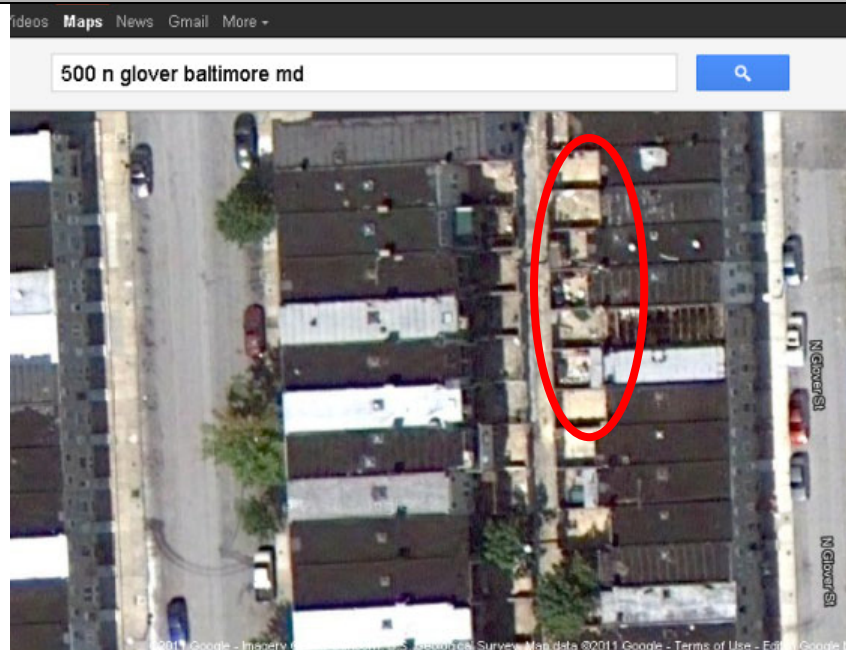
Site ID: HC-TR-B-503

Google Map shows back yards with trash from aerials. Retrieved 10/19/11.

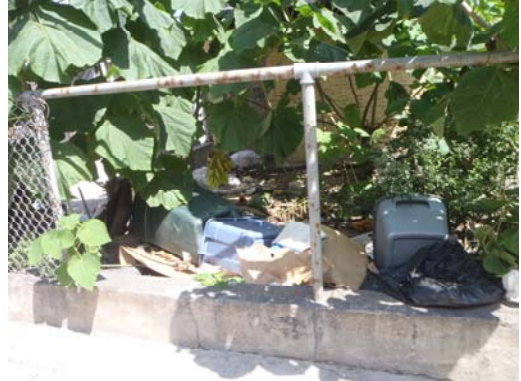
Problem Trash dumping and improper trash disposal (no lid on can) at site behind house and in alley, potential hazardous wastes, rats, residents report that they want area cleaned and want other residents to dispose of trash properly.

Follow Up 311 results for 8/23/11 were: 1) HCD-Sanitation Occupied Private Property and 2) closed 9/14/11.

- Education for trash program and education for recycling program
- City to contact owners for action(s)
- Neighborhood watch
- City clean-up
- Volunteer clean-up
- Remove weeds and shrubs
- Neighborhood group continue to report to 311 and track investigation until resolved
- 311 Service Type could include: "Trash Can/Recycling Container Complaint," "Dirty Alley Cleaning," "Housing Inspection - Trash and/or Weeds," or "Housing Inspection – Rodent"
- Future strategies needed to deter continued dumping in the area (e.g., signs, surveillance camera, physical barrier(s), lighting, etc.)

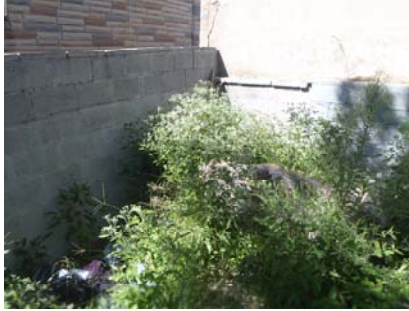
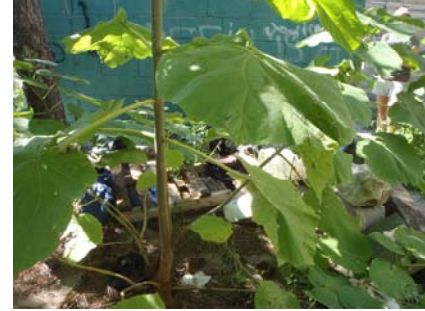
Problem Legacy dumping site behind house and in alley, potential hazardous wastes, rats, evidence of people staying in area.

Follow Up 311 results for 8/23/11 were : 1)HCD-Sanitation Occupied Private Property and 2) closed 9/14/11.

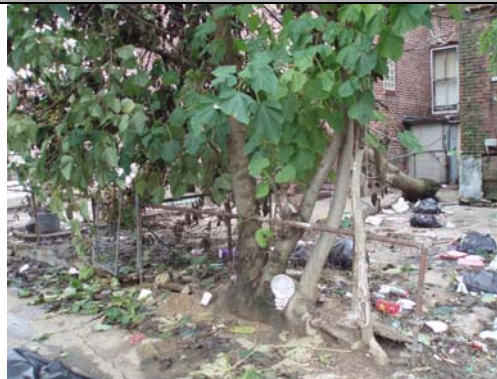
Problem Legacy dumping sites behind houses and in alley, potential hazardous wastes, several rats observed during site visit, and residents report eyesore and health hazard.

Follow Up 311 results were: 1) Forestry Down Tree and 2) open.

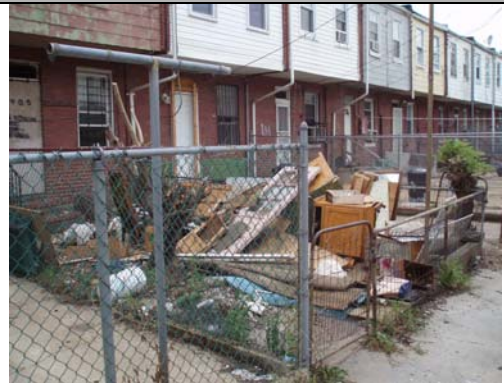
Problem Two dumping sites behind houses and in alleys, both household and construction dumping, potential hazardous wastes, rats, residents report eyesore and health hazard.

Follow Up 311 results were: 1) HCD-Illegal Dumping and 2) closed 9/15/11

- Education for trash program and education for recycling program
- City to contact owner for action(s)
- Neighborhood Watch
- Volunteer clean-up
- City of Baltimore clean-up
- Neighborhood group continue to report to 311 and track investigation until resolved
- Future strategies needed to deter continued dumping in the area (e.g., signs, surveillance camera, physical barrier(s), lighting, etc.)

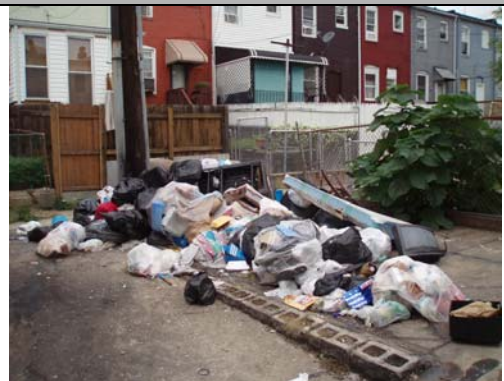
Problem Legacy household trash dumping site behind houses, potential hazardous wastes, and rats.

Follow Up 311 results were: 1) HCD-Illegal Dumping and 2) closed 9/15/11.

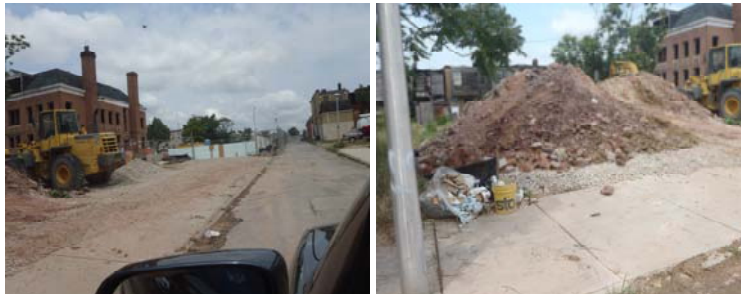
Problem Erosion and sediment control needed at construction site.

Follow Up Reported to the City for enforcement on 6/20/11. Al Barnes from Baltimore City (410-396-4190) inspected the site and silt fences were installed (7/25/11). Al Barnes will continue to follow-up. The Center revisited on 8/23/11 and generally acceptable, but some areas of silt fence should be repaired.

- Follow erosion and sediment control policies in place
- Neighborhood group continue to report to 311 and track investigation if problem persists
- Reinspect as needed

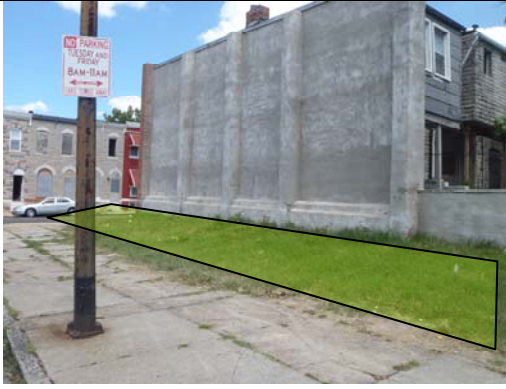
Location	Site Photo	Opportunity Identified	Representative Opportunity Photograph
915 N. Montford Avenue

Bioretention

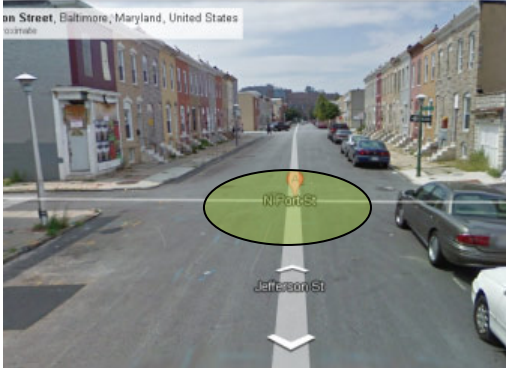
Roundabout with bioretention

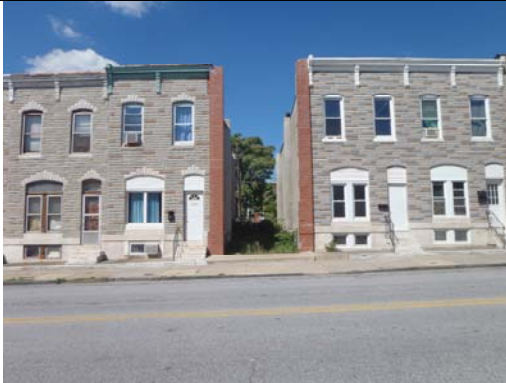
Location	Site Photo	Opportunity Identified	Representative Opportunity Photograph
408/412 N. Milton Avenue

Rainwater Harvesting

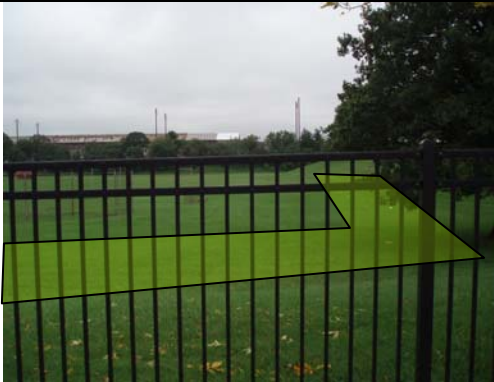
Rain Garden or Bioretention

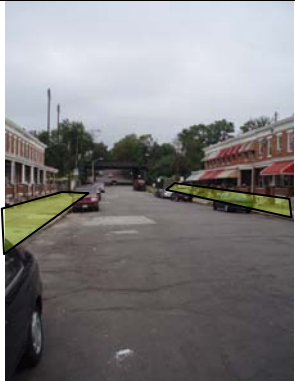
Tree planting on the block

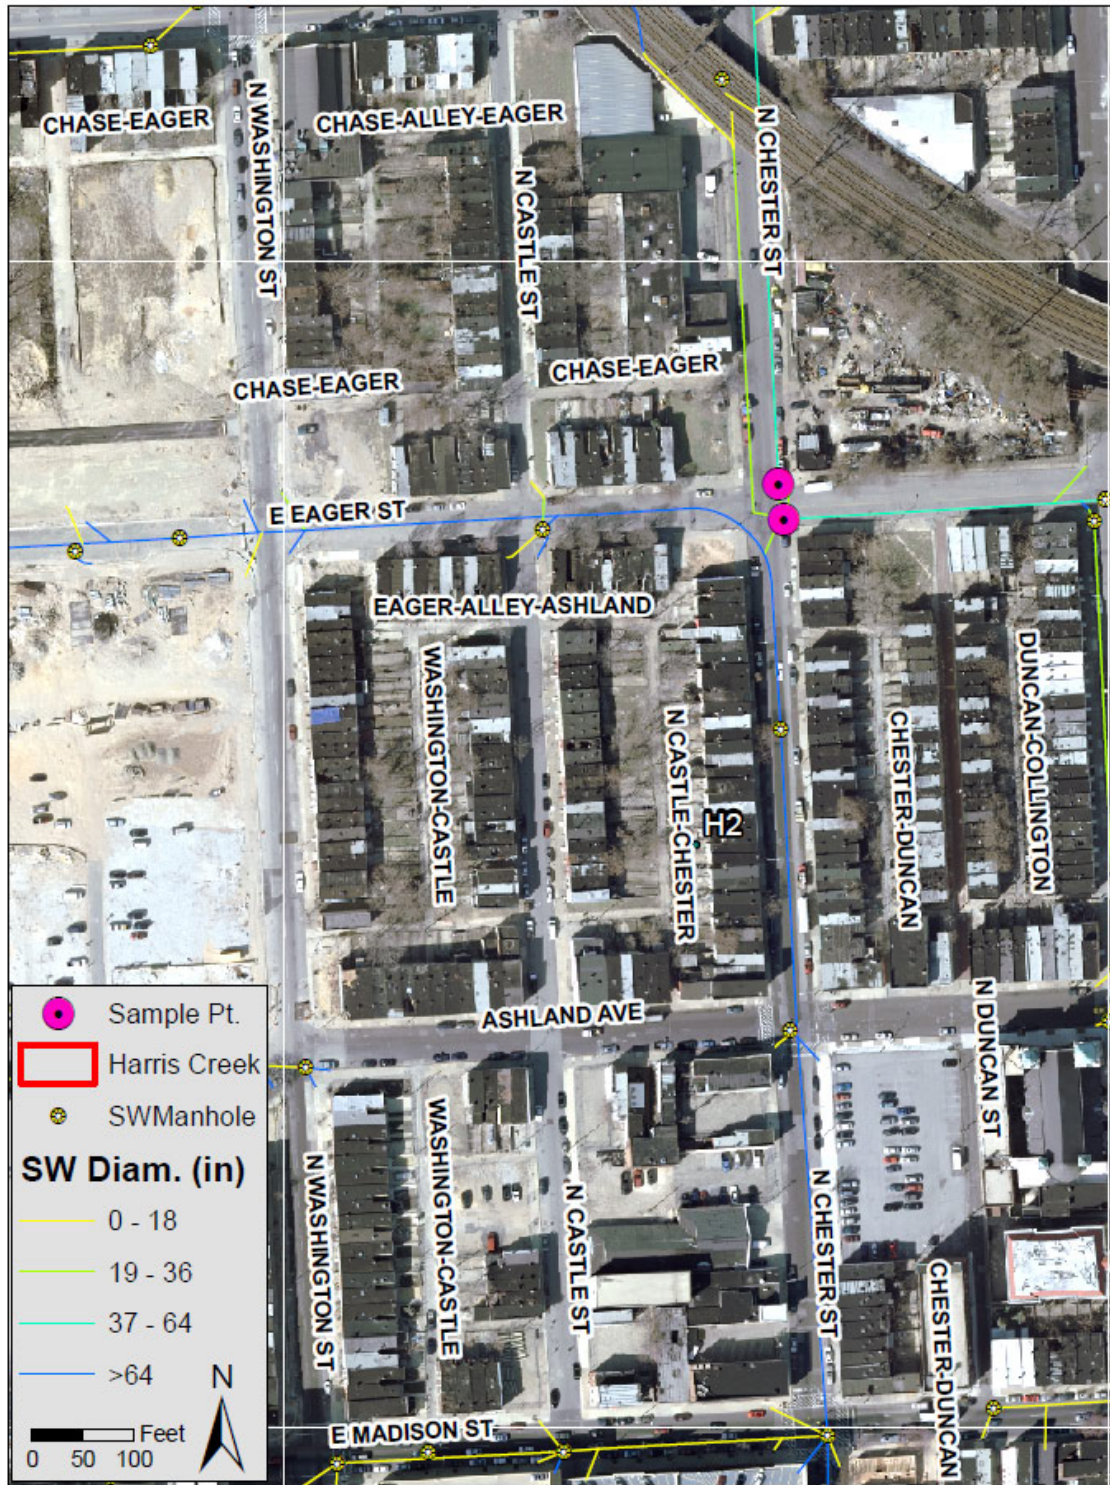
Appendix A Figure 1. Example map illustrating two sample locations (pink dots) chosen because they represent major junctions within the stormdrain system.

Because the Harris Creek watershed is an entirely piped stream network, sampling for illicit discharges could not take place through outfall screening as is typically done in an open stream channel. Therefore, sampling occurred from street level by accessing manholes directly above major junctions within the storm drain system. These sites were identified ahead of time through a desktop assessment using GIS. An example map depicting the location of two water sampling points can be found in Appendix Figure 1.
