# Final Wicomico River Watershed Management Plan - Updated

April 2014

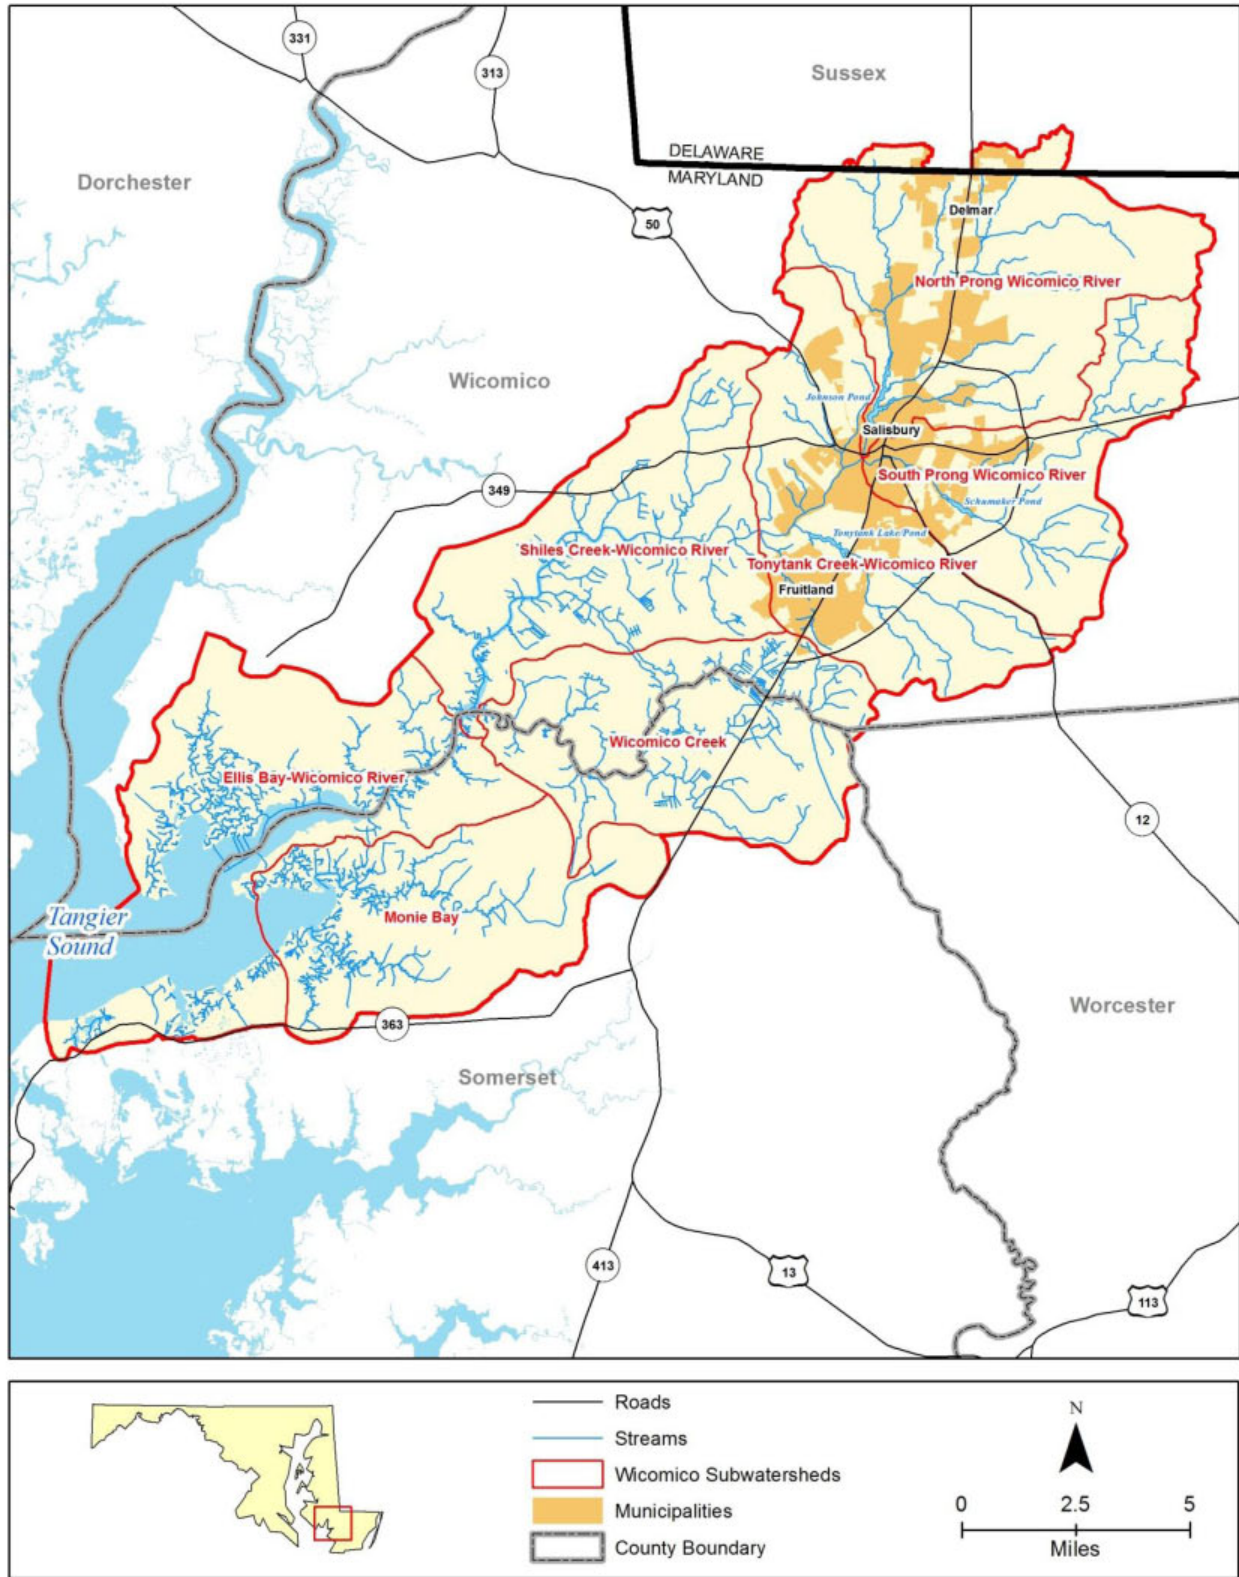
Figure 2. 1. Wicomico River Watershed

<b>Subwatershed</b>	<b>Area (acres)</b>	<b>Jurisdiction (%)</b>	<b>Stream Length (mi)</b>	<b>303d Stream Miles (% Impaired)</b>	<b>Impervious Cover (%)</b>	<b>Major Land Cover</b>
Monie Bay	18,448.93 (12.5%)	Somerset Co. (100%)	78.55	0.00 (0.0%)	0.35	Evergreen Forest (16.3%), Woody wetlands (24.5%), Emergent Herbaceous wetlands (19.4%)
Wicomico Creek	20,424.44 (13.8%)	Wicomico Co. (39.9%), Fruitland (0.3%), Somerset Co. (59.6%)	91.65	13.38 (14.6%)	0.84	Evergreen Forest (14.9%), Woody wetlands (22.6%), Cultured Crop (24.3%)
South Prong	14,816.08 (10.0%)	Wicomico Co. (83.2%), Salisbury (16.8%)	32.82	17.73 (54.0%)	11.24	Developed, open space (13.7%), Cultured Crop (24.3%), Woody Wetland (16.9%)
Ellis Bay	28,805.25 (19.5%)	Wicomico Co. (55.1%), Somerset Co. (44.9%)	113.46	7.15 (6.3%)	0.57	Open Water (31.6%), Woody wetland (14.5%), Emergent herbaceous wetland (25.7%)
Shiles Creek	21,541.96 (14.6%)	Wicomico Co. (98.5%), Fruitland (0.7%), Somerset Co. (0.7%)	82.04	16.11 (19.6%)	1.86	Evergreen Forest (10.8%), Cultured Crop (27.2%), Woody Wetland (17.9%)

Tonytank Creek	18,563.77 (12.6%)	Wicomico Co. (72.8%), Salisbury (15.6%), Fruitland (11.7%)	37.68	9.98 (26.5%)	9.94	Developed, open space (16.7%), Cultured Crop (25.9%), Developed, low intensity (10.9%)
North Prong	24,833.91 (16.8%)	Wicomico Co. (75.9%), Salisbury (14.2%), Delmar, MD (4.3%), Delaware Co. (4.3%), Delmar, DE (1.3%)	44.76	41.10 (91.8%)	7.84	Developed, open space (10.2%), Cultured Crop (27.2%), Woody Wetland (11.9%)
<b>Total</b>	<b>147,434.34</b>		<b>480.96</b>	<b>105.45 (21.9%)</b>

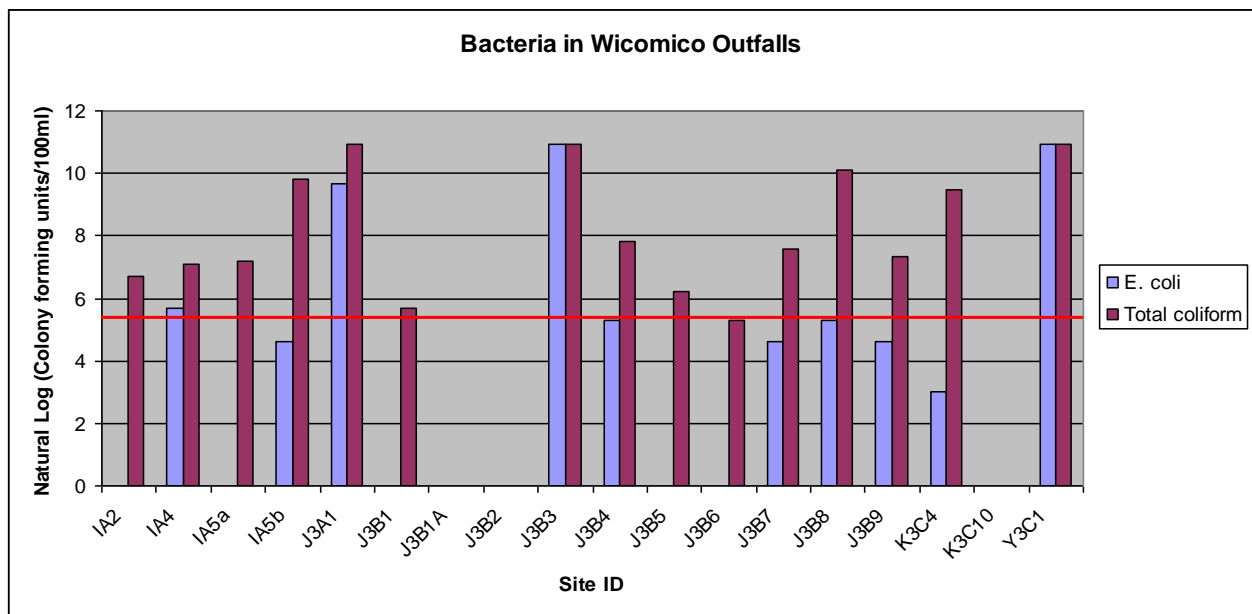
Illicit discharges are another potential source of bacteria to the watershed. The Center conducted illicit discharge detection and elimination (IDDE) staff training and outfall screening with the City of Salisbury in 2011. The study found 40% of screened outfalls with dry weather flow and 23% of those outfalls with dry weather flow had E. coli concentrations above the EPA’s standard for water contact recreation (235 CFU/100 ml for a grab sample) (CWP, 2011). In addition, very high concentrations of total coliforms were seen in many outfalls as well (Figure 2. 8).

**Figure 2. 8. E.coli and Total Coliform Concentrations in Salisbury Outfalls**

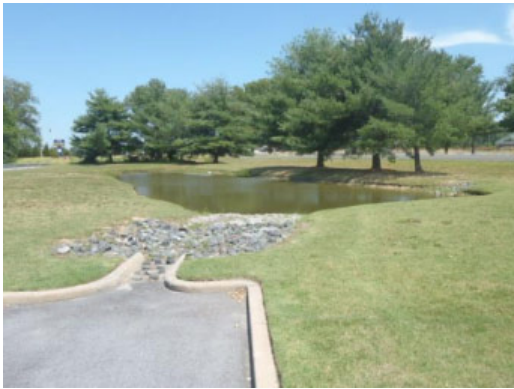
Several sites inspected as a part of the reconnaissance inventory included existing wet ponds. While some of these wet ponds included an outlet structure that maintains a permanent pool while providing detention capacity for large storms, many did not. These other wet ponds generally had a single weir overflow that directs water to a road ditch or other structure (Figure 4. 1). These types of wet ponds provide less treatment during storm events, and may be difficult to retrofit effectively. It appeared that the outlet structures (usually overflow weirs) did not provide any significant restriction of flow, especially for smaller storm events, such as the 2-year storm. If the ponds are not providing detention of storm events, they still have a water quality benefit, but not as much as if detention were provided.

**Figure 4. 1. Wet pond with weir outlet structure to road ditch**

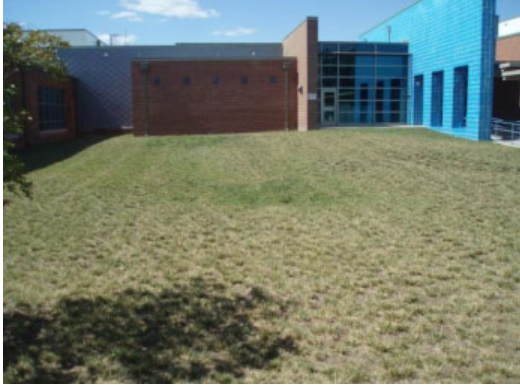
**Figure 4. 2. Rain garden opportunity at Prince Street School**

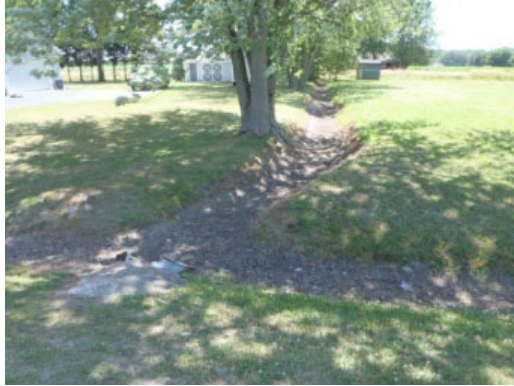
**Figure 4. 3. Opportunity for ditch restoration in SP\_NSA\_6.**

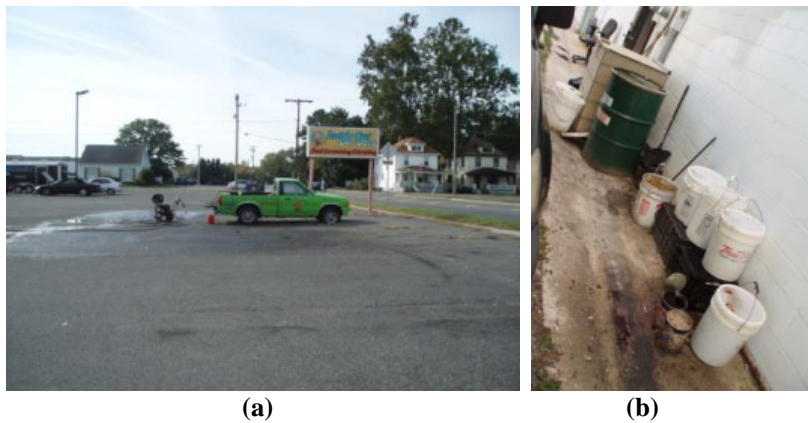
**Figure 4. 8. (a) Commercial vehicle washing on impervious cover (HSI\_20a) and (b) improperly stored materials (HSI\_20b)**

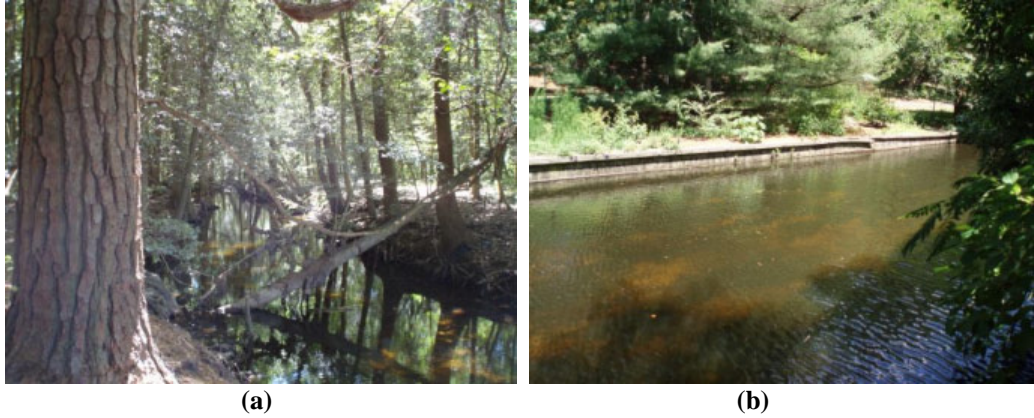
**Figure 4. 9. (a) RCH 13 - "excellent reach" and (b) channelized section of RCH4 - "poor" reach**

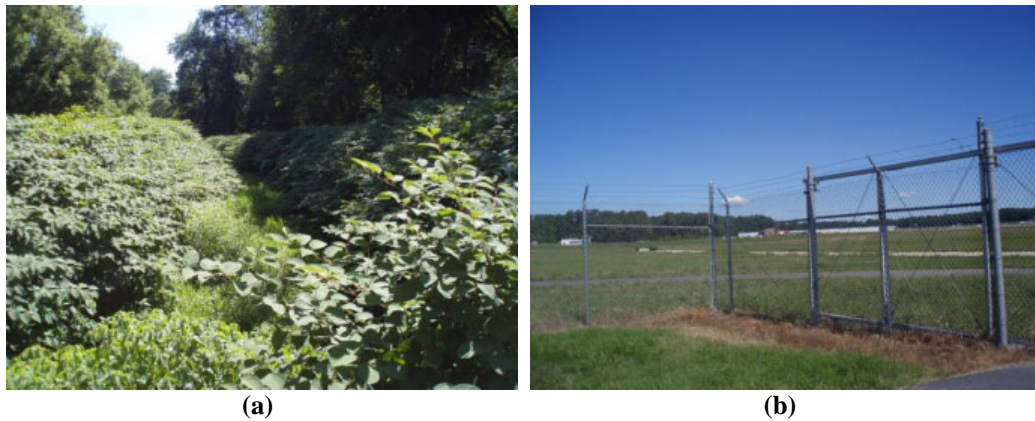
Figure 4. 10. (a) Impacted buffer (IBI 701) has been overrun with invasive Japanese knotweed and (b) channel modification (CM 3101) at the airport

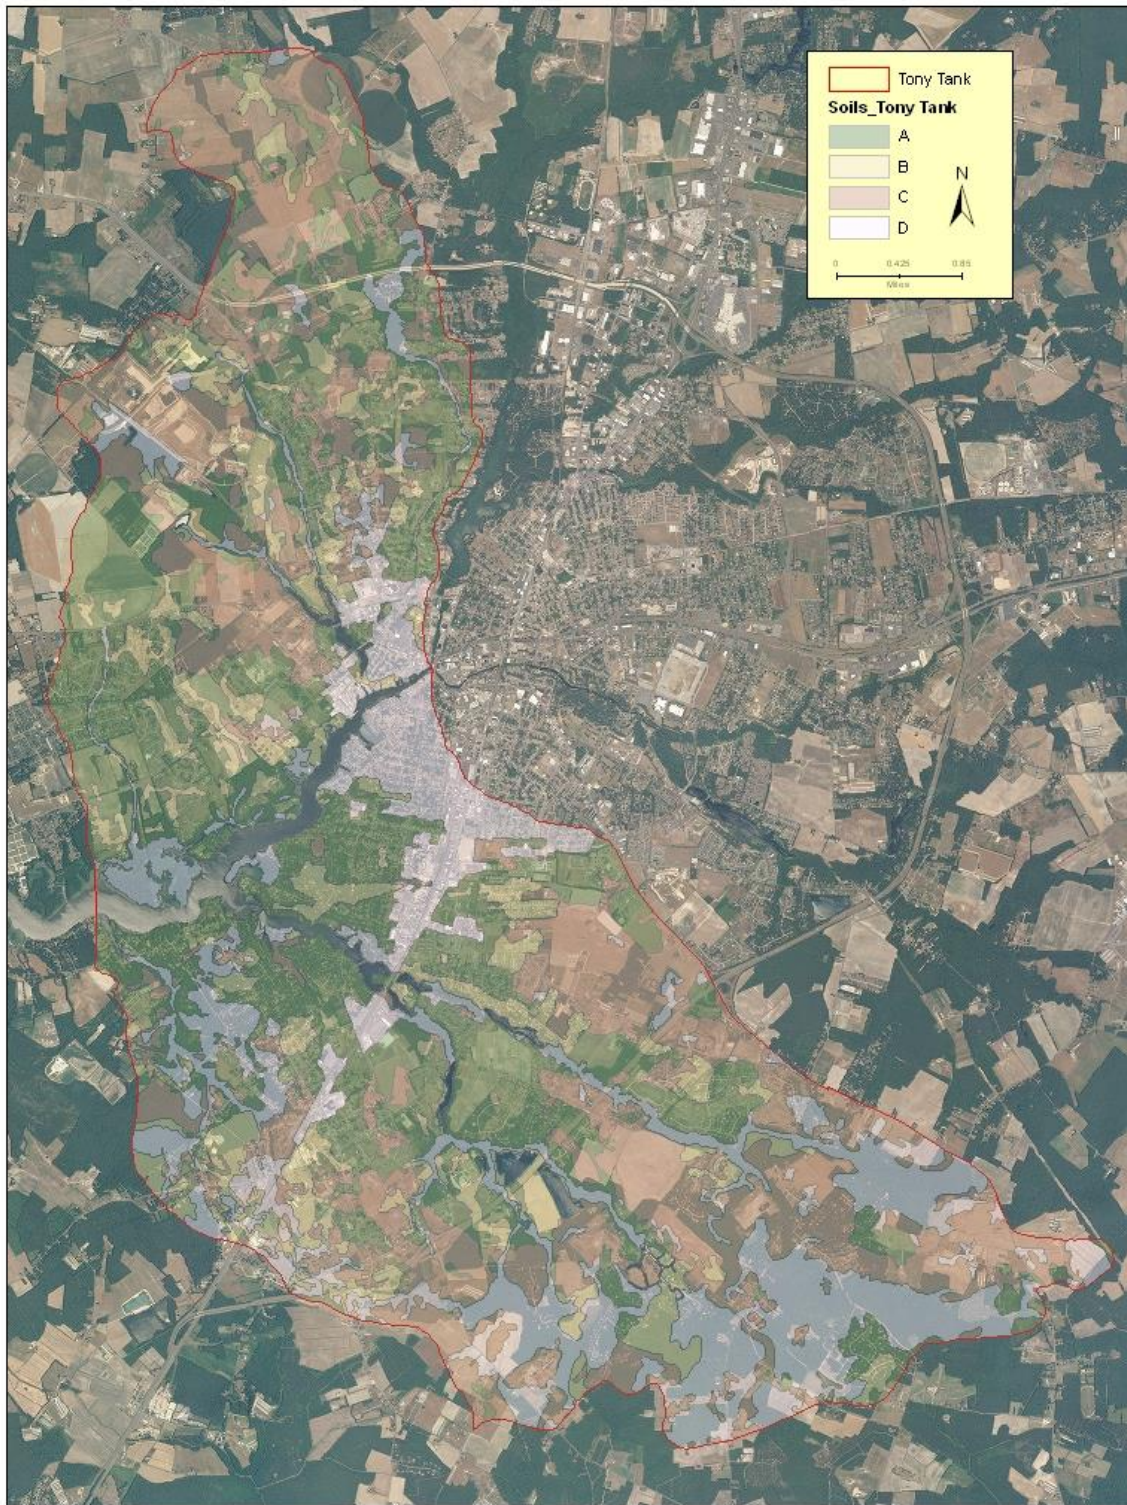
**Figure 4. 13. Soil Distribution across the Tony Tank subwatershed**

<b>Table 4. 13. Soils in the Tony Tank Subwatershed</b>	
Hydrologic Soil Group	Acres (%) <sup>8</sup>
A	5,941 (32.0%)
B	2,246 (12.1%)
C	5,506 (29.7%)
D	4,287 (23.1%)

<sup>8</sup> 582 acres of water not accounted for under soils.

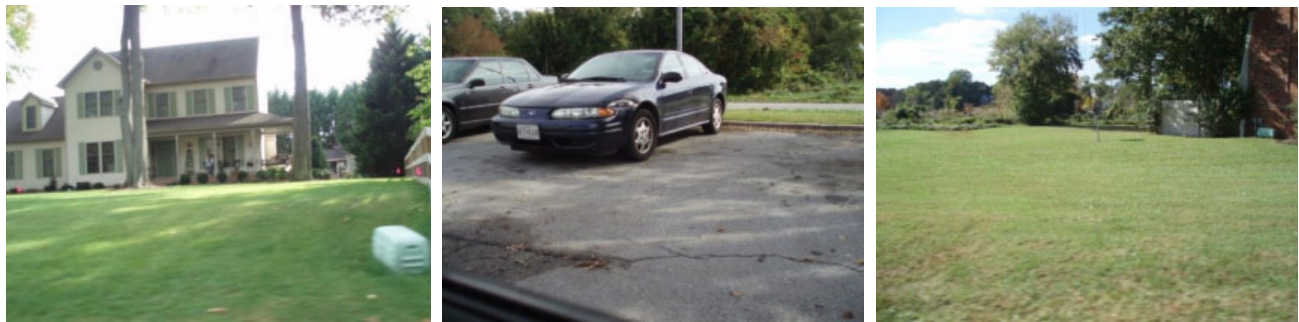
Figure 4. 15. (a) Opportunity for outreach regarding lawn maintenance at TT\_NSA\_37; (b) dirty parking lots at TT\_NSA\_39; and (c) ample opportunity for tree planting at TT\_NSA\_22

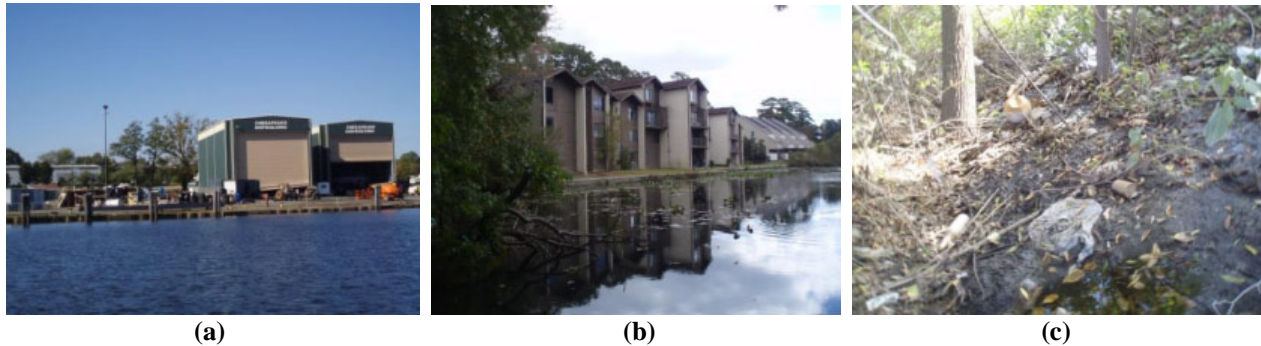
**Figure 4. 18. (a) Hotspot operation and impacted buffer (IB46-1); (b) impacted buffer in Canal Woods development (IBI3\_1) and (c) opportunity to engage local neighbors in a volunteer trash clean-up (TR36\_1)**

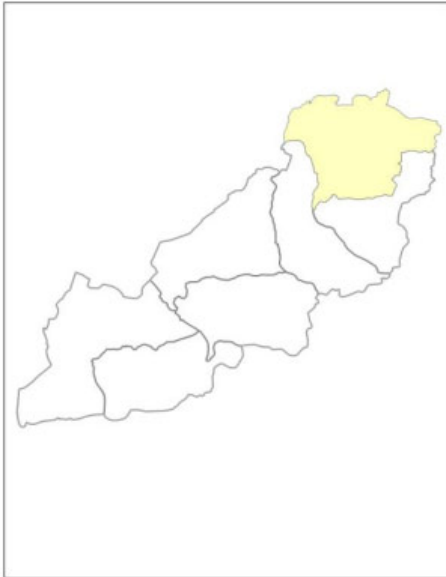
Drainage Area		24,834 acres
Existing Impervious Cover		1,947 acres (7.84%)
Stream Miles		44.8 miles
2006 Land Use	Developed, Open Space	10.2%
	Developed, Low Intensity	6.3%
	Developed, Medium Intensity	4.0%
	Developed, High Intensity	2.6%
	Forest / Shrub	28.9%
	Cropland and Pasture	34.4%
	Woody & Herbaceous Wetlands	12.0%
Jurisdictions as Percent of North Prong		14.2% Salisbury 4.3% Delmar 76% Wicomico County

The North Prong has been classified as an Impacted/Rural Mix subwatershed (CWP, 2013). Most of the watershed is in the County (76%), with 14% in the City of Salisbury and 4% in Delmar. Land use is a mixture of forest and shrub (29%), cropland and pasture (34%) and is less developed than the South Prong and Tony Tank (Table 4.21). Soils are primarily in hydrologic soil groups C (moderately high runoff potential, slow infiltration) and D (high runoff potential, very slow infiltration) (Table 4. ). Hydrologic group A soils have low runoff potential and high infiltration rates and B soils have moderately low runoff potential and moderate infiltration rates. Figure 4.20 shows the distribution of soils across the subwatershed.

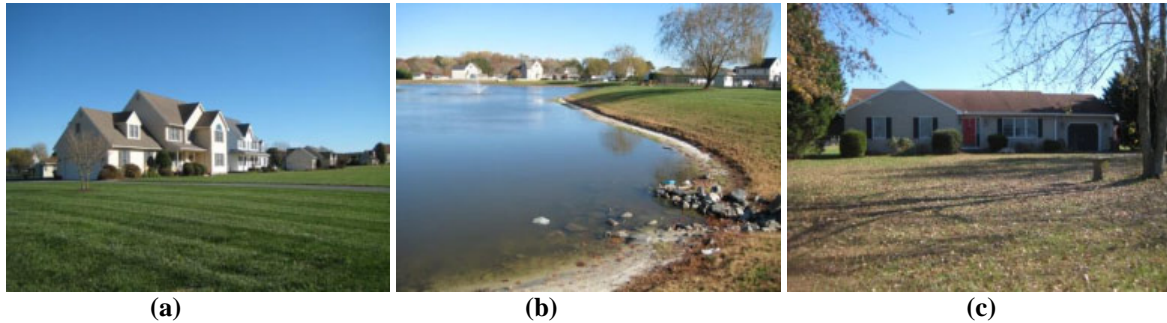
**Figure 4.21. (a) High pollution severity as evidenced by a highly managed lawn at NP\_NSA\_19a; (b) Stormwater pond at NP\_NSA\_20 with opportunity for vegetated buffer, pond retrofit and floating wetlands to improve water quality; and (c) Opportunity for rain gardens at NP\_NSA\_19b.**

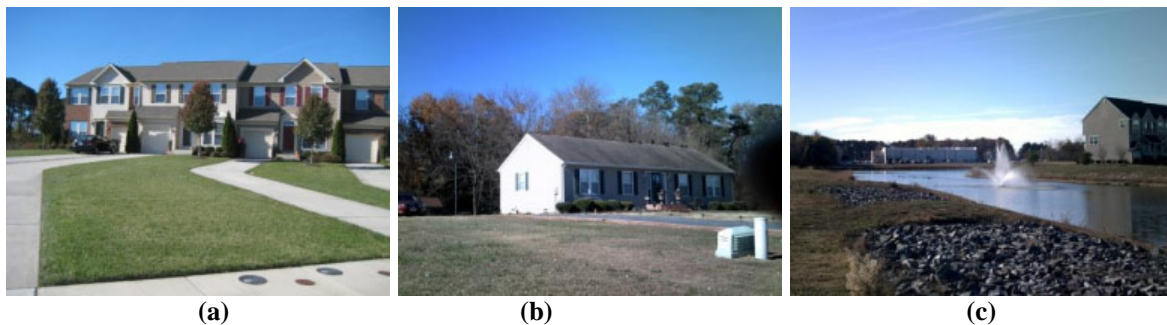
**Figure 4.22. (a) Highly manicured lawn at NP\_NSA\_21 with high pollution severity and little available space for restoration; (b) Lots with little tree canopy at NP\_NSA\_8; and (c) Stormwater pond mowed to edge at NP\_NSA\_10.**

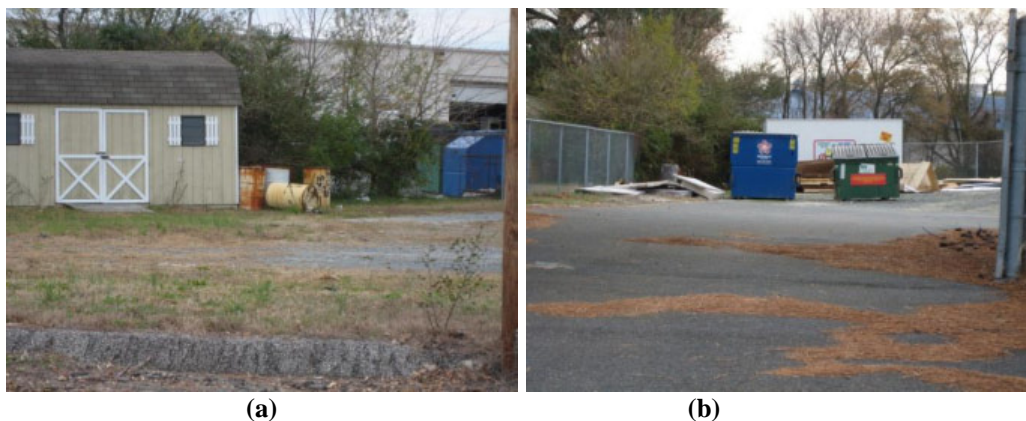
**Figure 4.23. HSI\_30 (a) 55-gallon unlabeled drums, rusting and knocked over at Line X and (b) Raw materials and trash strewn about behind the commercial property at the southeast corner of Northwood Drive and Alexander Avenue.**

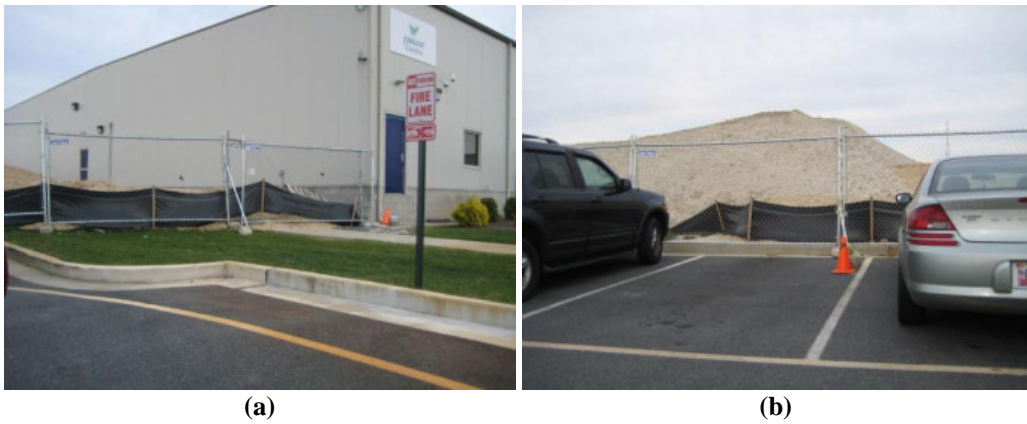
- HSI\_31, Jubilant Cadista, Kiley Dr. (Figure 4.26): Poor erosion and sediment control practices.

Figure 4.26. HSI\_31 (a) and (b) Poor erosion and sediment control (ESC) practices at Jubilant Cadista.

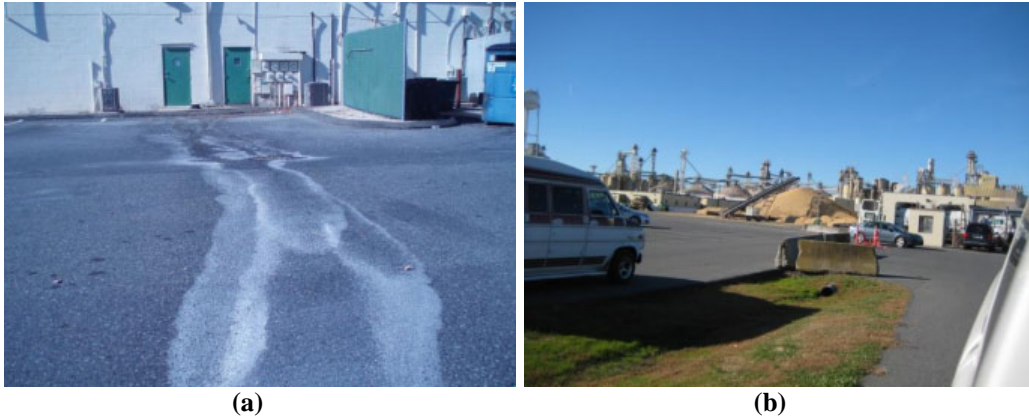
**Figure 4.27. (a) Staining on parking lot leading to storm drain at Hunan Delight (HSI\_5) and (b) Raw materials stored outside without cover at the Perdue plant (HSI\_12).**

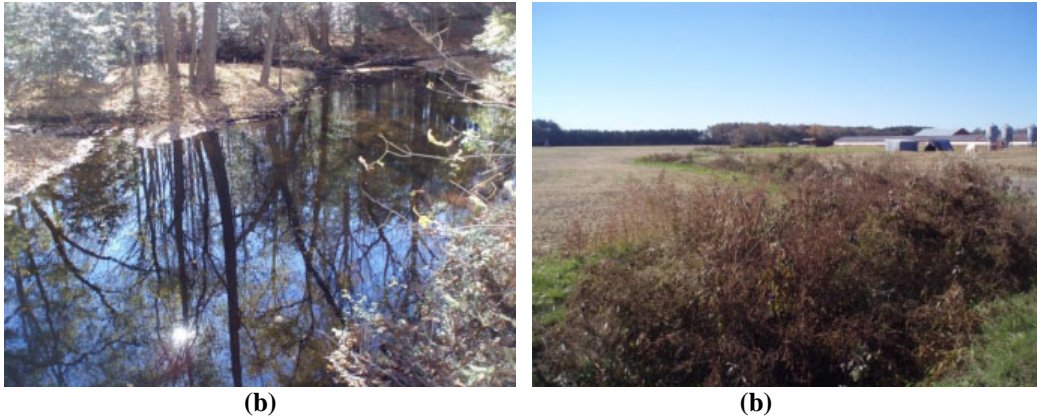
**Figure 4. 28. (a) RCH 101a - "excellent reach" with wide, forested buffer and good floodplain connectivity and (b) RCH 104 - "very poor" reach in the headwaters modified as a drainage ditch.**

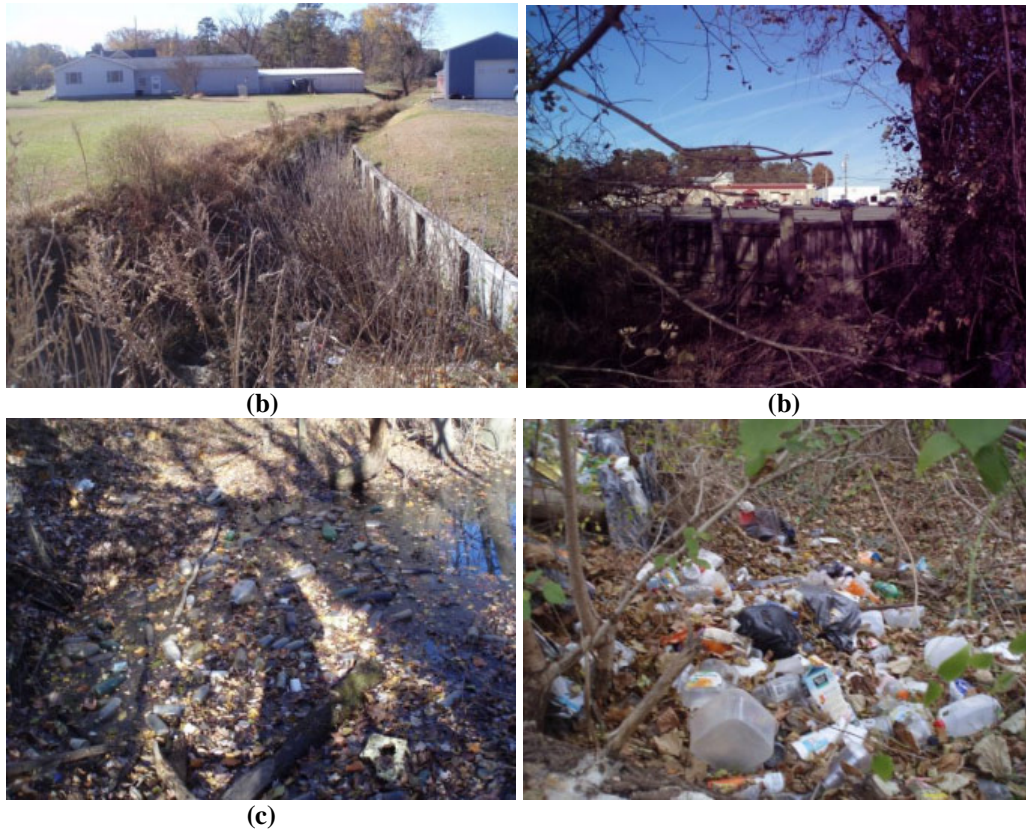
**Figure 4. 29. (a) Headwater stream modified as tax ditch (IB105\_2); (b) impervious lot to edge of stream (IB204\_1); (c) Trash accumulation at TR113a\_1; and (d) Dumping at TR304\_1.**
