# Coconut Rolls as a Technique for Natural Streambank Stabilization

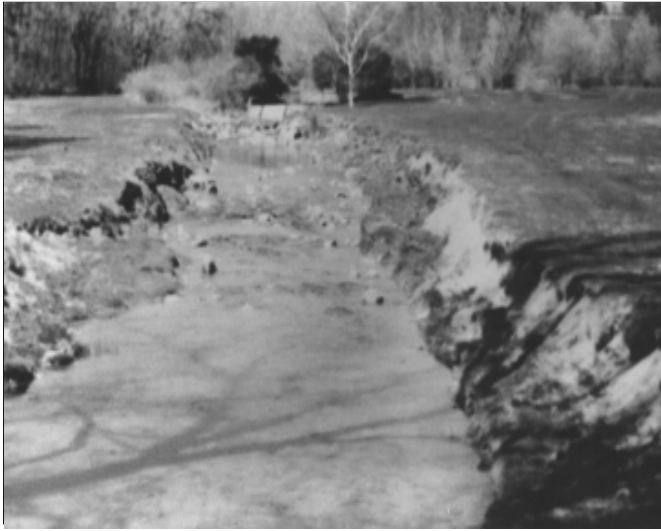
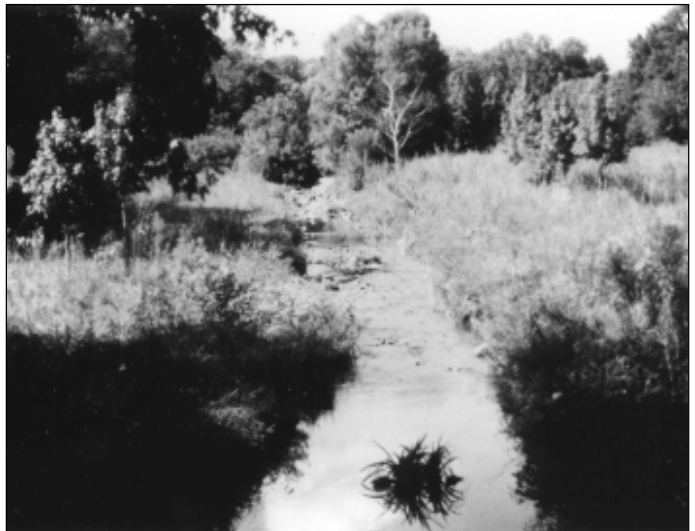
**Figure 2: Vegetation Establishment on Coir Rolls: Mystic River, Medford, MA October 1993 (A) and October, 1994 (B)**

A key design issue for streambank stabilization is how to physically protect the bank from erosion until the vegetation has become fully established. One solution is to use rolls of coconut fiber (also known as coir rolls) along the toe of the bank. The coconut roll acts as a flexible but resistant foundation for streambank plantings (Figure 1). Fiber rolls are initially plugged with native hydrophytic plants and then laid along the toe of the bank where they retain water and nutrients. The coir rolls eventually degrade but give plants enough time to form a dense network of intertwining roots that holds the bank (Figure 2, A and B).
