Evaluation of Permeable Pavements in Cold Climates

Kortright Centre, Vaughan

Final Report

December 2012

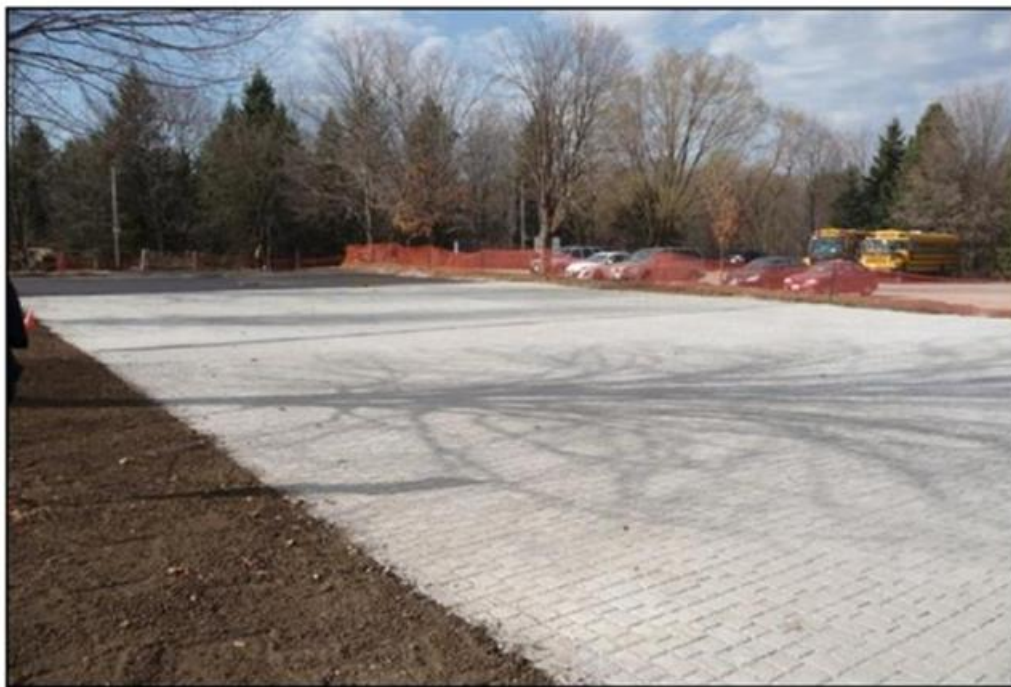
Figure 3.1: Kortright permeable pavements

In 2009, one of the parking bays was replaced with new permeable and impermeable pavements. The new permeable pavement parking lot, shown in Figure 3.1, consists of four 230–233 m² pavement cells. Two cells were constructed with permeable interlocking concrete pavers (AquaPave® and Eco-Optiloc®), one cell was constructed with Pervious Concrete and one cell was constructed with traditional asphalt. The clear stone granular base for the permeable pavements provides roughly 49 cm of storage. A schematic of the facility is shown in Figure 3.2 and outlines the location of the 4 pavement cells and general location of the drainage pipes. A description of the construction and photographs of the new parking bay is provided in Appendix A.

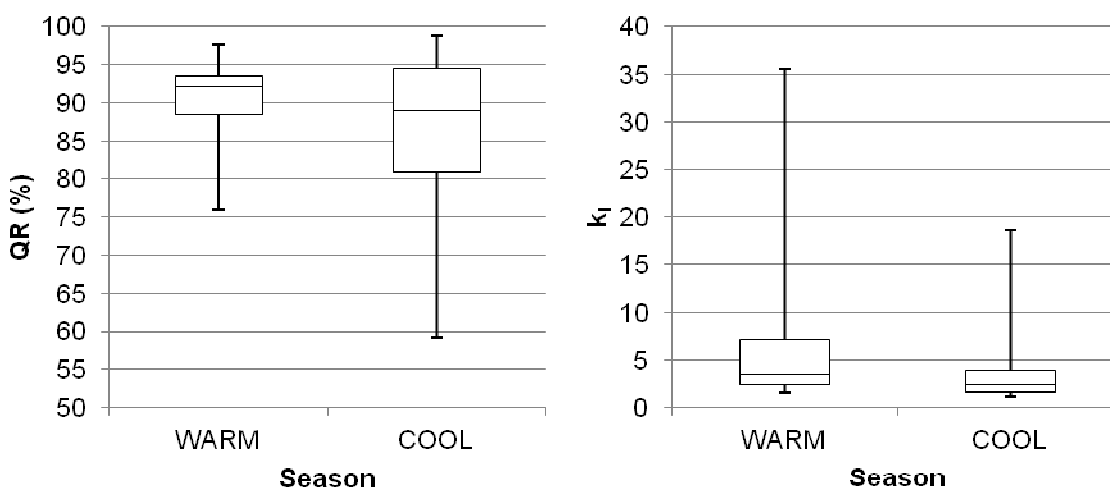
Figure 6.6: Seasonal peak flow reduction and lag coefficient boxplots

Comparing hydrologic variables between a warm (May-September) and cool (October-April) season reveal some differences in performance. Peak flow reductions are slightly larger and less variable during the warm season (Figure 6.6), although the PPs continued to provide large reductions, QR >60%, throughout the cool season. Slow release of water during winter melt events contributed to higher cool season peak flow variability. The relative delay of stormwater, represented by k_t , also tended to be longer during the warm season compared to the cool season but the summer months also displayed higher variability overall.

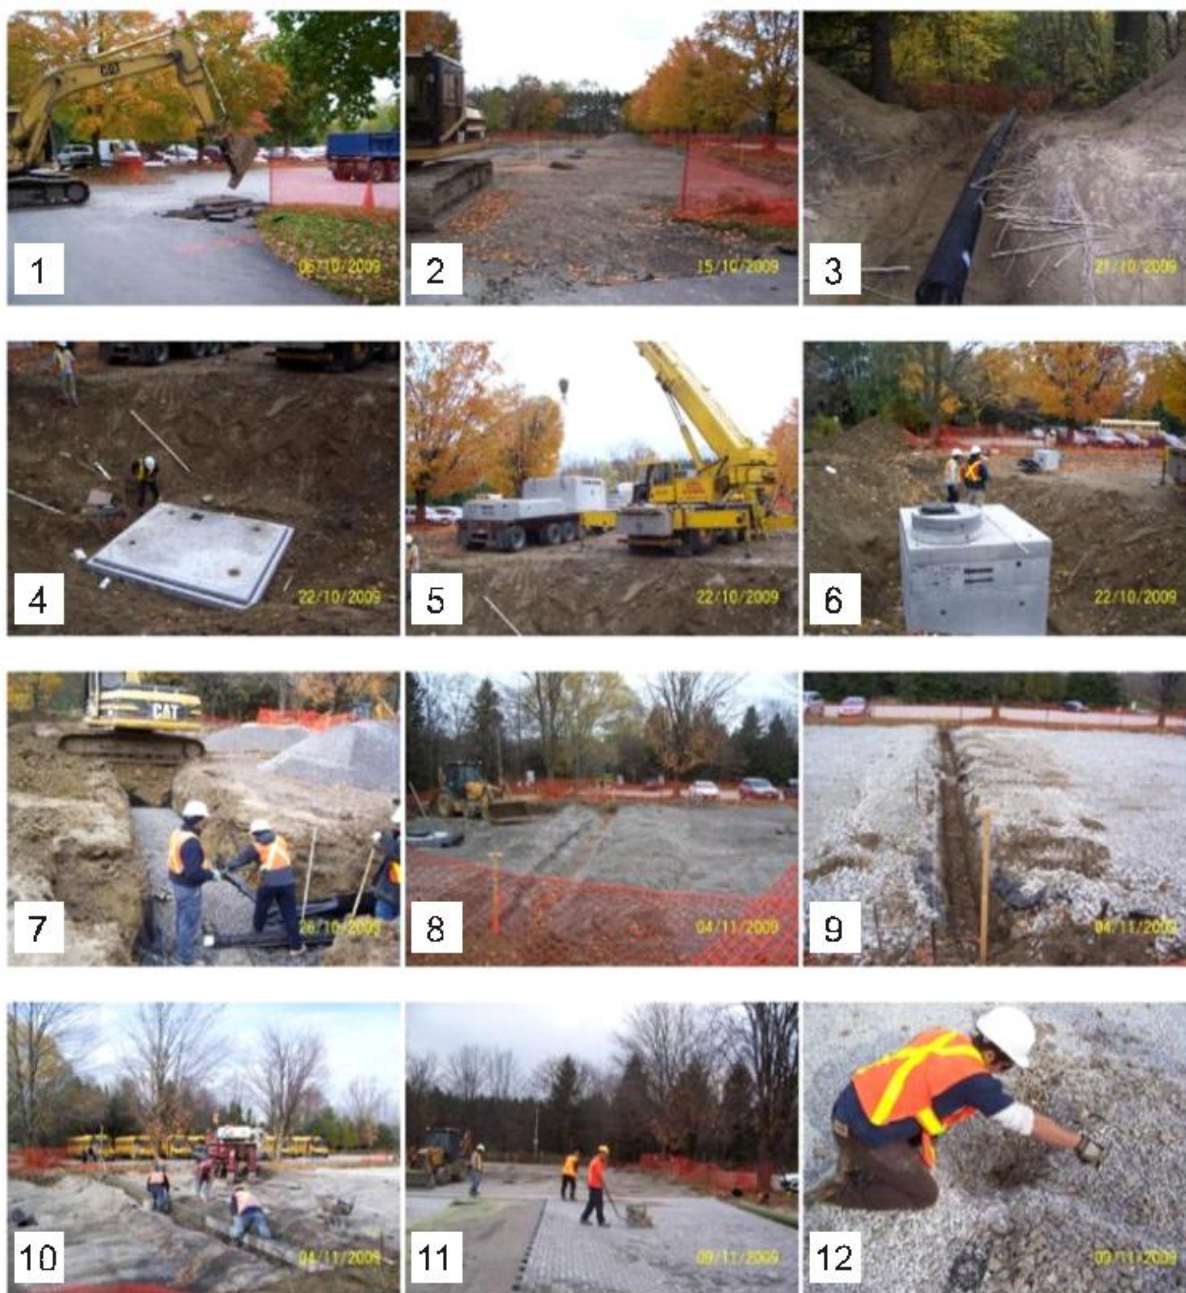
Figure A1: 2009/2010 photos

Construction of the new permeable pavement parking lot took place over the fall of 2009. The existing asphalt and fill was removed (1) and excavated (2) in preparation for the construction of the new parking lot. A drainage pipe was installed which allows runoff and water exfiltrating from the permeable pavement to discharge to the adjacent forest (3), where rip rap and a granular soakaway was installed to prevent erosion. A concrete pad (4) and vault (5) was installed which houses the equipment needed to monitor flows and collect water quality samples. The vault is accessed through a manhole and at the same elevation as the pavement so that the entire monitoring systems is gravity fed (6). With the control vault in place four drainage pipes were placed. These pipes collect stormwater from the four pavement cells. In the control cell the pipe connected to a catchbasin and drains surface runoff from the asphalt pavement. In the three permeable pavement cells the pipe is perforated and collected water that has infiltrated through the pavement and granular fill. An additional collection pipe was placed at a lower depth beneath a meter of native material under the Aquapave® PICP cell. The pipe was positioned in a trench of granular material above an impermeable liner so that water could easily drain into the pipe (7).

All four pavement cells were filled and levelled with clear stone granular material (except for the asphalt, which used a dense graded base) (8). In the permeable pavement cells this material provides up to 49 mm of storage during precipitation events. Trenches were dug between each cell (9) and a concrete curb was installed to hierologically separate the cells (10). The paving material was installed for the asphalt, the AquaPave® and the Eco-Optiloc® in early November (11). Temperature sensors were embedded in the pavement and below for the asphalt and Aquapave® PICP (12). A shallow well was dug through each pavement and transducers were installed to monitor water level responses within the pavement. Since pervious concrete required higher overnight temperatures for curing, the pervious concrete plot was installed in the spring of 2010.
