Urban Water Journal

Illicit discharge detection and elimination: Low cost options for source identification and trackdown in stormwater systems

Keywords: illicit discharge; stormwater; MS4; outfall; E. coli

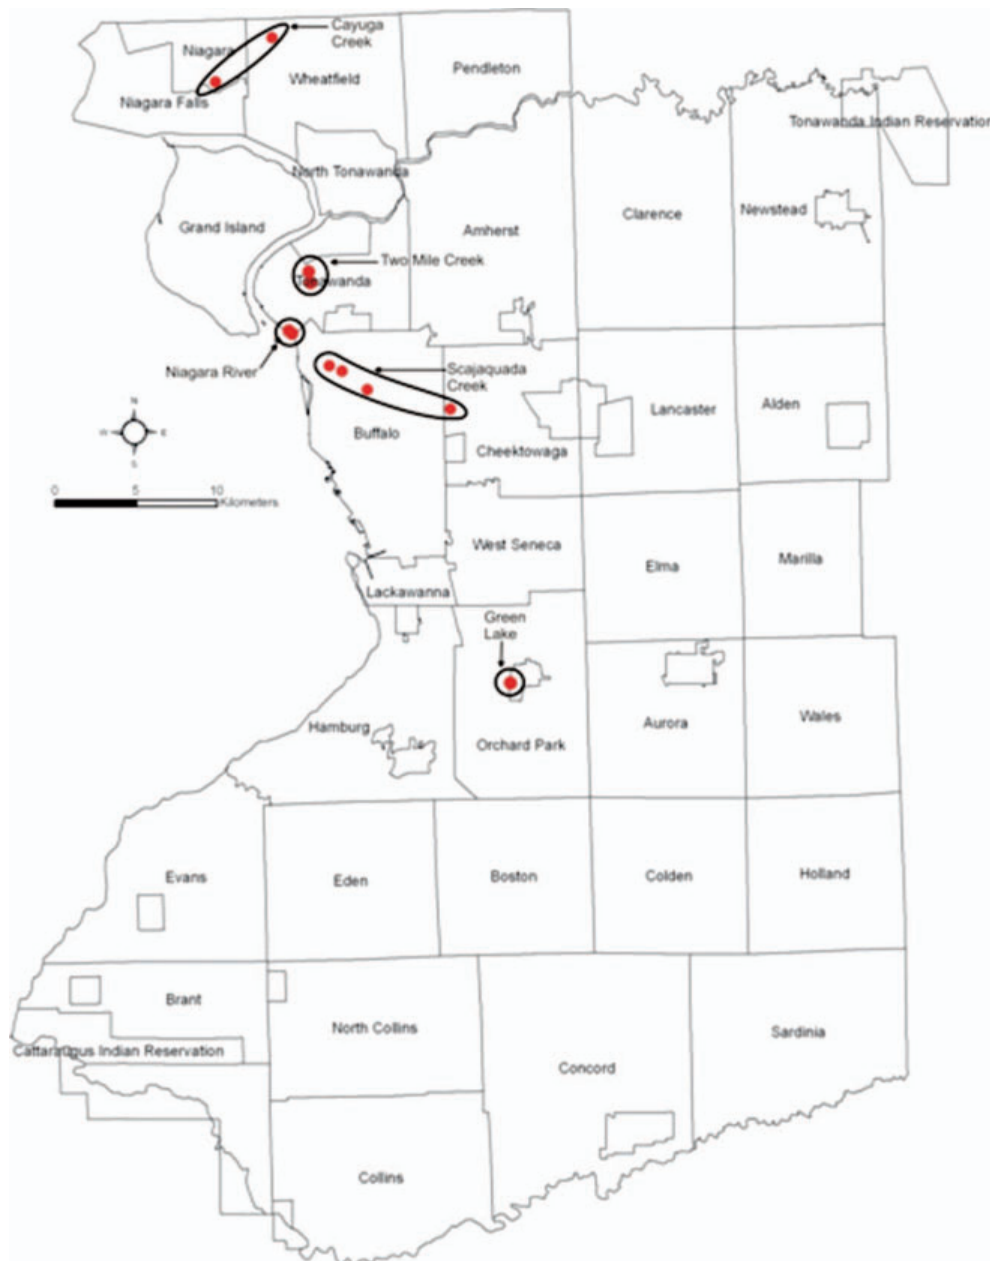
Figure 1. General location of receiving water samples.

Water samples were collected in five different receiving water bodies, Cayuga Creek (Niagara County), Scajaquada Creek, Niagara River, Two Mile Creek, and a tributary leaving Green Lake (Figure 1). The sample sites generally were located as an upstream and downstream pair. The Cayuga Creek site had a total of three permitted stormwater discharges between the upstream and downstream location; Niagara River had four permitted stormwater discharges between the upstream and downstream location; Two Mile Creek

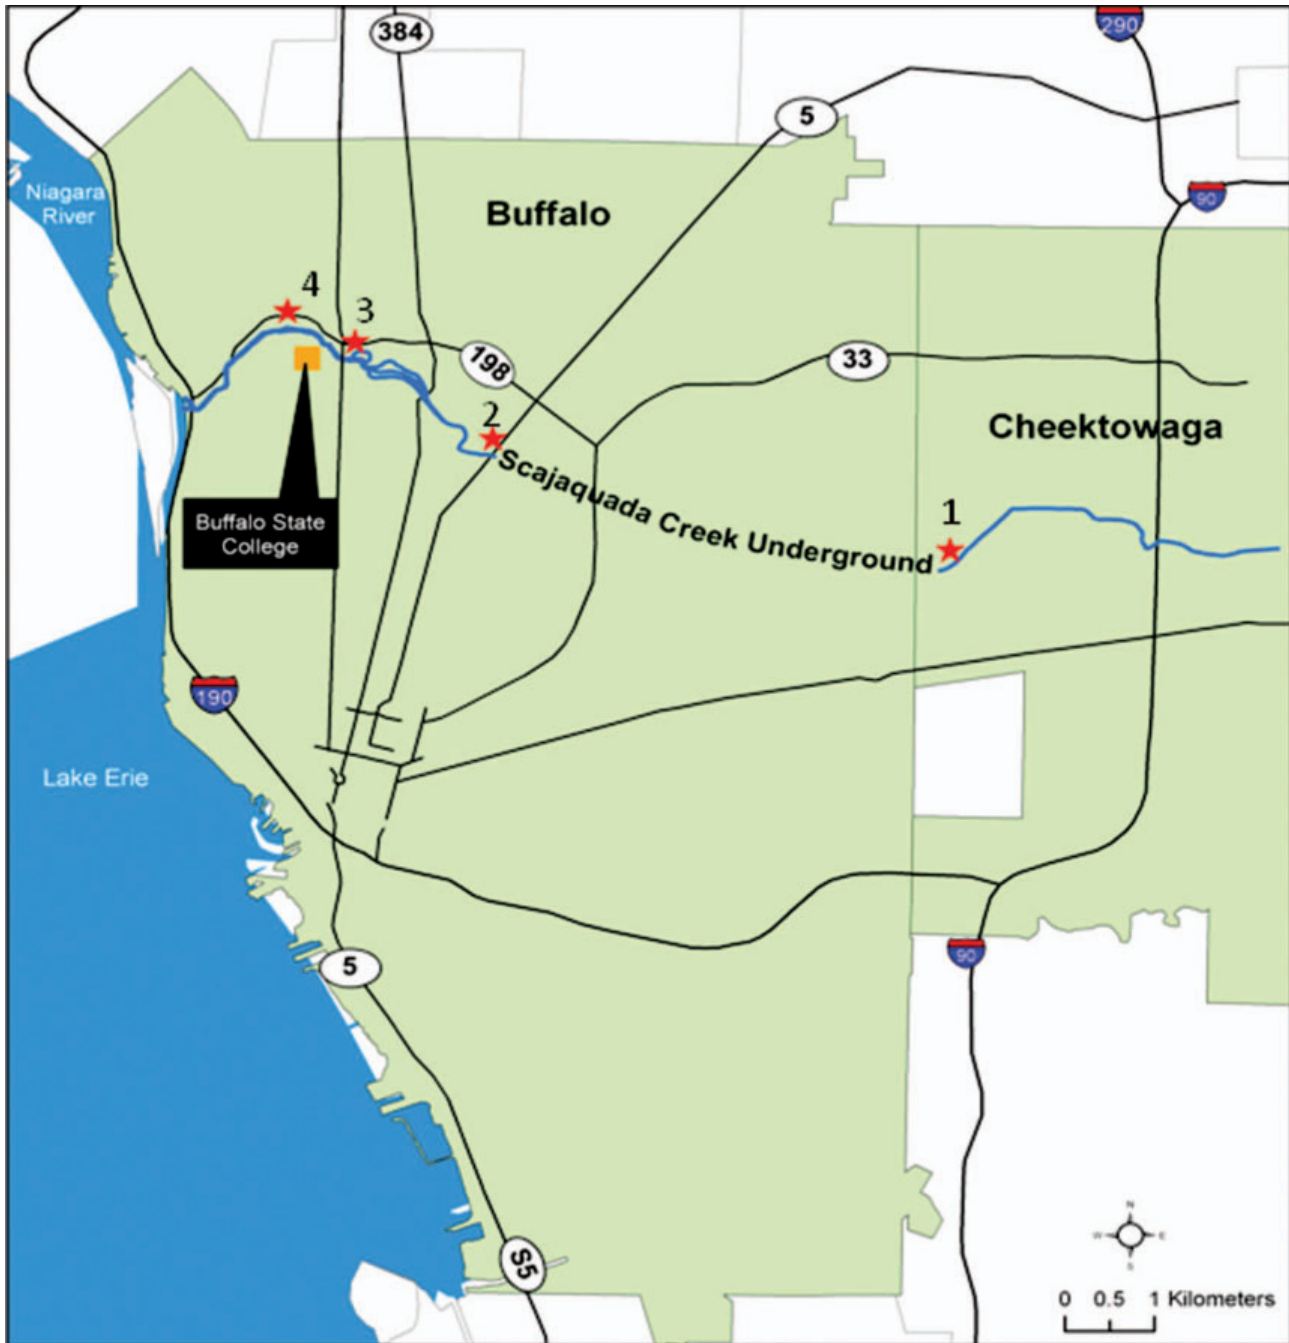
Figure 2. Scajaquada Creek sample sites. The creek flows through an underground tunnel between sites 1 and 2.

Sampling was conducted during storm events at various combinations of the four sample sites on Scajaquada Creek, depending on team availability and storm duration. These sites were selected as being common to the Buffalo Sewer Authority’s CSO Long Term Control Plan Phase II Study. Samples were collected for the storm events of 24 July 2008, 1 October 2008, and 16 October 2008 and the results are summarized in Table 3. The levels of *E. coli* observed in Scajaquada Creek for storm events generally were higher than those observed for Cayuga Creek. Several city of Buffalo CSOs discharge to Scajaquada Creek between sites 1 and 2 and CSO points also are located in the vicinity of sites 3 and 4.

and CSOs. For the 24 July 2008 event, three of four Buffalo State stormwater discharge points located between Scajaquada Creek sample sites 3 and 4 had

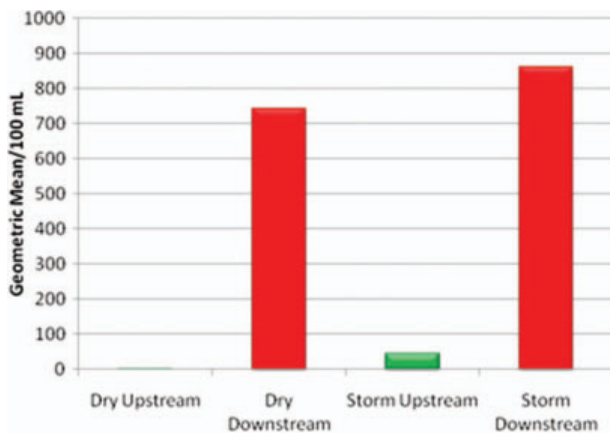
Figure 4. Geometric mean *E. coli* levels in Cayuga Creek.

A total of 62 samples (21 dry weather days, 41 wet weather days) were collected at the upstream and downstream sites on Cayuga Creek between 27 July 2007 and 25 July 2008 for *E. coli* analysis and the results are summarized in Figure 4. The maximum measured *E. coli* level for a storm event at the upstream site was 18,900 CFU/100 mL and the maximum measured *E. coli* level for the downstream site was 11,500 CFU/100 mL. However, as shown in Figure 4 there was a general trend towards increasing *E. coli* levels in the downstream direction for both dry weather and storm event conditions. In general, the upstream site exhibited relatively low *E. coli* levels. Mean storm event levels were higher than dry weather flow at both sites.

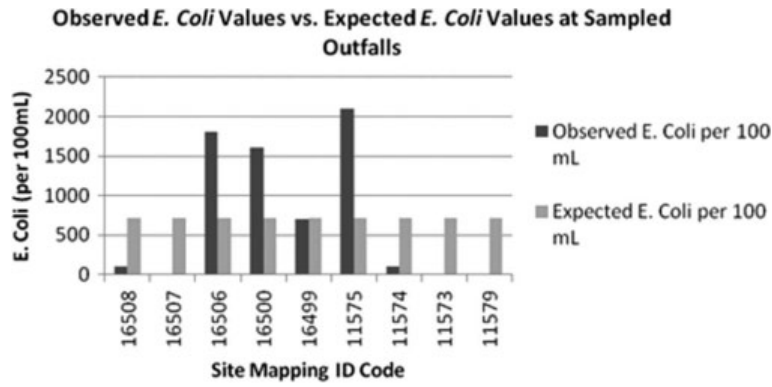
Figure 6. E. coli results for stormwater discharges to Cayuga Creek, event of 10/21/08. Site mapping ID codes for locations between the upstream and downstream sites in Cayuga Creek are: NI6 = 16508; NI5 = 16507; and NI4 = 16506.

Although the municipalities in the Cayuga Creek watershed were not participants in this demonstration project, there are three permitted stormwater outfalls (NI6, NI5, NI4) between the upstream and downstream sites (Figure 5). Samples were not collected at these outfalls during dry weather flow. However, samples were collected at most of the stormwater outfalls shown in Figure 5 in association with the storm event of 21 October 2008 (0.4 inches (10.1 mm) of rain). The geometric mean *E. coli* level at the outfalls for this event was 711 CFU/100 mL, which is taken as the “expected” level (Figure 6). Site NI4 (Figures 5 and 6), in particular, could be an

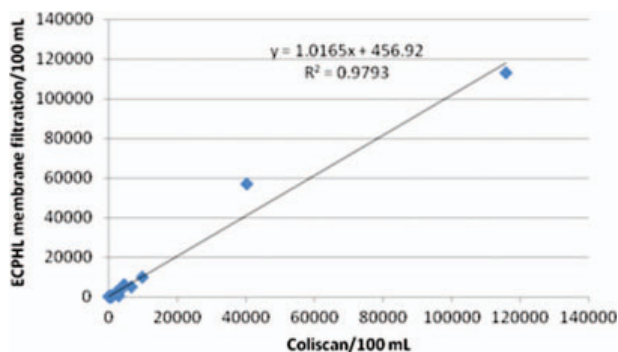
Figure 7. Comparison of E. coli levels determined using Coliscan Easygel[®] and membrane filtration, Erie County Public Health Lab (ECPHL).

A total of 21 samples (10 receiving water and 11 storm sewer) were collected in duplicate and analyzed at Buffalo State and at the Erie County Public Health Laboratory for E. coli. The Erie County Public Health Laboratory analyzed E. coli using membrane filtration according to U.S. EPA Method 1603. Finally, a YSI 6920 datasonde was used to compare dissolved oxygen measurements with the CHEMetrics visual test kit measurements, as well as measurements of pH and conductivity with the Hanna Instruments HI9811 field meter.

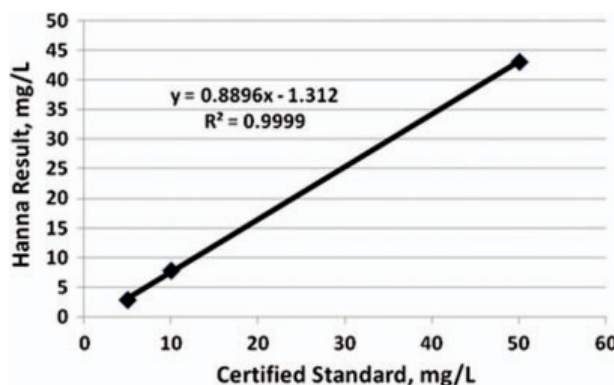
Figure 8. Potassium standards analysis with Hanna HI 93750 photometer. Each point is the mean of a triplicate analysis.

Certified standards for potassium, nitrate, fluoride, chromium VI, copper, total phosphorus, and ammonia were analyzed in triplicate. All parameters except potassium were measured using the Hanna Instruments C 200 photometer. Potassium was measured using the Hanna Instruments HI 93750 photometer. Results of the mean of triplicate samples for potassium, nitrate, chromium VI, copper, and fluoride are shown in Figures 8–12. The Hanna Instruments C 200 photometer recorded a mean triplicate result of 1.03 mg/L for the total phosphorus standard of 1.0 mg/L. The Hanna Instruments C 200 photometer also recorded a mean triplicate result of 0.41 and 1.03 mg/L for the ammonia standard of 0.5 and 1.0 mg/L, respectively. Results of the certified standards analysis show that the Hanna Instruments photometers were capable of producing reliable results suitable for a trackdown study.

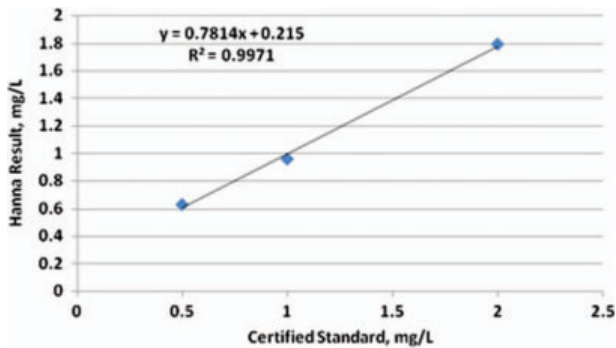
Figure 12. Fluoride standards analysis with Hanna C 200 photometer. Each point is the mean of a triplicate analysis.
