Paxton Creek North Subwatershed Restoration Plan

Produced by the Center for Watershed Protection
for the Paxton Creek Watershed and Education
Association

Funded by the National Fish and Wildlife
Foundation and the Canaan Valley Institute

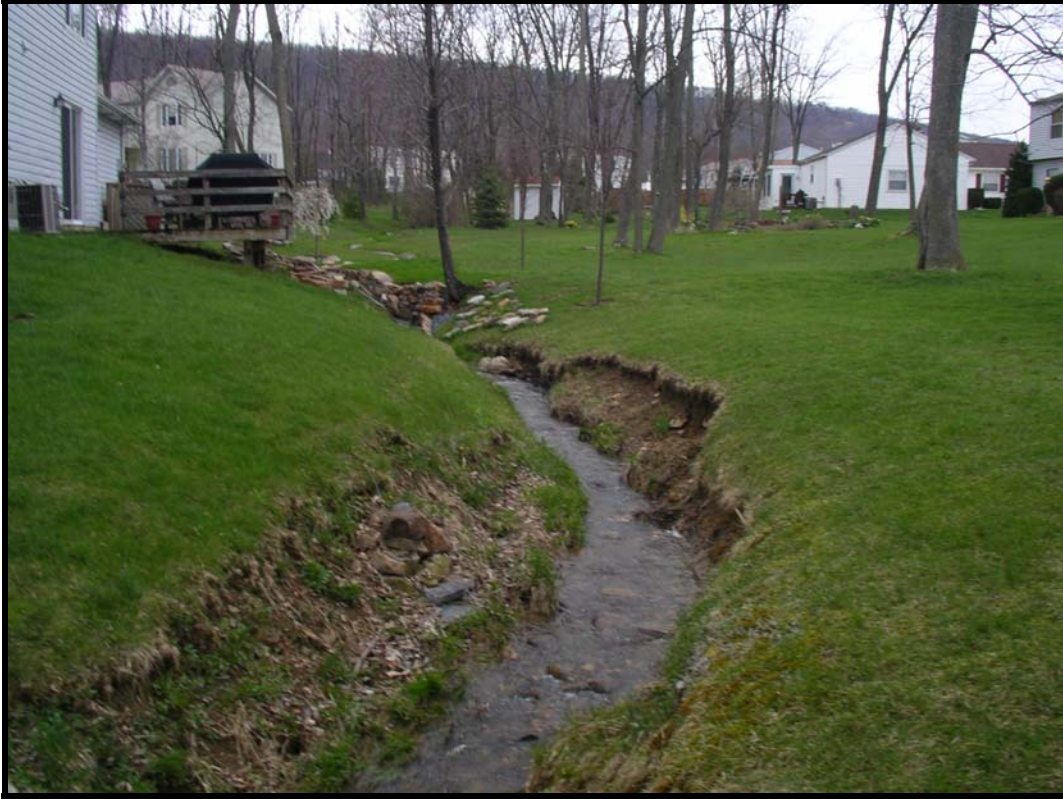
Figure E-3 - Backyard stream in need of a buffer in Upper PCN

Common observations in the field included a lack of forested stream buffers, particularly in residential neighborhoods (Figure E-3), significant deposits of sediment in the stream in the lower portion of the subwatershed (Figure E-4), and little management of stormwater runoff from existing developments (Figure E-5).

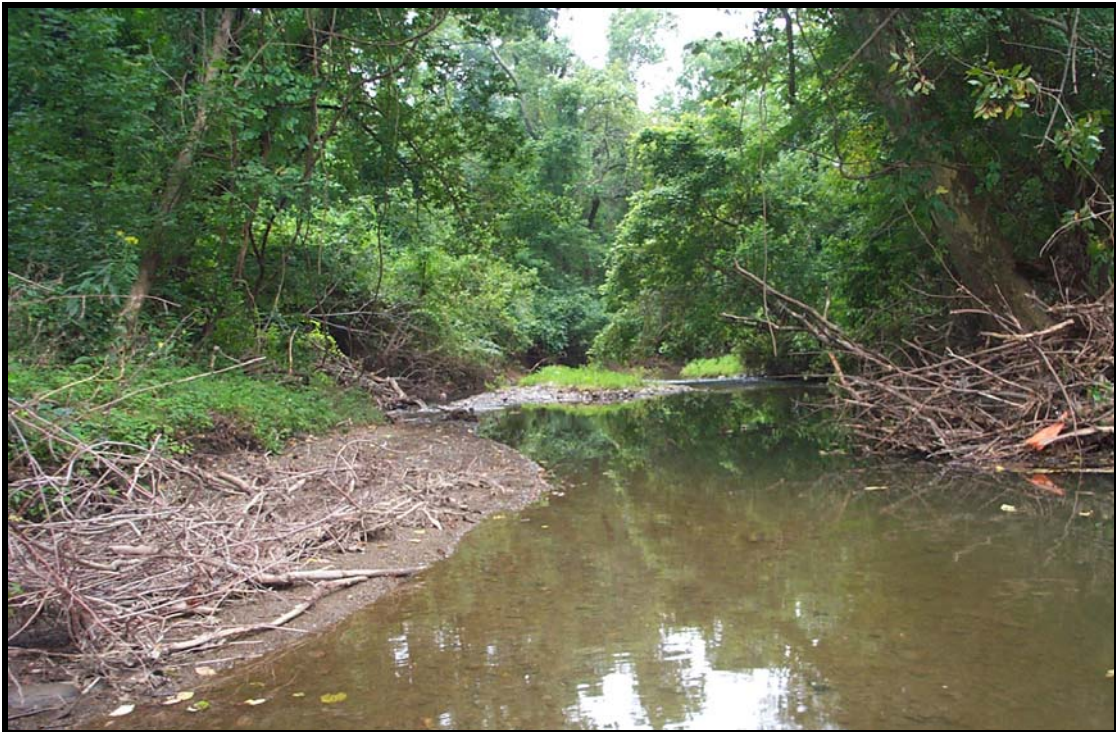
Figure E-4 - Sedimentation in Lower PCN

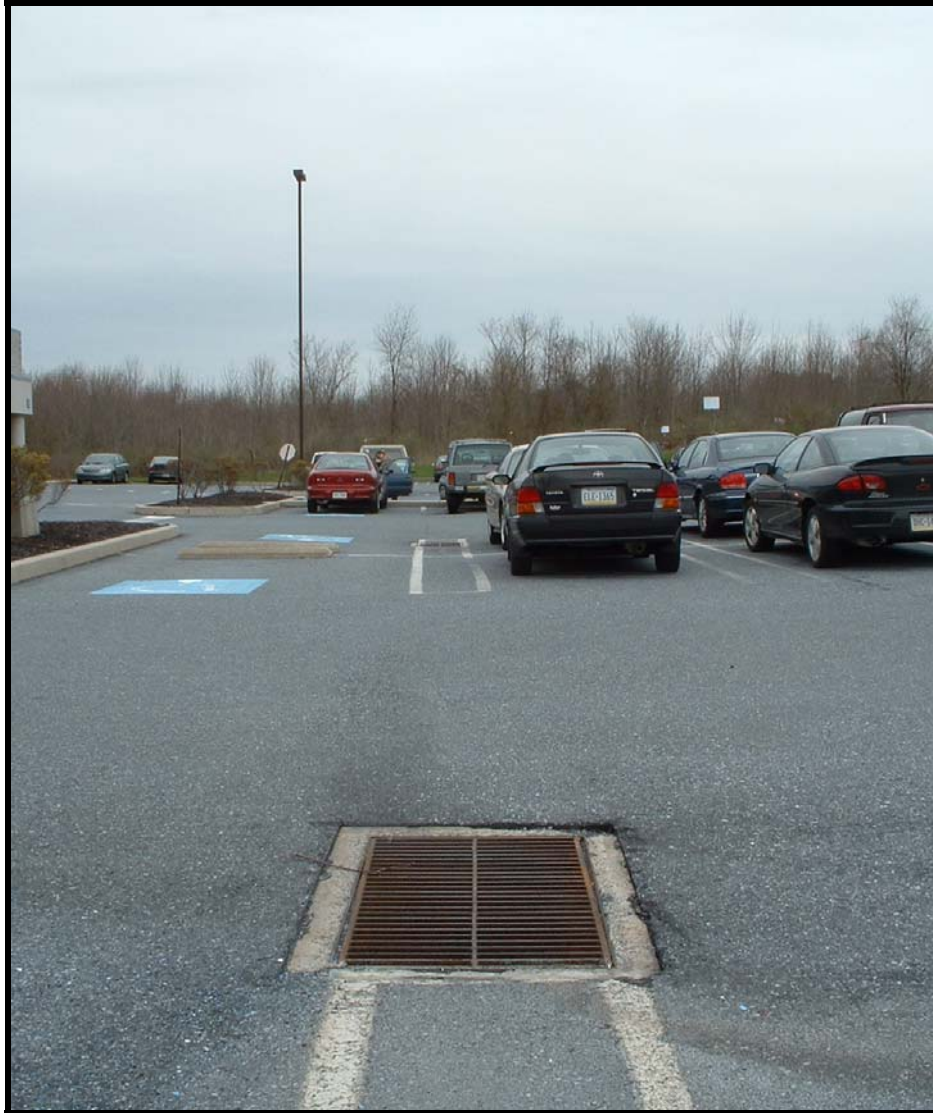
Figure E-5 - Large expanse of pavement drains untreated to the storm drain in Upper PCN

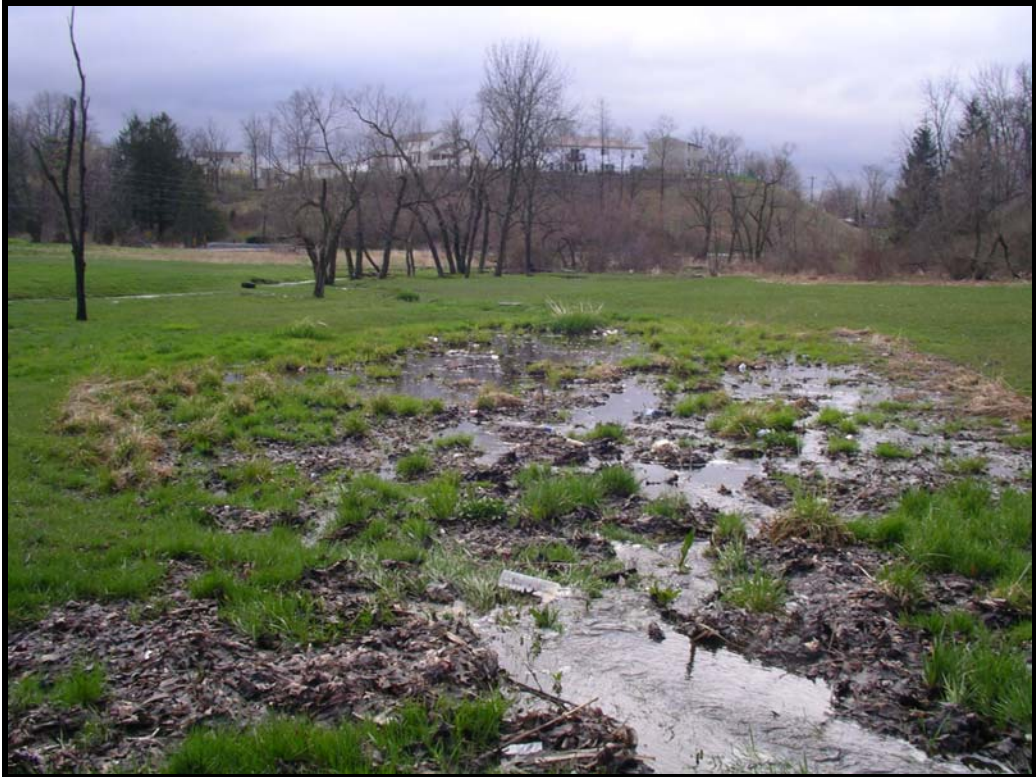
Figure E-7 depicts the highest priority large-scale restoration project, located at Centennial Acres. This project entails reforesting the stream buffer and creating a stormwater wetland complex to treat runoff from the nearby development. Figure E-8 depicts the highest priority small-scale restoration project, located at Forest Hills. This is a simple stream buffer planting project and is located in the headwaters of Upper PCN.

Figure E-7. Location for a wetland creation/enhancement project at Centennial Acres

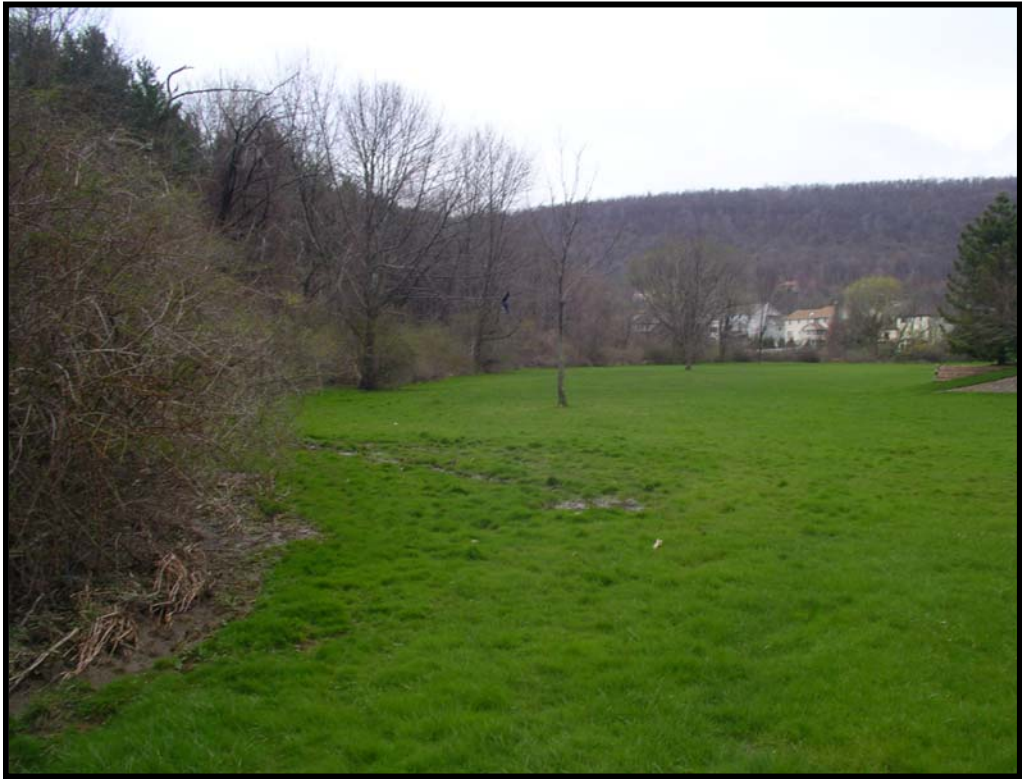
Figure E-8. Buffer planting site at Forest Hills

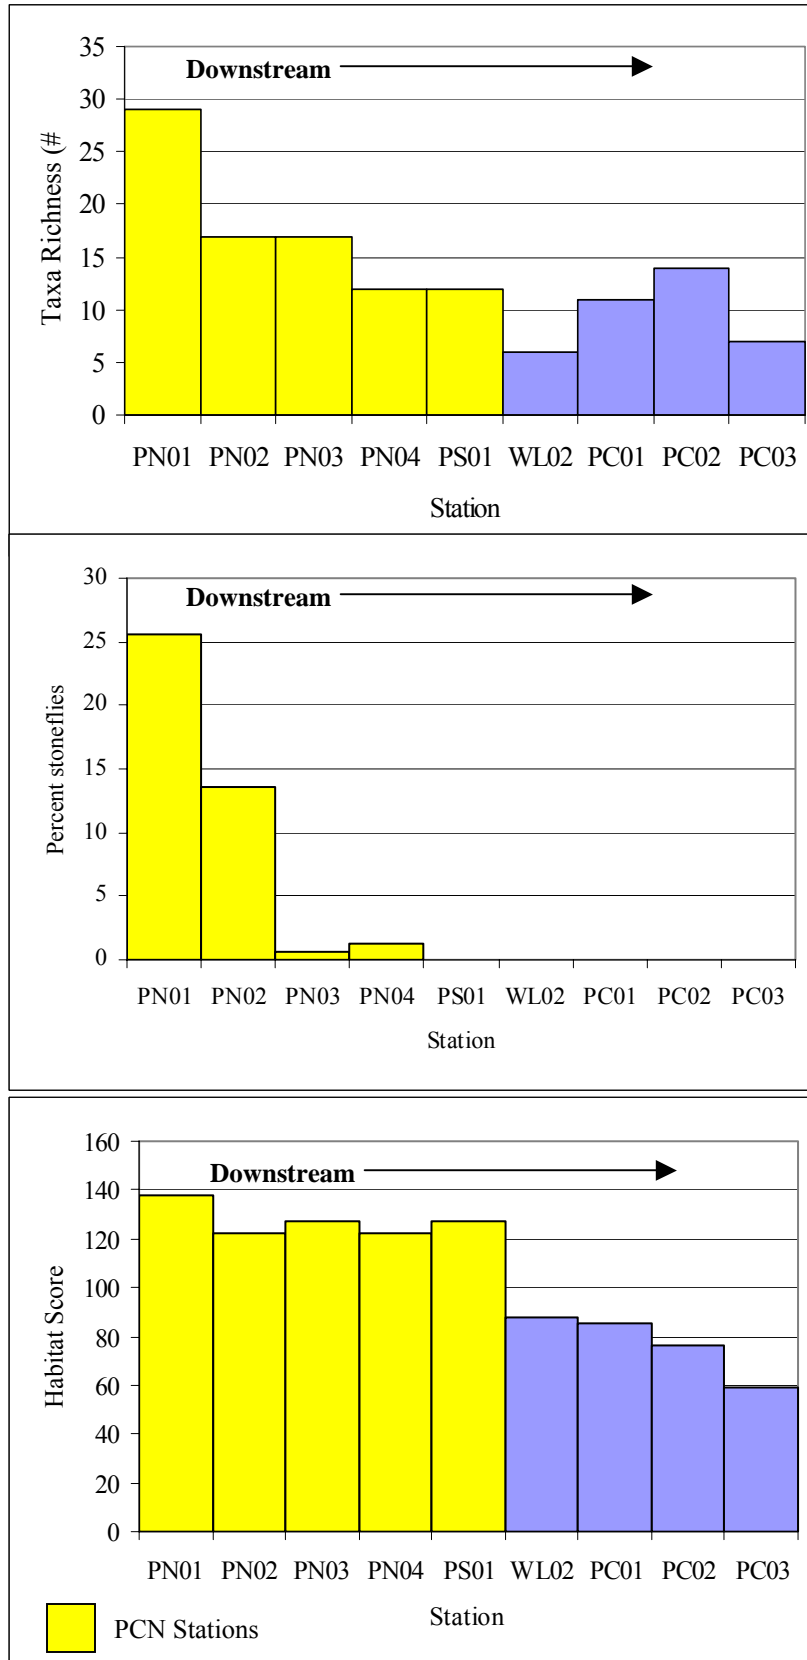
Figure 7. Biological condition of sampling sites along the mainstem Paxton Creek: taxa richness, percent stoneflies and habitat

Results of the Macroblitz sampling for the entire Paxton Creek watershed are presented Figure 7 with PCN stations highlighted in yellow (McAllister, pers. comm.). The trend illustrates a decline in the macroinvertebrate community (indicated by taxa richness and percent stoneflies) and the decline in habitat scores from upstream to downstream locations along the Paxton Creek mainstem.

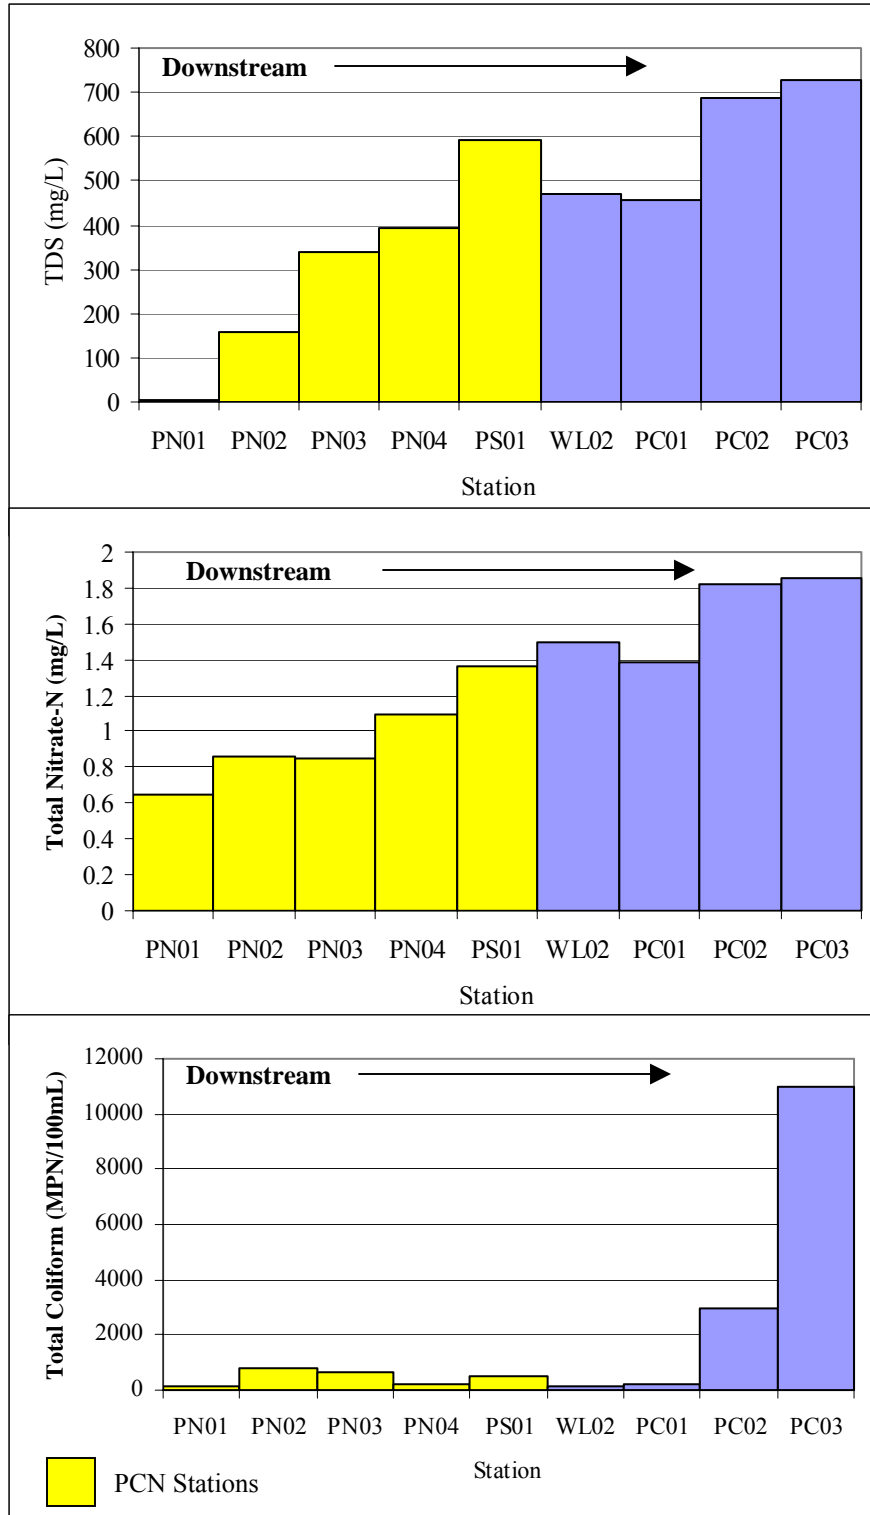
Figure 9. Water Quality concentrations along the mainstem of the Paxton Creek for total dissolved solids (TDS), total nitrate –N and total coliform

Figure 9 illustrates the general increase in concentrations of total dissolved solids and total nitrate-nitrogen from upstream to downstream locations along the Paxton Creek mainstem within the entire Paxton Creek Watershed (PCN sites are highlighted in yellow). Total coliform concentrations increased greatly from the most upstream location (120MPN/100ml at PN01) to the most downstream location (11,000MPN/100ml at PC03), but did not show any particular pattern within the PCN sites. A subset of the Macroblitz data collected is presented in Table 7 and the full data set is provided in Appendix C.

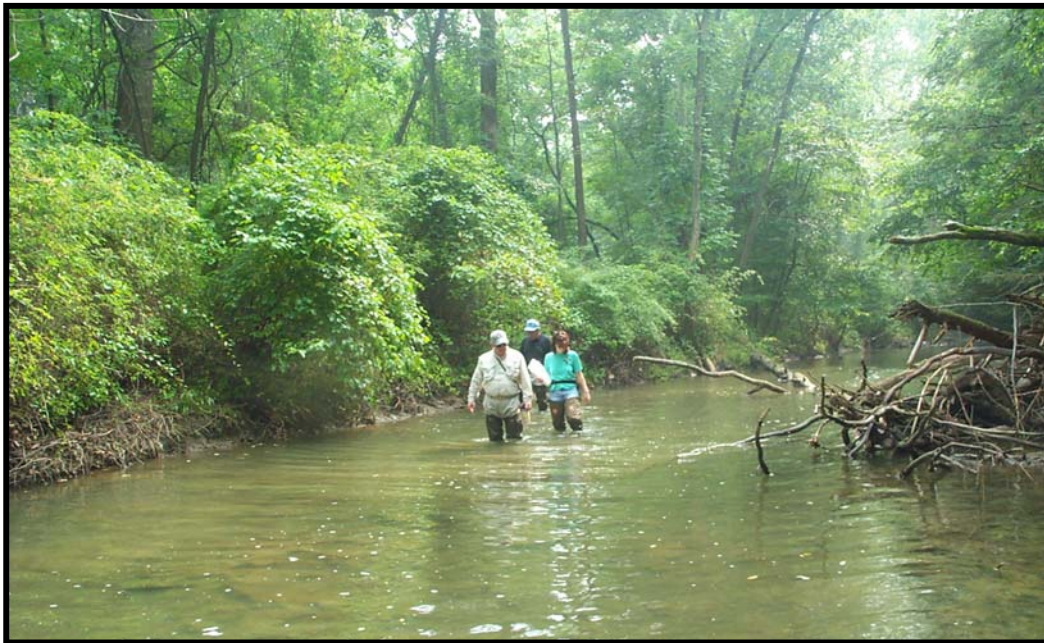
The Unified Stream Assessment (USA) is a continuous stream walk method to systematically evaluate conditions and identify restoration opportunities within the stream corridor of small watersheds (Figure 11). The USA is designed to rapidly collect basic information needed to assemble a manageable list of potential restoration projects in the stream corridor. These projects include storm water retrofits, stream restoration, riparian management, and discharge prevention. The USA protocol was adapted to avoid duplication of the Skelly and Loy (2003) physical stream assessment by focusing on verifying restoration priorities, and to identify other problems within the stream corridor such as sewer overflows, trash dumping and stormwater outfalls (Table 9).

Figure 11. Conducting the USA in Paxton Creek North

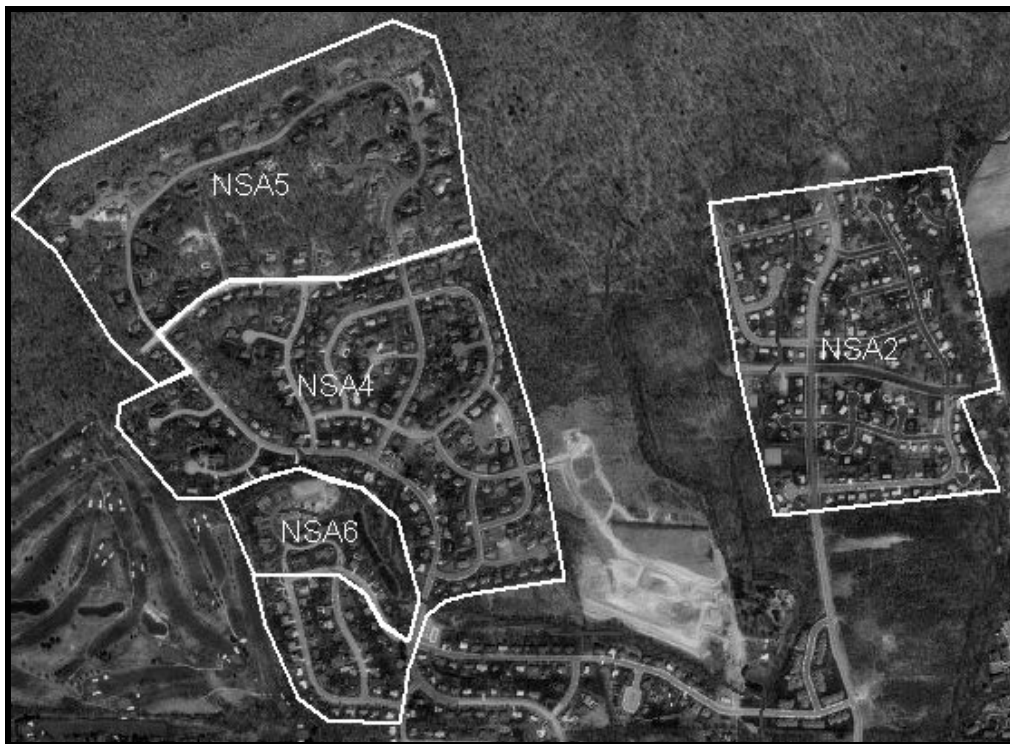
Figure 13. Example Neighborhood Delineation from Upper PCN

USSR field teams identified potential hotspot and neighborhood locations to assess prior to going out in the field. Distinct neighborhood units were delineated using GIS data layers and digital orthophotos (Figure 13). The USSR field teams focused on identifying hotspots, municipal operations, and residential pollution-producing behaviors that contribute to nutrient loading, as well as areas with significant reforestation opportunities. Streets and storm drains were not evaluated during the PCN field assessment.

Residential neighborhoods were assessed in terms of age, lot size, tree cover, drainage, lawn size, general upkeep, and resident stewardship. Those with similar characteristics and restoration potential were grouped into a single assessment form. Neighborhoods were assigned a pollution severity of “severe,” “high,” “moderate,” or “low,” using a set of benchmarks set forth in Wright et al. (2004). Pollution severity is an index of how much non-point source pollution a neighborhood is likely generating based on easily observable features (lawn care practices, drainage patterns, oil stains, etc). A restoration potential was also determined for each neighborhood type of “high,” “moderate,” or “low.” Restoration potential is a measure of how feasible onsite retrofits or behavior changes would be based on space, number of opportunities, presence of a strong HOA, etc.

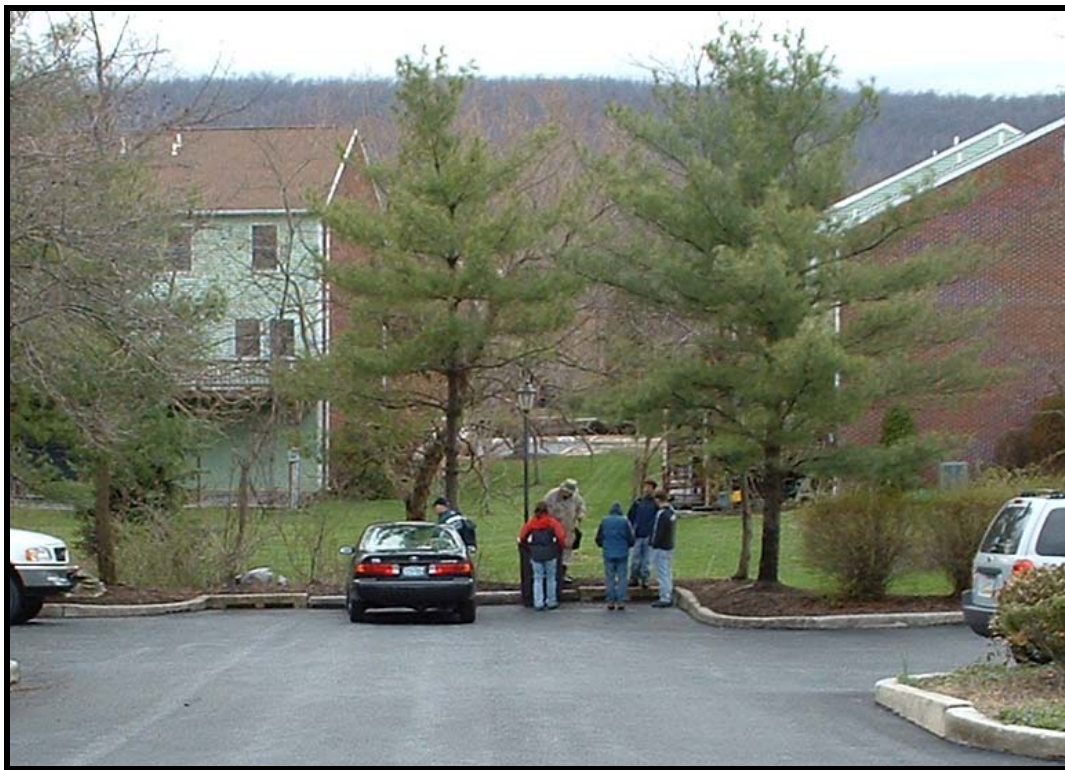
Individual hotspot locations were assessed for pollution potential based on observed sources of pollution and the potential of the site to generate pollutants that would likely enter the stormdrain network (Figure 14). The Hotspot Designation Criteria as set forth in Wright et al. (2004) was used to determine whether the site was a “confirmed” or still a “potential” hotspot based on field crew observations.

Figure 14. - USSR teams evaluating a potential retrofit site

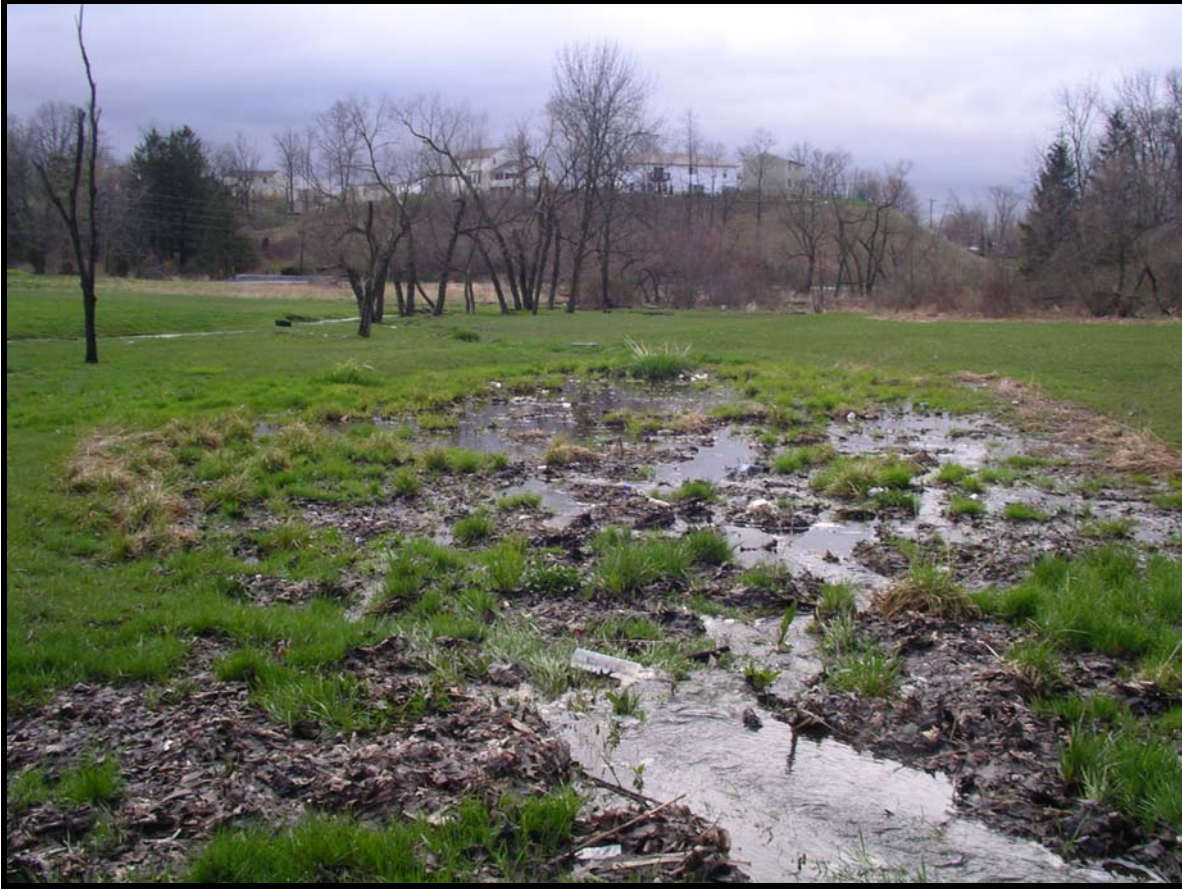
Figure 19. Location for a wetland creation/enhancement project

The second component of this project is the conversion of an open grass/wet area located between the stream and the Centennial Acres neighborhood to a wetland complex with a forebay, low marsh, high marsh and permanent pool to treat runoff from the existing development (Figure 19). This area would treat approximately 5 acres (22% impervious cover). Access to the site looks good, but could involve the need to cross the stream. Additional information is needed on the precise drainage area and location of utilities before pursuing this project for implementation. This site provides a good opportunity to monitor the before and after effects of stormwater treatment practices (since the only upstream change will be the one new development). A conceptual design for Centennial Acres can be found in Appendix I.

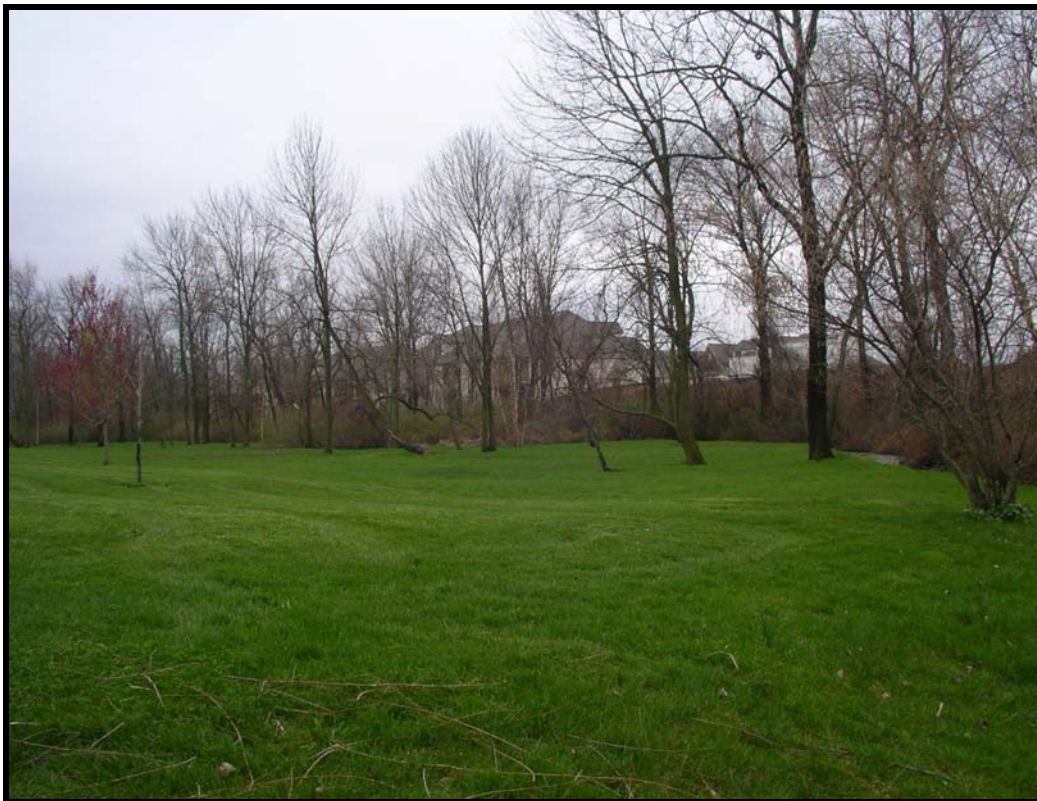
Figure 21. Location for riparian reforestation and stream restoration at Fairfax Village North

The field crew spoke with several residents who seemed interested in these potential projects. Since the open areas are maintained by a single entity (the local homeowners association or HOA), this may simplify the process of getting landowner approval for implementation. Skelly and Loy expressed interest in doing stream restoration design for this site, and another local consulting firm, HRG, expressed interest in developing more detailed concepts for the sand filter/bioretention areas. In addition, the HOA has indicated that they have some funds available for project implementation. The site has good access but site plans would be necessary in order to identify any potential conflicts with sewer or electric utilities. Conceptual designs for Fairfax West are provided in Appendix I.

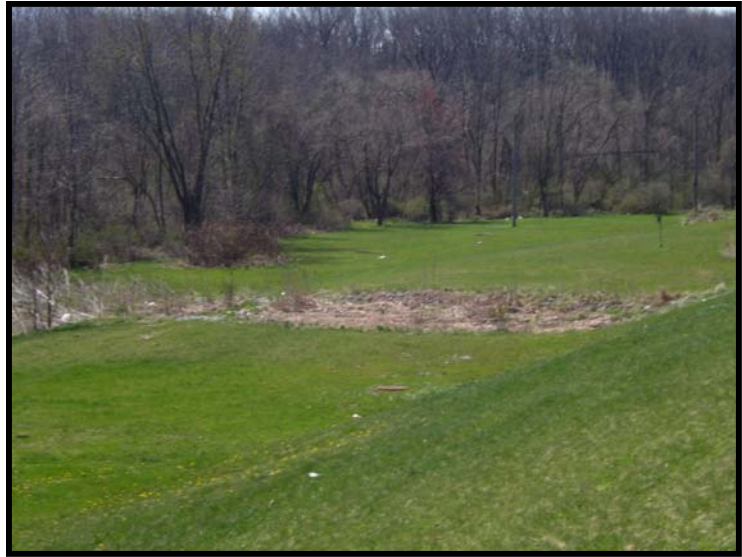
Figure 22. Potential riparian planting and stormwater wetland retrofit site

The Honey Bee Golf Center is located in Upper PCN in an area of commercial development along Linglestown Road. This site contains a potential reforestation project of approximately 500 feet of stream (right bank) to achieve a 25 to 50-foot wide buffer (Figure 22). This site is in view of Linglestown Rd. and represents a great opportunity for riparian reforestation that would be visible to the public. The site also contains two potential stormwater retrofits, although further investigation is warranted to determine the stormwater conveyance on the site. One retrofit entails conversion of an existing dry pond to a Carroll County sand filter (Figure 23), and the second involves retrofitting of an outfall to create a stormwater wetland by tapping into the existing groundwater table in the floodplain (Figure 22). Opportunities also exist on this site for pollution prevention due to outdoor storage of sand and other materials near a storm drain. Conceptual designs for Honey Bee Golf Center are located in Appendix I.

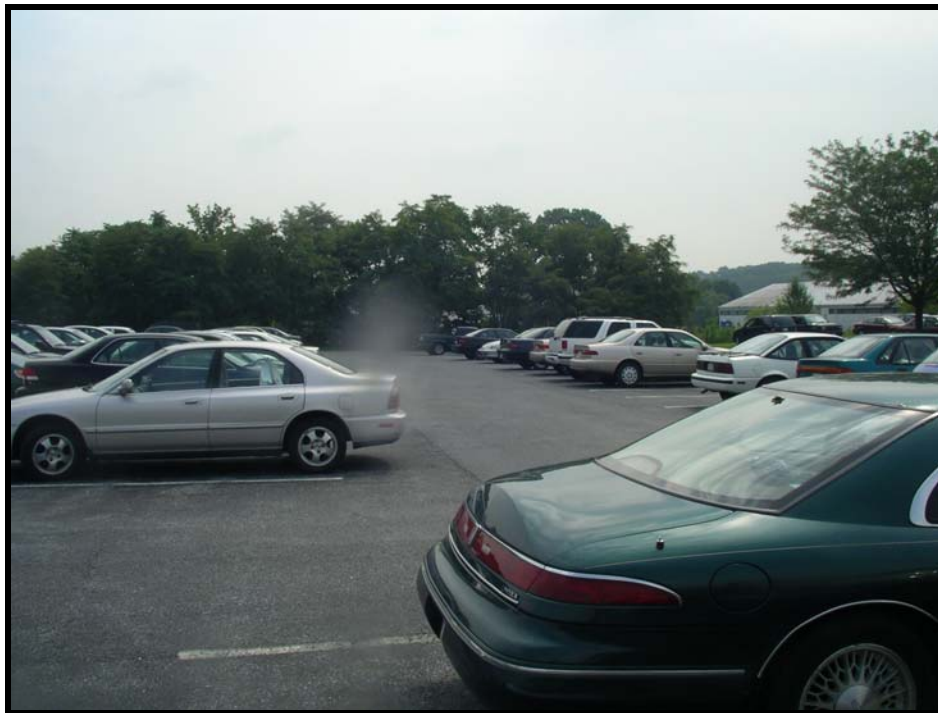
Figure 24. Extensive parking located at the Vartan Property

Detailed site plans would be needed for the Vartan Property as it is unclear where the rooftop runoff drains. The existing parking areas do not have curbs and incorporate grass swales along the edges, providing the ideal situation for conversion to bioretention areas. The proposed bioretention facility for the office building parking lot is located immediately adjacent to the Davis property (a small-scale priority site), and some local erosion is occurring where the runoff flows down to the Davis site (Figure 27). Runoff from this site also appears to be affecting the Glaser property (a small-scale priority site) further downstream. Therefore, any restoration done at these downstream sites should be closely coordinated with restoration efforts at the Vartan Property. This site has good access and there will not likely be any conflicts with utilities. Conceptual designs for the Vartan site are provided in Appendix I.

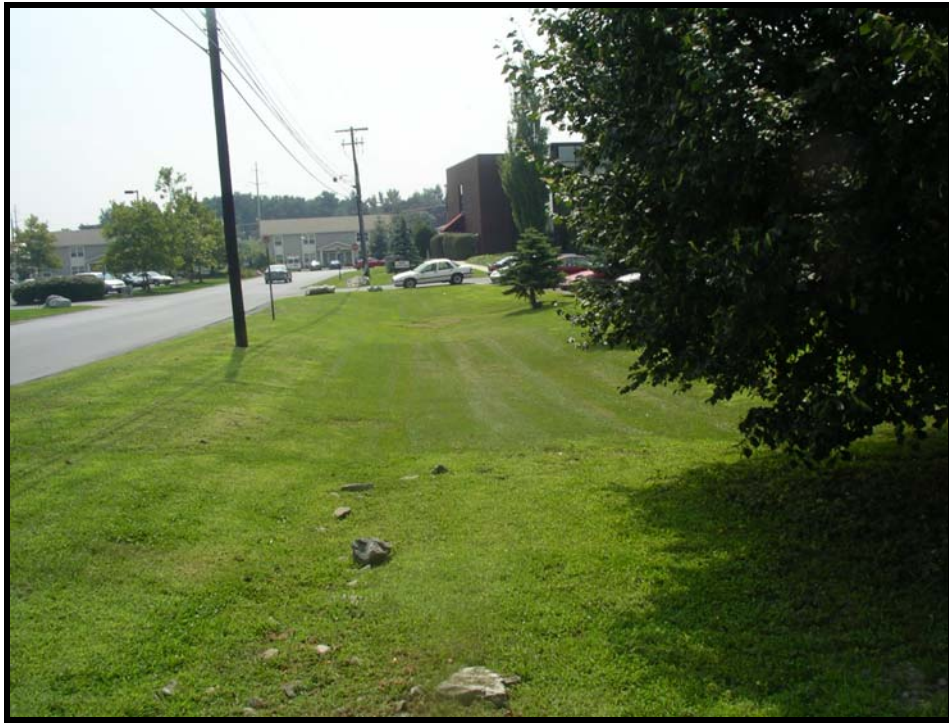
Figure 25. One of several prime locations for bioretention on the Vartan Property

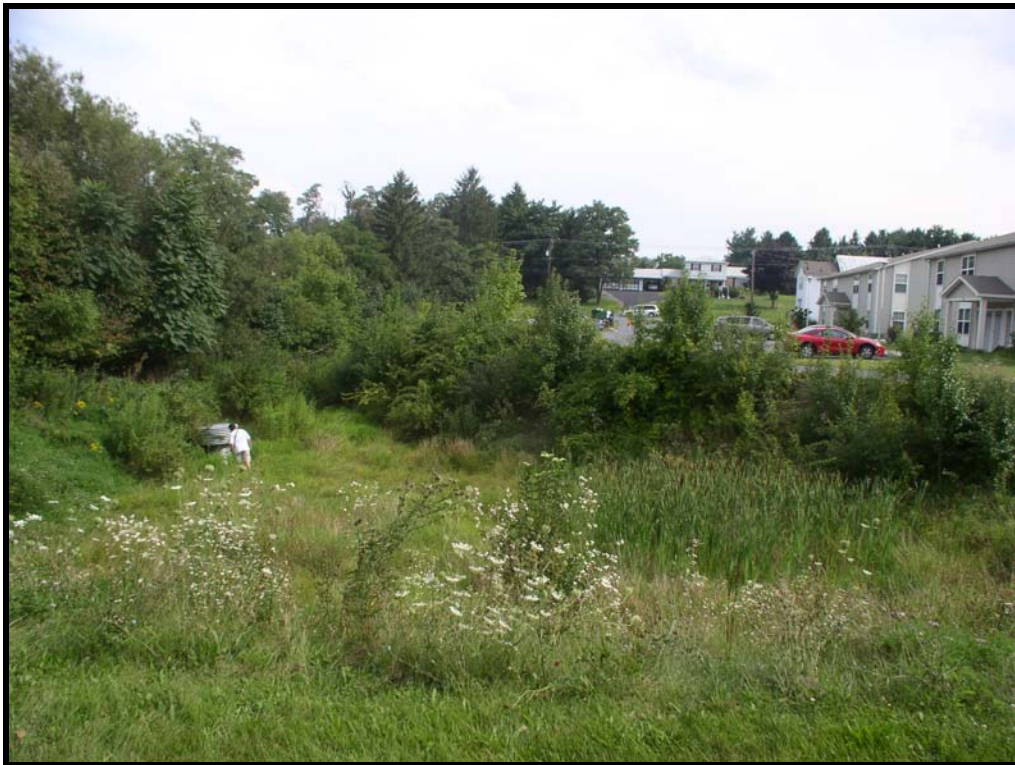
Figure 26. Potential dry pond retrofit at the Vartan Property

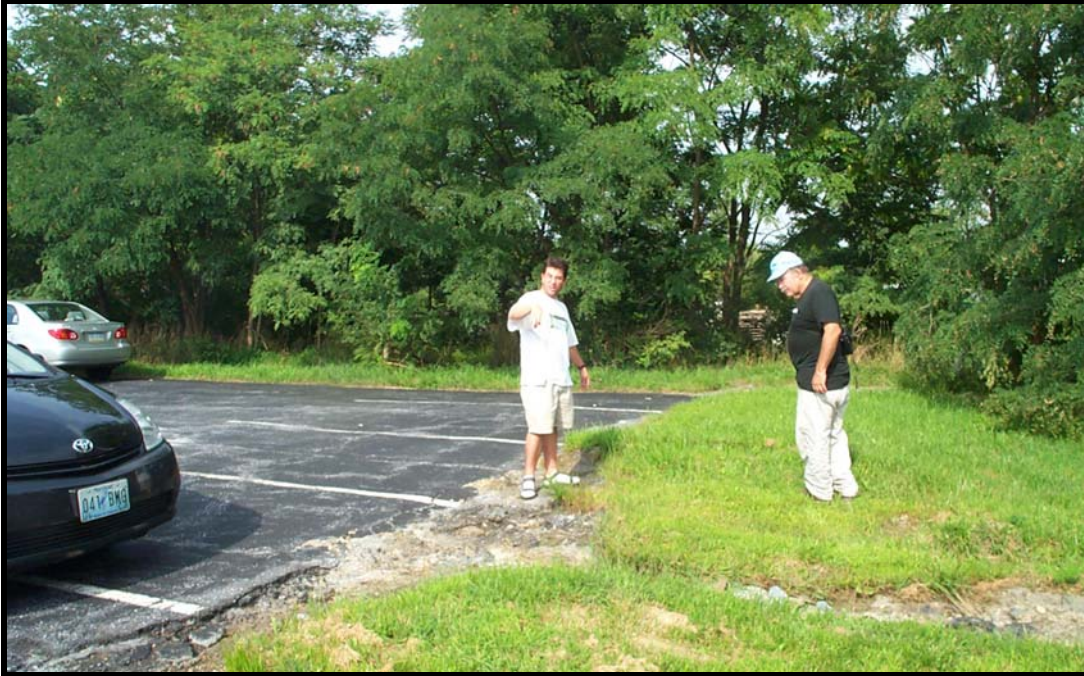
Figure 27. Runoff from Vartan Property office building parking lot causes channel erosion just upstream of Davis Landscaping

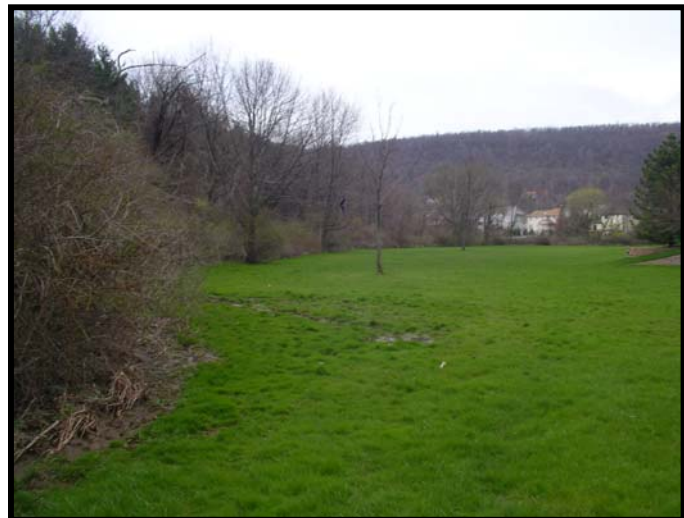
The Forest Hills site is located in Upper PCN behind the homes on the south side of Forest Hills Drive in the Forest Hills development (Figure 28). This simple project would entail reforesting approximately 600-1000ft of stream on the left bank. For this project, it will be important to establish community interest and buy-in. This may entail developing multiple planting plans and concepts that illustrate how attractive the planting projects could be, as well as soliciting community input at neighborhood meetings. The implementation approach taken may also vary depending on whether the land along the stream is owned by a homeowners association, the township or by individual property owners.

Figure 28. Forest Hills reforestation site

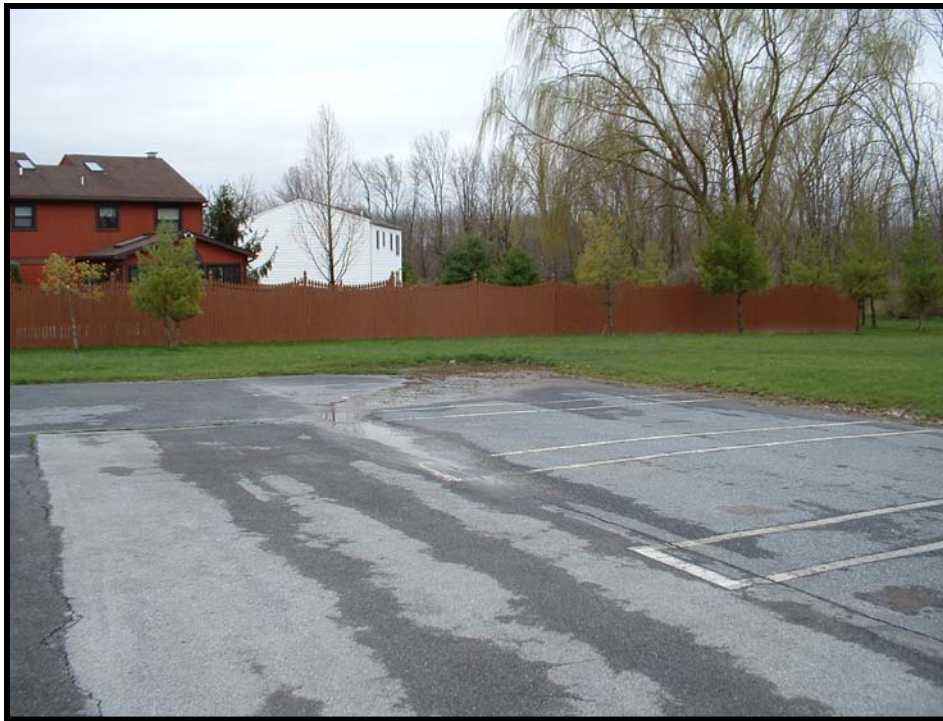
Figure 29. Proposed location for a stormwater retrofit at Centennial Acres Park

Centennial Acres Park is a neighborhood park located near Colonial Road and Continental Drive in the Upper PCN headwaters. This park contains a small parking lot, tennis courts, playground, pavilions and open turf areas. A small stream runs through the property. The proposed stormwater retrofit at this site includes a small turf area below the parking lot that has some minor erosion. The retrofit portion of this project could be used to treat the runoff from the parking lot by converting to a bioretention facility (Figure 29). This area may also capture some runoff from the road but the exact drainage area is unclear. In addition, some under-utilized turf areas in the south end of the park could be reforested (two acres or so) with trails to allow access to the stream. Invasive plants (honeysuckle, multiflora rose) along the stream and forest edge should also be removed. A conceptual design for Centennial Acres Park is provided in Appendix I.

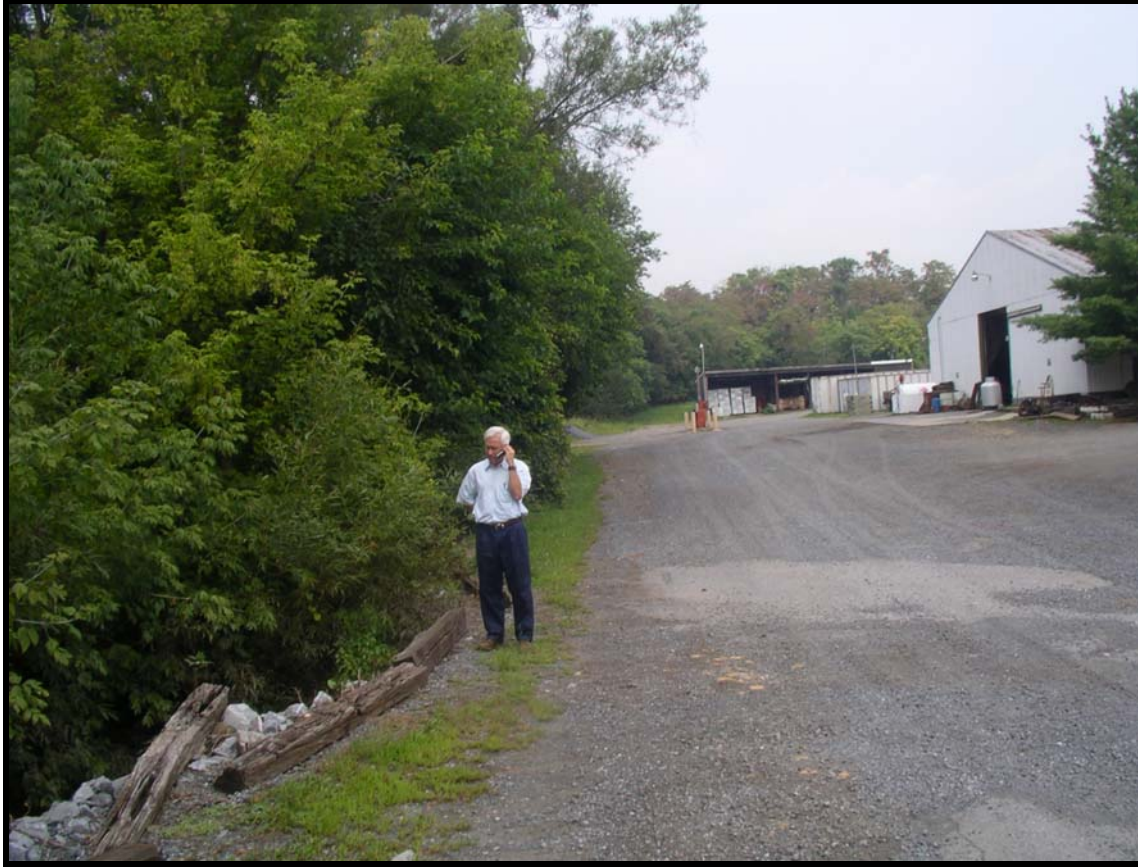
Figure 30. Davis Landscaping site for potential pond creation

Davis Landscaping is located north of Paxton Church Road just below the Vartan property (Figure 30). The site does not currently have any stormwater management and is also receiving a lot of runoff from the upstream Vartan property during storms. The property owner is very interested in installing stormwater management practices and, in fact, was going to pursue this on his own anyway. The proposed retrofit includes installation of a new detention pond to treat runoff from the site.

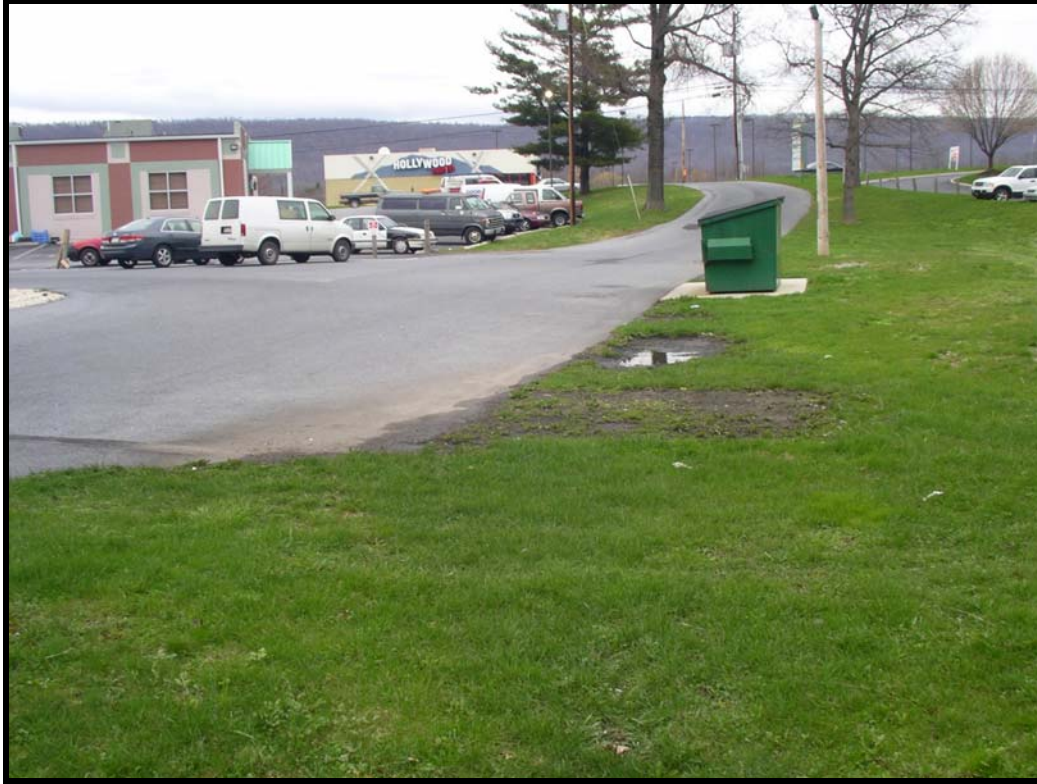
3B Ice Cream is located at the corner of Linglestown Road and Colonial Road in Upper PCN. This site was previously identified as a priority retrofit by CWP during the 2003 retrofit inventory. The initial concept for this site was revised during recent field work to expand the area that would be treated by this retrofit. The proposed retrofit would involve conversion of a shallow lined grass depression into a bioretention facility by modifying the existing outlet with a riser/drop inlet structure (Figure 31). Additional runoff can be directed to the bioretention area from an adjacent office building by installing a field connection. Site plans are needed to determine if any conflicts with utilities exist, and the site has good access. Conceptual designs for 3B Ice Cream are provided in Appendix I.

Figure 31. Location that should be drained to previously identified retrofit at 3B Ice Cream

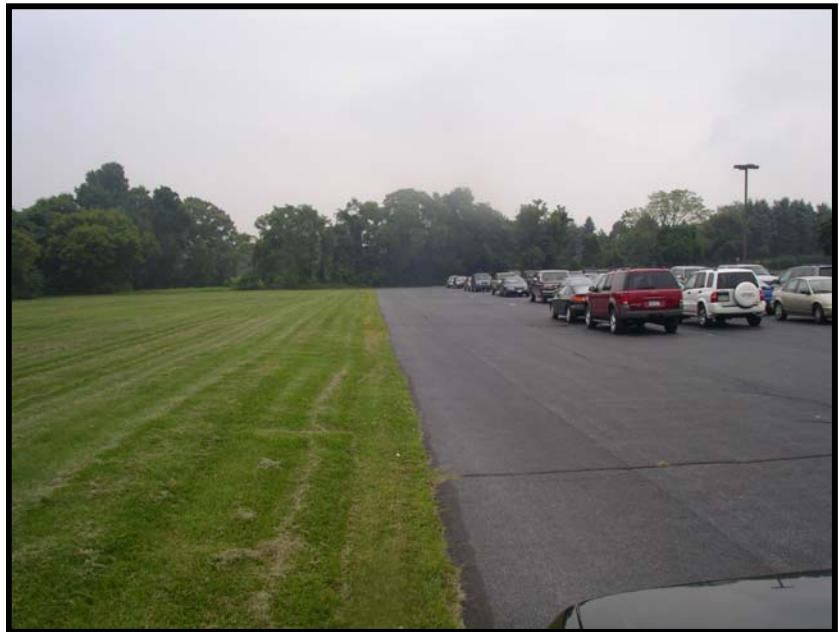
Figure 32. Potential bioretention area at State Police Headquarters

The State Police Headquarters is located south of I-81 above Elmerton Avenue in Lower PCN. This site has a large parking lot that drains to multiple storm drain inlets within the lot. The stormwater retrofit proposed here is to redirect the parking lot flow from the stormdrains to an adjacent grassy field that would be converted to bioretention (Figure 32).

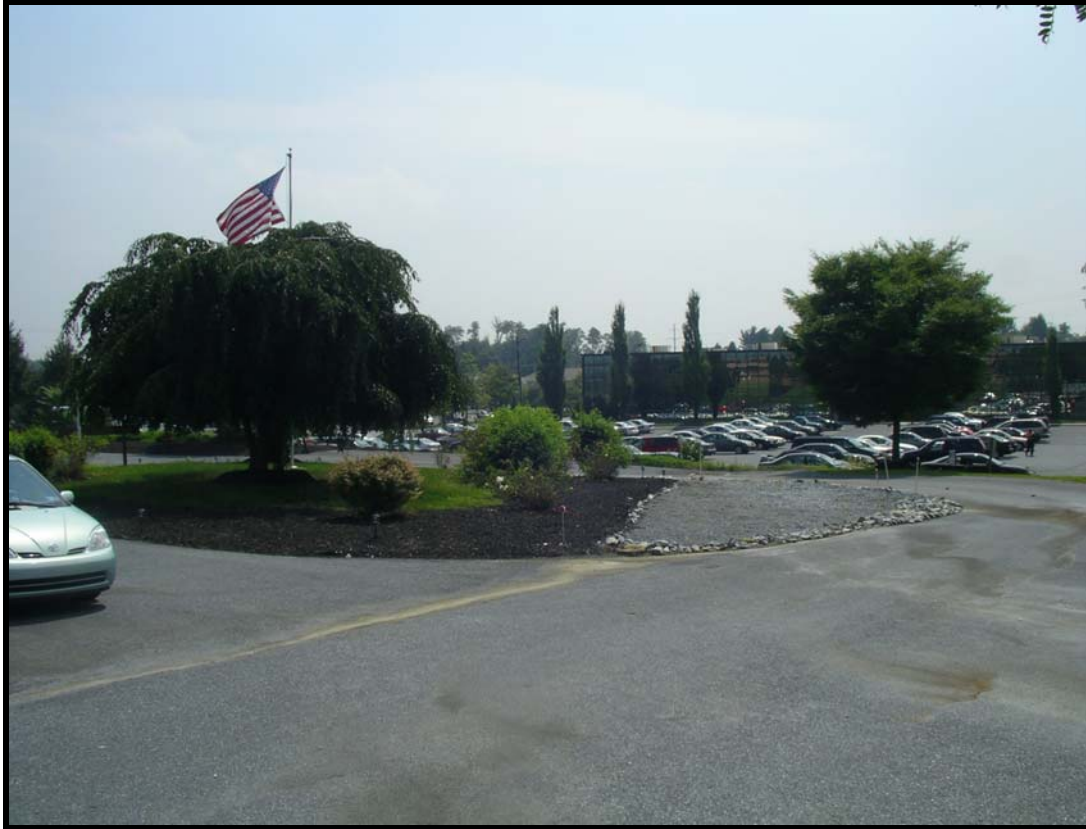
Figure 33. Island that could be converted to bioretention at the Salvation Army site

The Salvation Army is located on Vartan Way in Lower PCN. This proposed retrofit involves converting a large traffic island in front of the building to a bioretention area that would treat runoff from 0.63 acres of impervious cover (Figure 33). The traffic island currently has areas affected by erosion. The bioretention area could also accept runoff from the building, parking area and driveway. A conceptual design for the Salvation Army is provided in Appendix I.
