Paxton Creek North Subwatershed Restoration Plan

Produced by the Center for Watershed Protection
for the Paxton Creek Watershed and Education
Association

Funded by the National Fish and Wildlife
Foundation and the Canaan Valley Institute

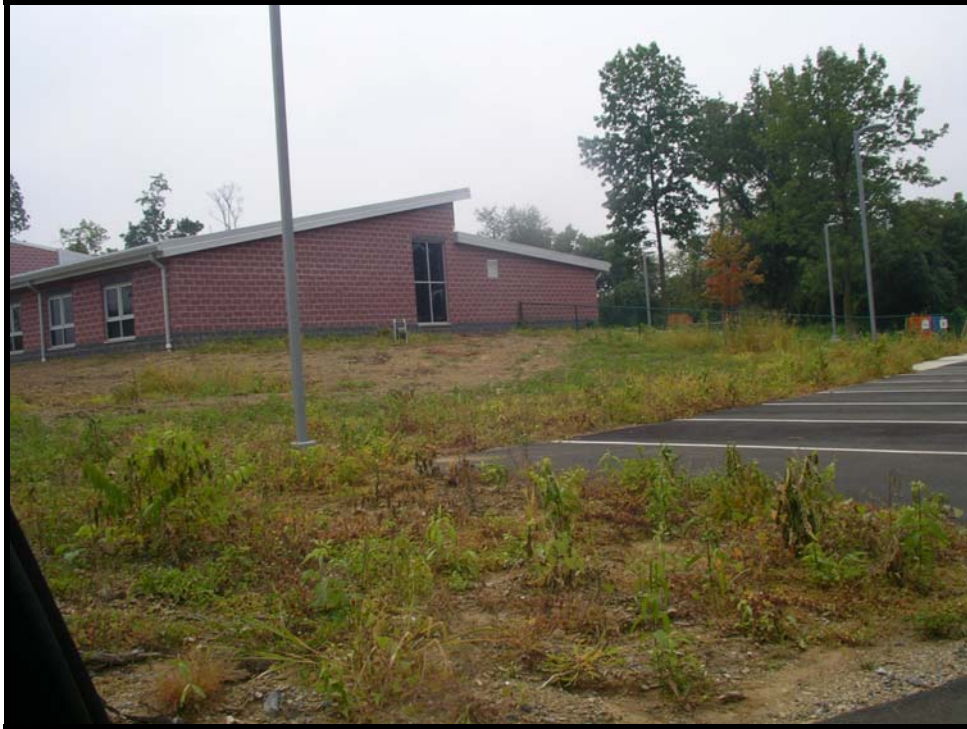
The first recommendation for this site is to install rain gardens using native plantings in existing turf areas along the parking lot to capture and treat runoff (Figure 34). This garden could serve as a demonstration site and would have educational value. An existing stormwater dry pond on site has some minor erosion that may or may not be the product of being recently established (Figure 35). If erosion is not due to recent establishment, a velocity dissipater could be installed in the pond to the control erosion problem, or the pond could be converted to a wet pond to

Figure 34. Space for stormwater treatment practice at the Londonderry School

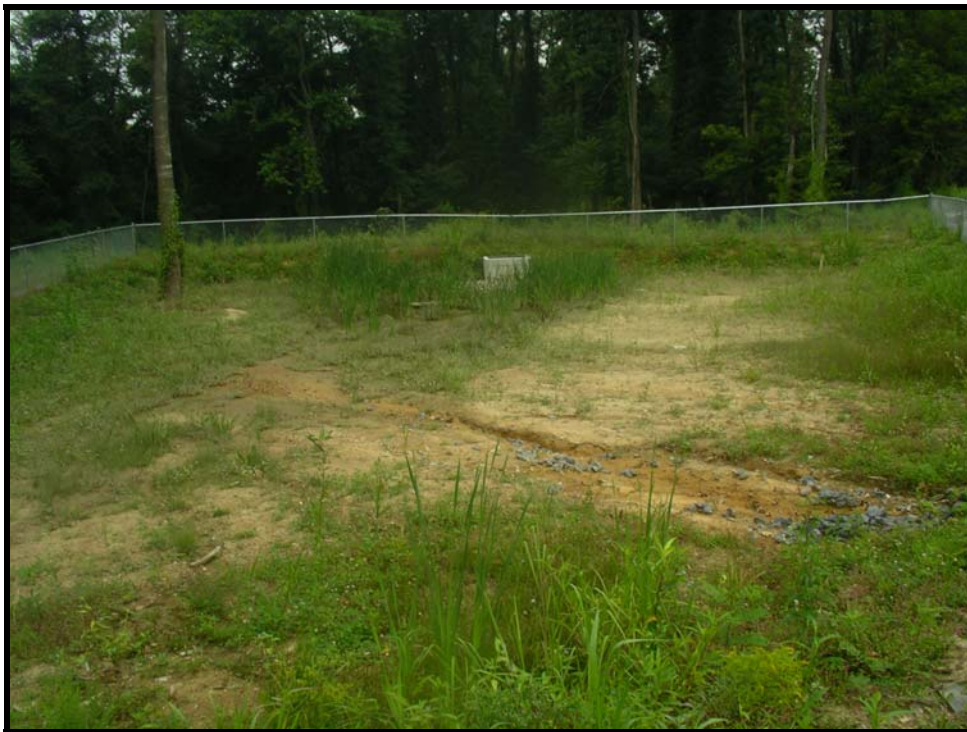
Figure 35. - Proposed dry pond retrofit at the Londonderry School

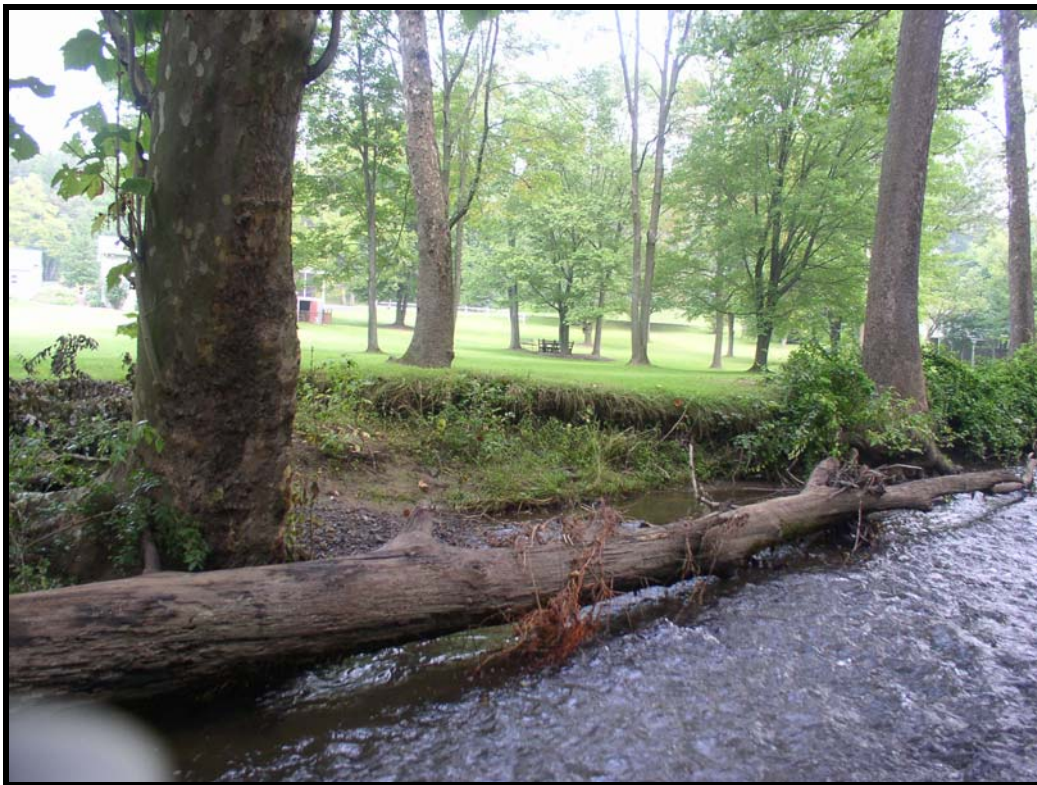
The Doehne Road site is located along a stretch of Paxton Creek that runs just south of Doehne Road in Lower PCN. The few residences on the south side of Doehne Road have very deep backyards consisting mainly of mowed grass with scattered trees (Figure 36). These yards descend at a moderate gradient to the edge of the floodplain of Paxton Creek, which is generally well over 150 feet wide in this area. A small, unbuffered intermittent tributary also flows through these yards to where it meets Paxton Creek. A sewer line runs through the floodplain but is located considerably north of the channel margin in most cases. Invasive vines (bittersweet) were noted at this site, as was minor bank erosion.

This site was part of a larger reach previously identified as a priority reach for reforestation and potential floodplain reconnection by Skelly and Loy (1998). The restoration actions recommended as part of this project include reforesting the right bank of the stream and both banks of the intermittent tributary with a 25 to 50 foot buffer of sycamores, green ash and river birch. Red osier dogwood could be used for bank stabilization or aesthetics on the smaller intermittent tributary. This site has multiple private landowners, but since the yards are extraordinarily deep, they may be amenable to yielding some of their lawn area for reforestation.

Figure 36. Photo of riparian reforestation area near Doehne Road

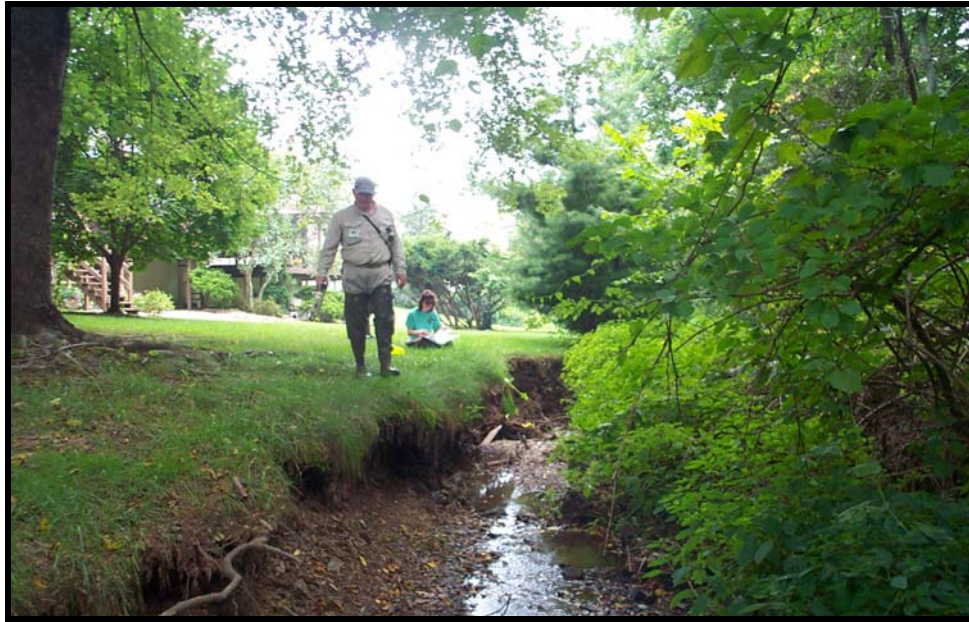
Figure 37. Undercutting bank and erosion at Paxton Crossing

have been exposed along the streambank at one portion of the site (Figure 38). The concept for the site is to re-grade the left stream bank to a 2:1 or 3:1 slope and use bioengineering and native plantings to stabilize the stream bank. The site is approximately 200 feet long with an additional 100 to 200 feet downstream that is piped and could be daylighted using a similar bioengineering restoration approach. Permitting and construction for the daylighting portion of the project would likely pose a more difficult and complex task and increase costs considerably.

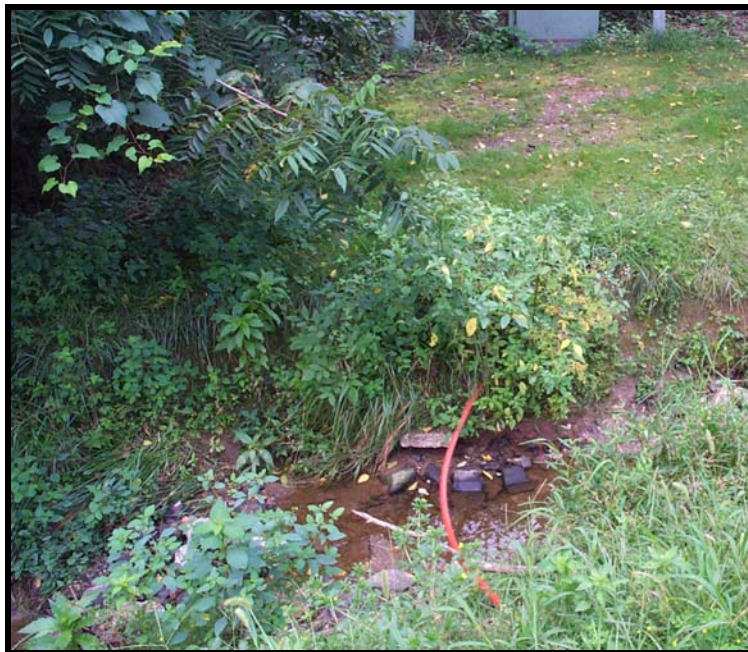
Figure 38. - Exposed electric wires at a Paxton Crossing stream

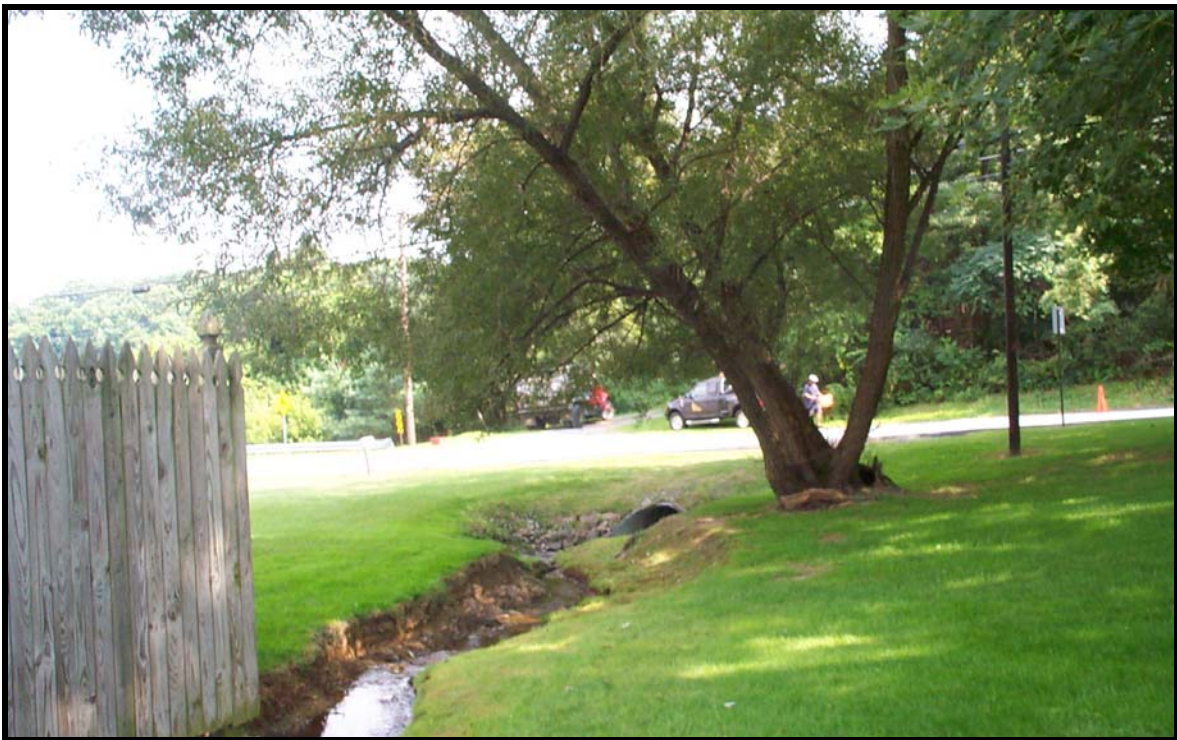
Figure 39. Small eroding stream located on the Glaser property

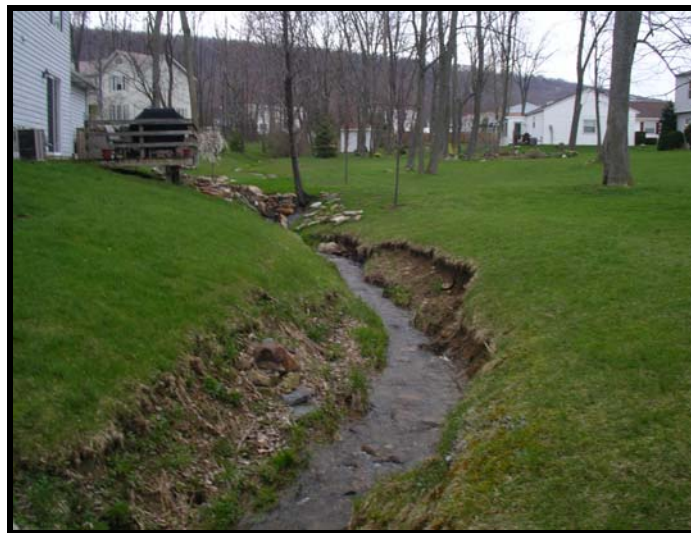
4. Adopt a stream buffer ordinance to protect existing forest buffers for all new development sites. Much of the PCN and its tributaries are currently unbuffered in existing residential developments (Figure 40). Stream buffers can be preserved for all new developments by adopting a stream buffer ordinance. The ordinance language should state that stream buffers are vital to maintain stream health and could also cite the anti-degradation clause of the Clean Water Act as the legal basis. A model stream buffer ordinance is provided at: www.stormwatercenter.net/Model%20Ordinances/buffer_model_ordinance.htm. Municipal stream buffer ordinances should be incorporated into the Dauphin County Greenway plan to ensure overall coordination of protection efforts.

Figure 40. Evidence of the need for a stream buffer ordinance in Paxton Creek North

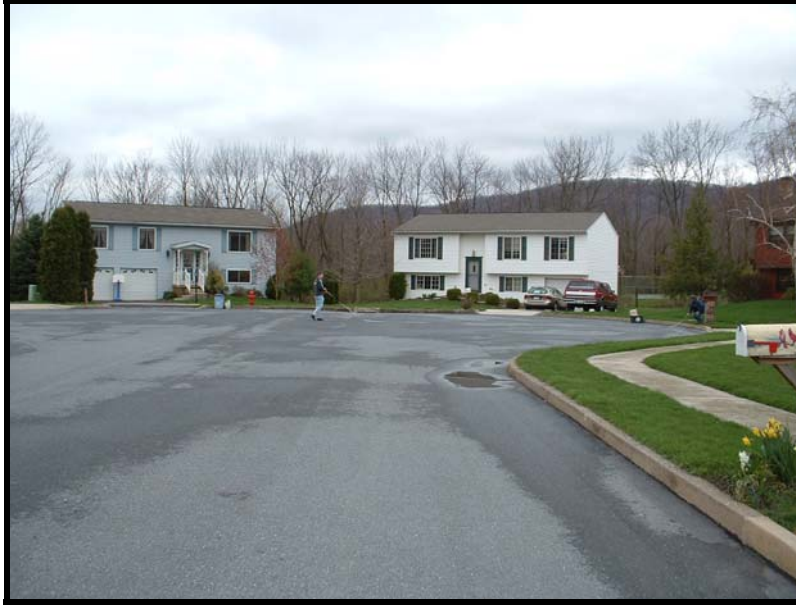
Figure 41. A 100-foot diameter cul-de-sac in Paxton Creek North (a lost opportunity for bioretention) illustrates the need for Better Site Design
