**GEOMORPHIC EFFECTS OF URBANIZATION IN
FORTY-ONE YEARS OF OBSERVATION**

LUNA B. LEOPOLD, REED HUPPMAN, AND ANDREW MILLER

Reprinted From: Proceedings of the American Philosophical Society
Volume 149 Number 3 September 2005

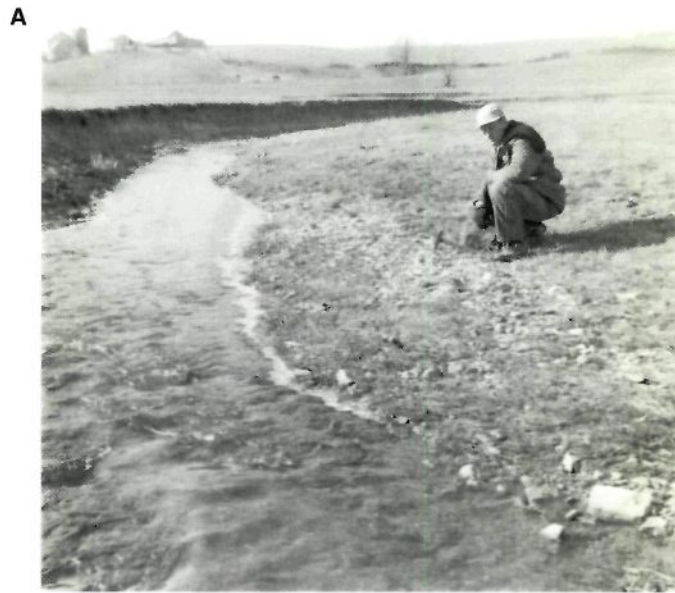
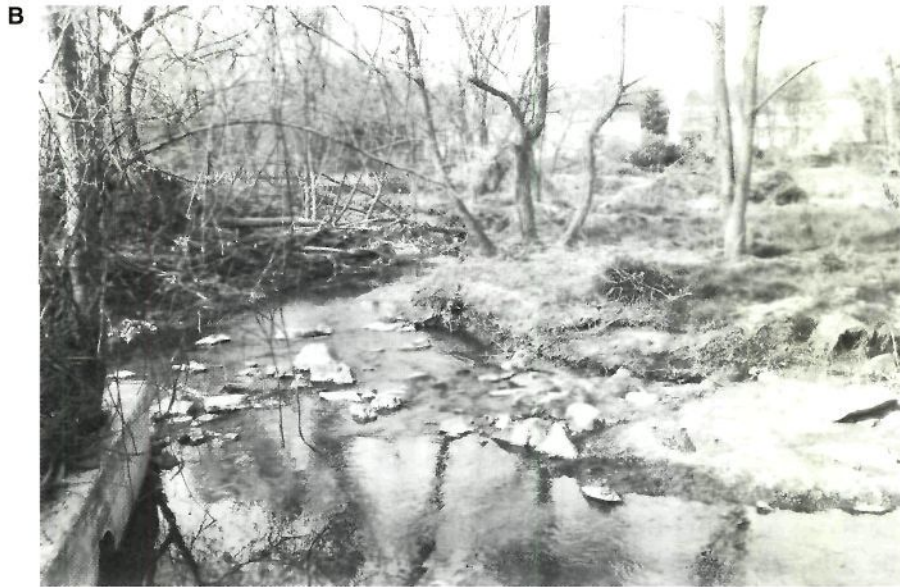
FIGURE 2. View downstream approximately at cross section 53–54. This location is about three hundred feet downstream of the map area of figure 1. Upper photo, figure 2A, taken in December 1959, shows grazed pasture and, in the distance, the original barn. In the lower photo, figure 2B, 1994, housing has replaced the farm. Large rocks in the streambed were introduced from far upstream by flood flows.

The small stream located near Rockville, Maryland, draining 3.7 square miles, was primarily cultivated farmland in 1952, with small areas of second-growth timber. The Piedmont soil is developed on deeply weathered schist. It is red to yellow in color and erodible. In a grazed meadow through which the stream meandered, a series of cross sections was surveyed, the end points of which were monumented. In 1956 a gaging station was installed somewhat upstream of the monumented sections. The general layout of the cross sections is shown in figure 1, and the aspect of the conditions at the start of the study is shown in figure 2A.

The increase in magnitude of the floods changed the bed material in the channel, as seen in figure 2. The many large angular rocks present in 1994 could not have come from bank erosion in the valley fill, because the alluvium is silt-clay and the original bed had inconspicuous riffles made up of fine gravel having a D50 of about 16 mm. Rounded gravel a few feet under the streambed was observed in the sewer trench, but because the bed was aggrading this could not be the source. We believe that the angular blocks of large size were carried into the reach by floods, excavated from the many sites upstream cleared during construction.

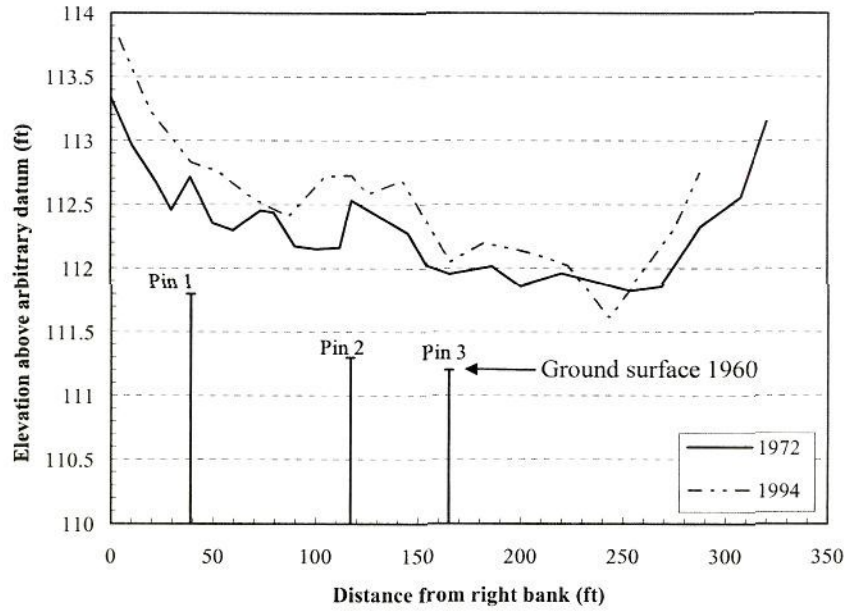
FIGURE 3. Profile of ground surface orthogonal to the channel that records overbank deposition. The three pins were driven down to the ground surface in 1960 on what appeared to the eye as a nearly level flood plain. In 1994, there had been an average deposition of more than a foot in thirty-four years.

After observing the increase in flood flows, we conjectured that overbank deposition, even some distance from the channel, might occur. In April of 1960 three iron pins were driven into the floodplain surface to record its elevation. These were at distances of 40, 128, and 155 feet from the channel. This seemed at the time rather a long shot because massive deposition appeared unlikely. As it turned out, even that small effort paid dividends, because floodplain deposition could not have been judged merely from channel cross sections. Figure 3 shows the profile across the floodplain. Deposition over the whole valley flat was 1.0 to 1.3 feet in depth.

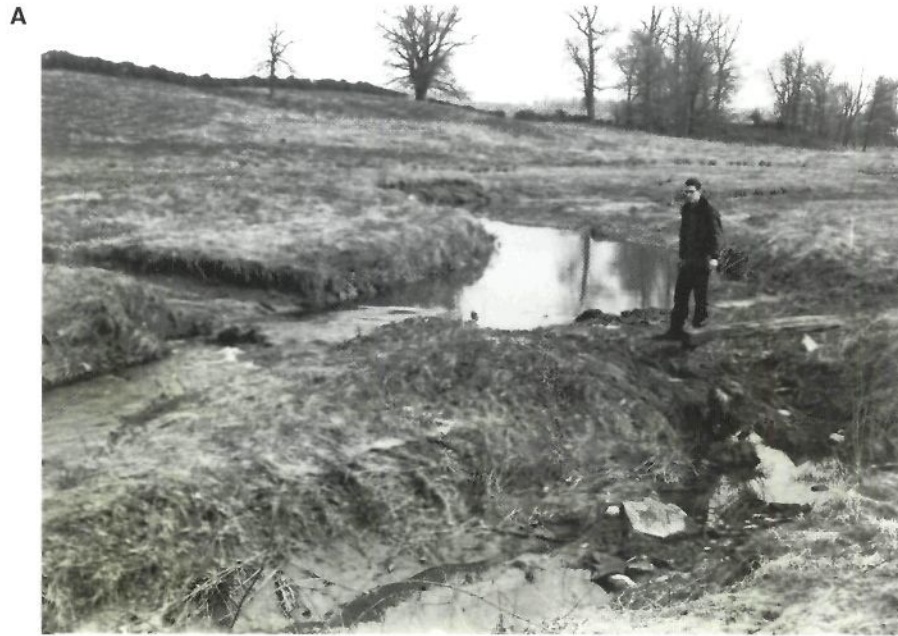
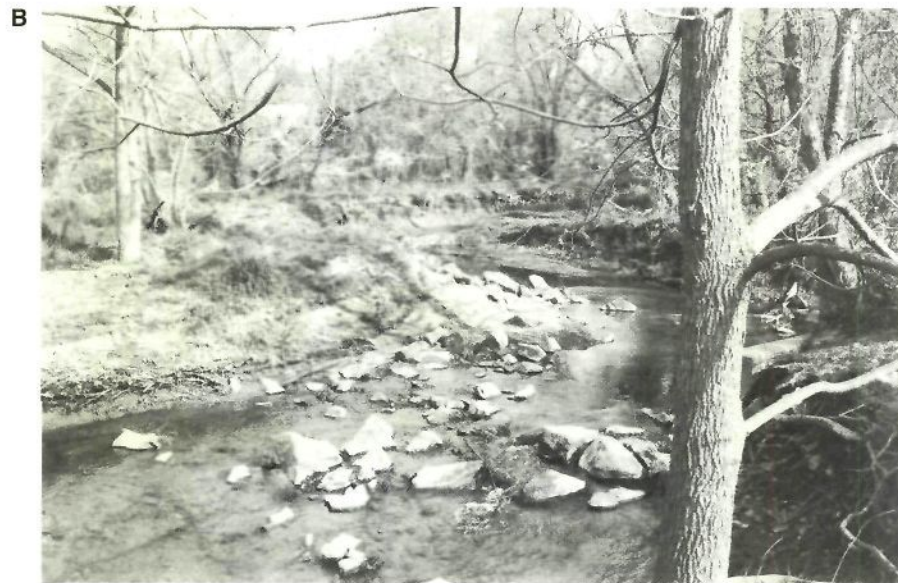
FIGURE 9A. View upstream in 1962 near a small island at Section 42. In 1994, figure 9B shows large angular rocks that had been brought in by floods.

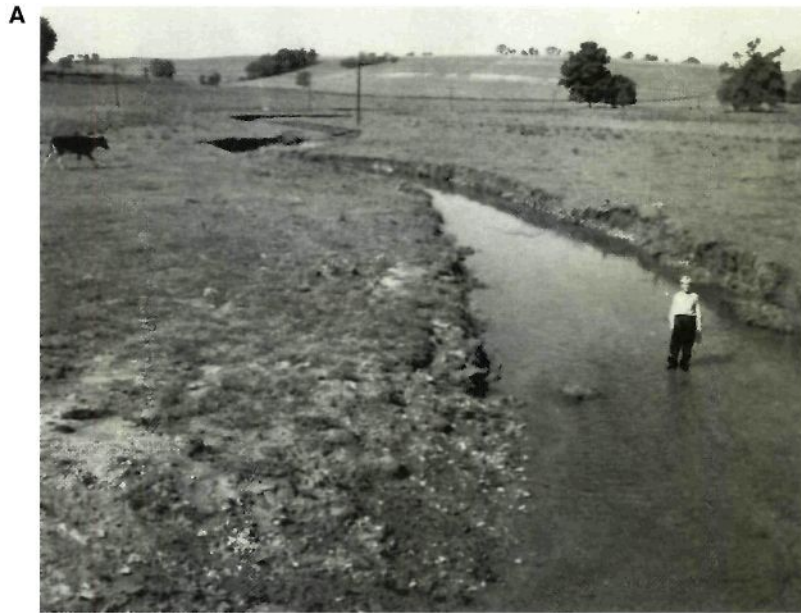
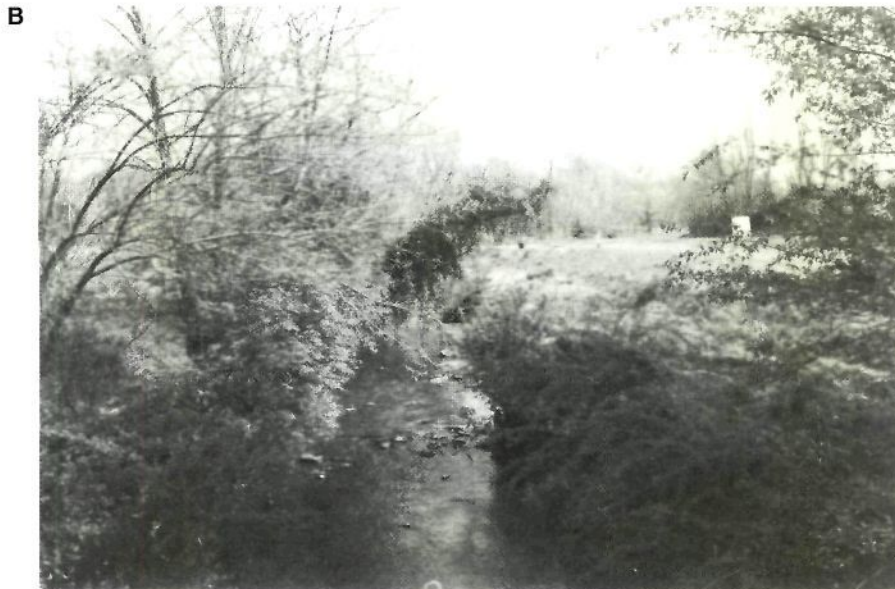
FIGURE 10A. View upstream in 1954 from bridge at lower end of the study area. Figure 10B shows the same view in 1994.

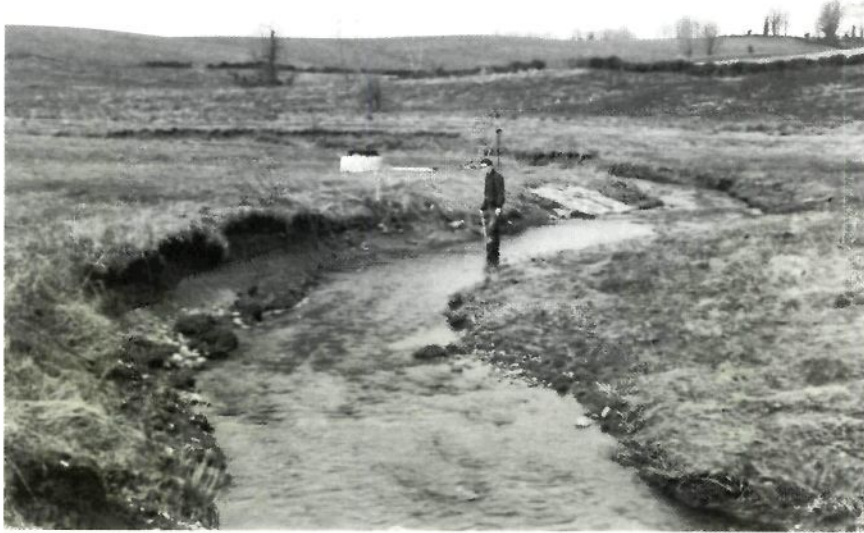
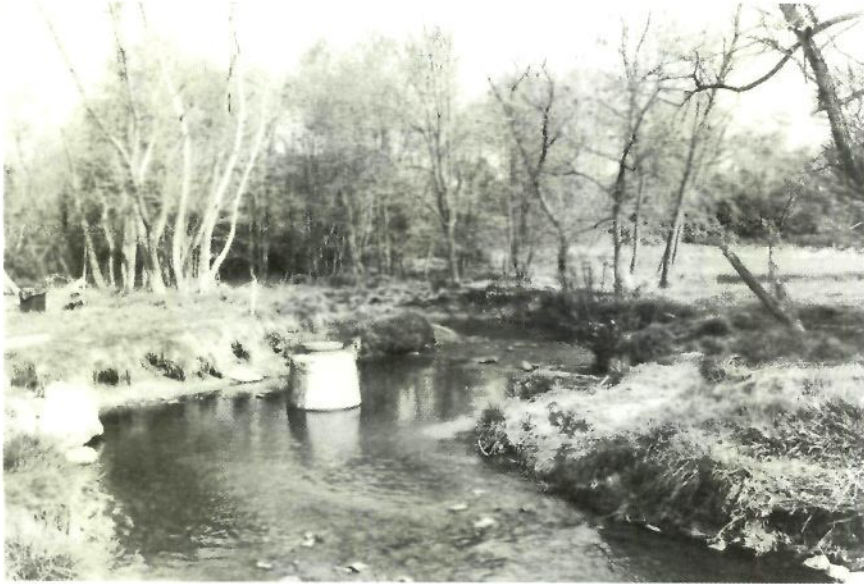
FIGURE 11A. View downstream in 1961 showing manhole far to the left of the channel. By 1994, in figure 11B, the channel had moved so far that the manhole stood in the center of the stream.

In 1961 a sanitary sewer line was put in a trench that extended downvalley through the study area. Though several meander bends were destroyed and some cross sections lost, the long-term effect was beneficial. The open trench provided an opportunity to study the stratigraphy of the valley fill, and the manhole covers gave us two permanent benchmarks.

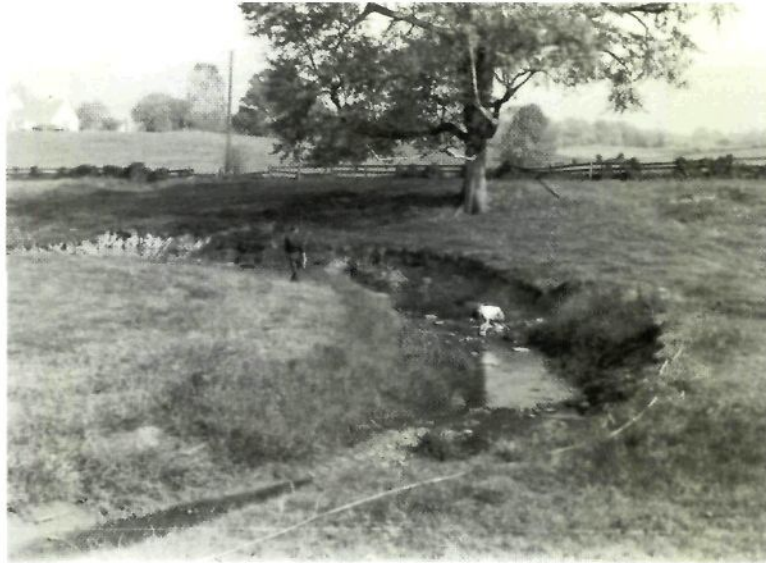
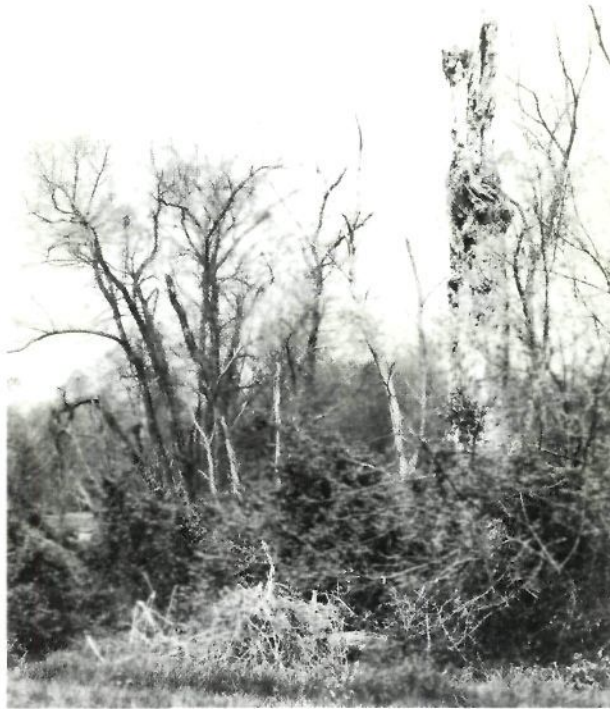
FIGURE 12A. View upstream in 1954 toward the maple tree on the roots of which we had put one of the principal benchmarks, BM 4. In figure 12B, photographed in 1994, the maple tree, now dead, has its roots eroded away by lateral movement of the stream. The channel is hidden in the brush at the bottom of the photo.
