Pollutant Analysis of HVAC Discharges in Montgomery County, Maryland

Abstract

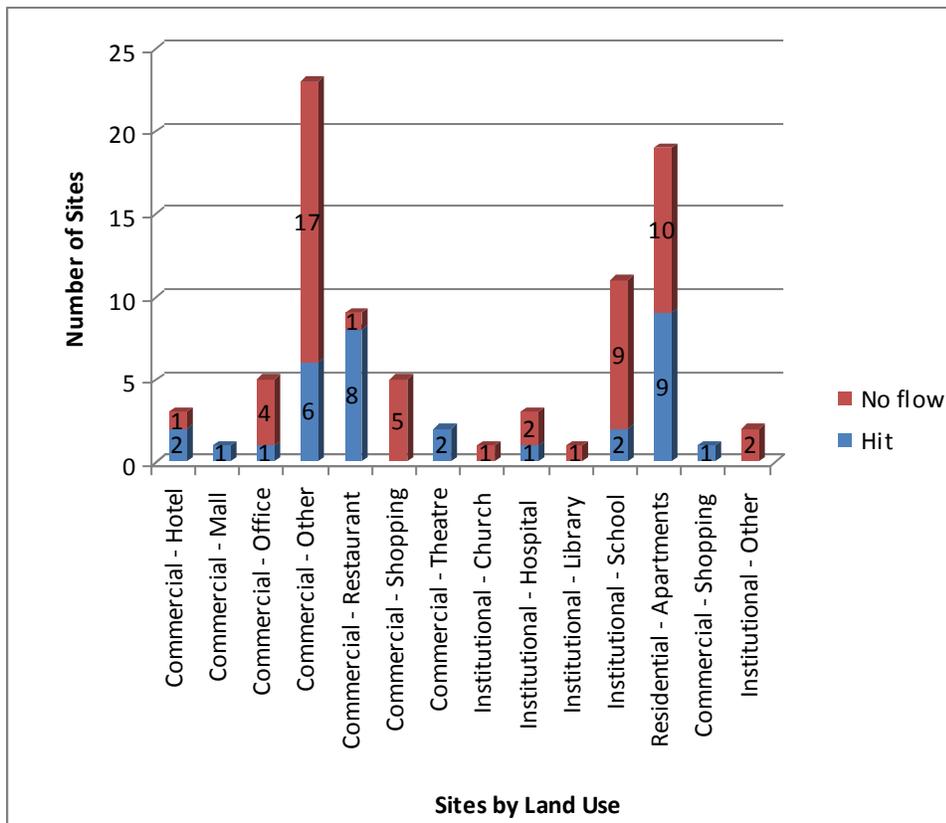
Figure 2. Site visits by land use, indicating the presence or lack of a discharge.

Field crews sampled 73 sites with roof areas greater than 20,000 sq. ft. as well as 13 buildings with roof areas less than this threshold. Figure 2 shows all sites by land use type. Of the 73 sampled buildings, 20 (27.4%) had a discharge. Thirty percent of these 20 sites were confirmed or likely to have HVAC sources. All discharges exceeded the ammonia threshold of 0.2 mg/L. The majority (58%) of the ammonia samples exceeded the MDL of the field colorimeter (> 5 mg/L). To estimate these sample concentrations, we diluted four of the samples that exceeded the MDL using a proportion of 1:1 for sample and distilled water; two of these still exceeded the MDL. The Maryland Department of the Environment does not have water quality standards for ammonia; however, USEPA recently updated its ammonia water quality standards to 1.9 mg/L for chronic conditions (30-day rolling average) and 17 mg/L for acute conditions (1-hour

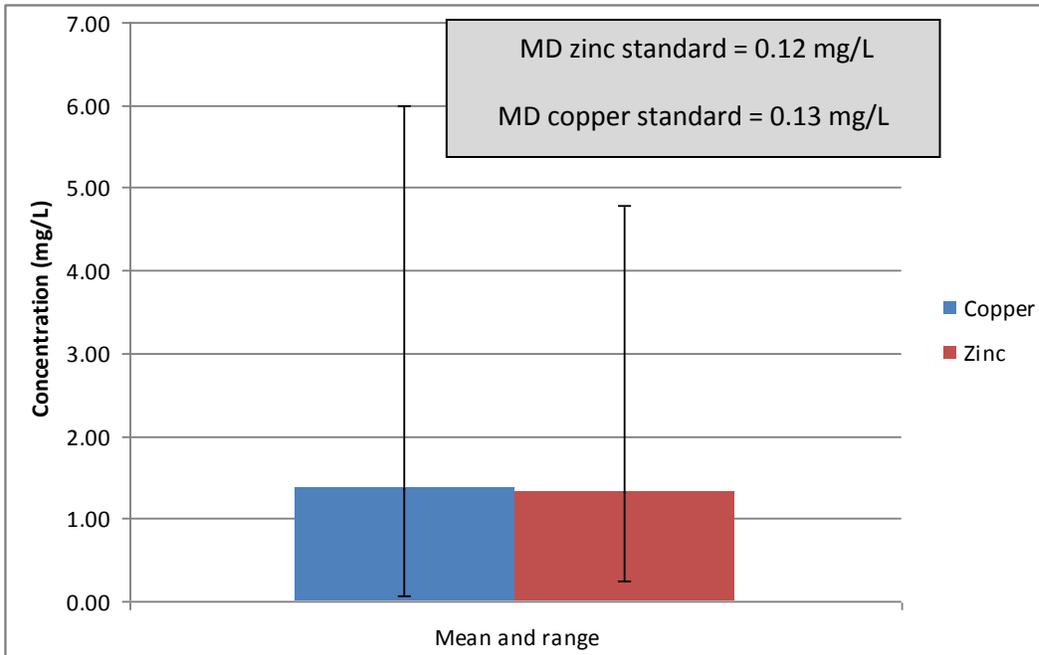
Figure 3. Heavy metal concentrations from HVAC discharges (n = 9).

average) to protect aquatic life from ammonia toxicity. Two samples also exceeded the copper field test MDL (>1.0 mg/L). Five samples were between 0.2 and 0.8 mg/L, and the remaining were non-detect using the field test kit. All of the laboratory-analyzed samples for metals were approximately ten times greater than the Maryland water quality standards (Figure 3). Maryland's water quality standard for zinc is 0.12 mg/L; for copper, it is 0.013 mg/L (acute) and 0.009 mg/L (chronic) to protect aquatic life from toxicity.

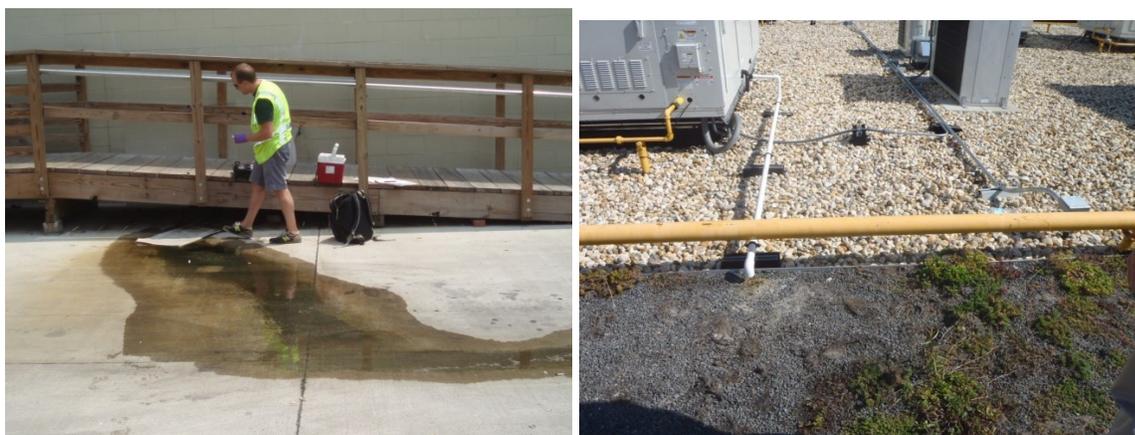
Figure 4. Sample point and discharge on street (left) and green roof and HVAC discharge point on roof of the same building (right).

inconclusive: one was confounded by a green roof (Figure 4), and the other indicated the discharge of cooling tower water to a roof drain at an apartment complex (Figure 5) that may or may not have been associated with the discharge sampled at the street level. Washdown water from the coil cleaning process, cooling tower “bleeding⁶,” biocide products, and refrigeration leaks are implicated as likely sources based on these interviews and inspections.

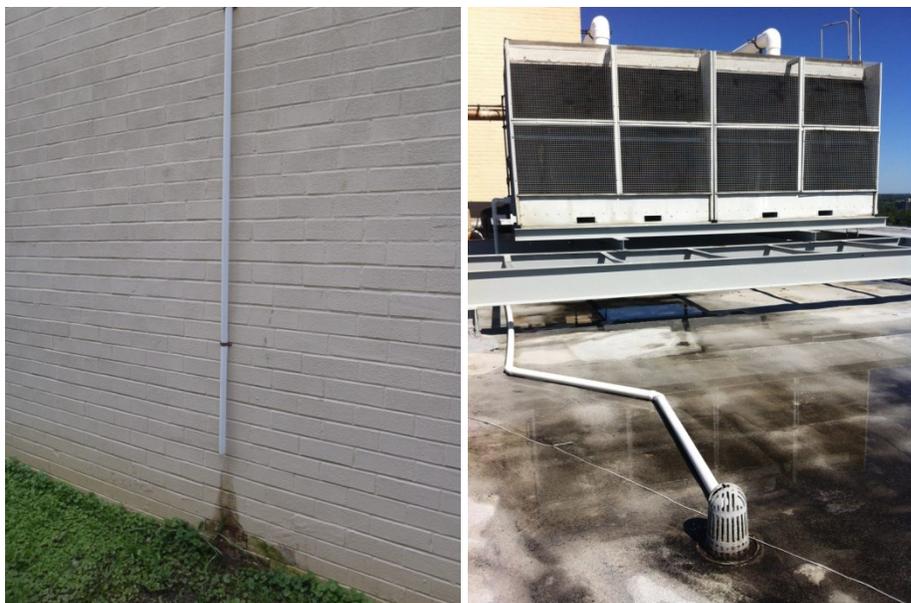
Figure 5. Sample point (left) and cooling tower discharge to roof drain of the same building (right). The roof drains are probably connected to the MS4 underground.
