Journal of the Center for Watershed Protection Association

## **Installation & Monitoring Of Instream Benthic Macroinvertebrate Platforms** *(HabiTubes & Habi-Mats) For Four Streams in Prince William County, Virginia*

# Installation & Monitoring Of Instream Benthic Macroinvertebrate Platforms

(HabiTubes & Habi-Mats) For Four Streams in Prince William County, Virginia

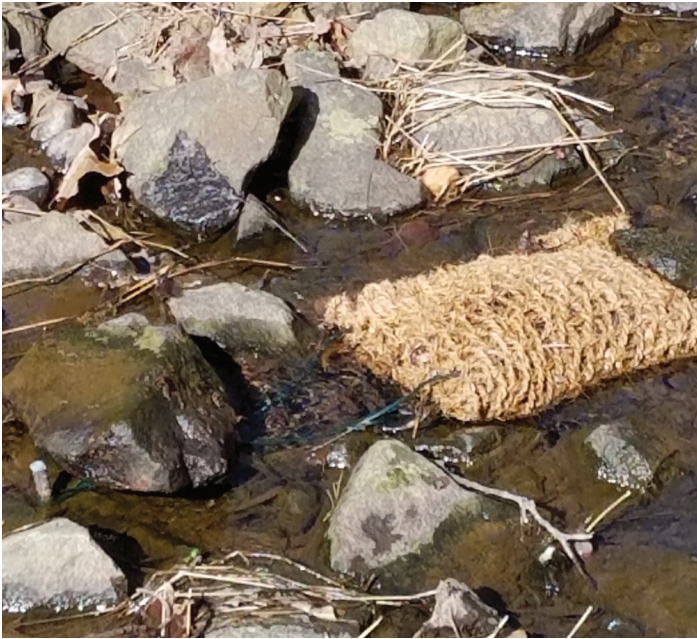
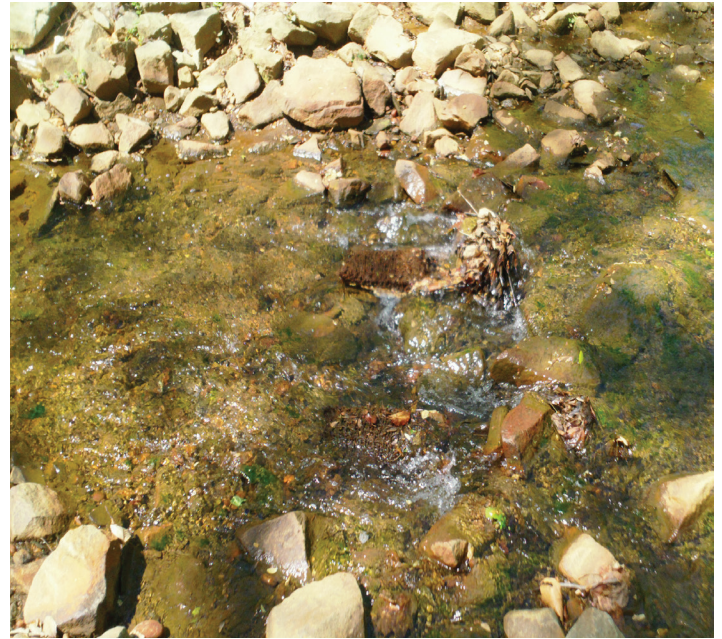
Figure 2. HabiTubes recently installed (left), and HabiTubes 2 months after installation (right).

HabiTubes are a patent-pending system that are comprised of an elongated pillow/tube made of coir fabric and filled with leaves or woody debris to provide habitat and food for benthic macroinvertebrates (Figure 2). They are placed in riffles and glides of streams to provide a semipermanent platform where these organisms can aggregate. The HabiTubes are used in urban channels where leaf packs do not occur due to a lack of riparian corridor or other impacts to detrital accumulation from storm events. This system can be used to enhance habitat in place or attract and grow organisms in a reference/donor reach and then relocated to a stream to kickstart a population where the organisms have been depleted.

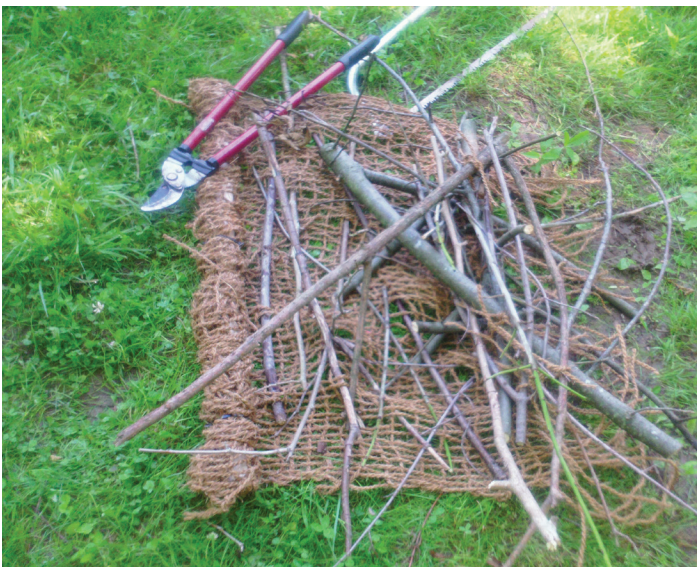
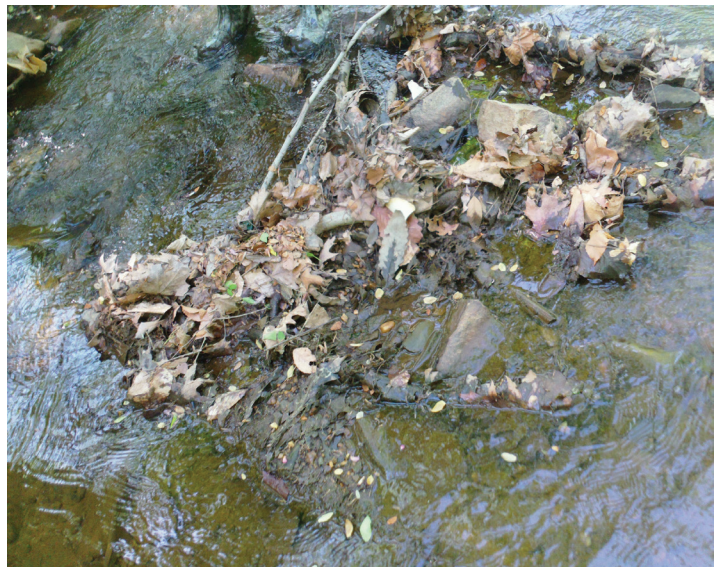
Figure 3. Habi-Mat prior to installation (left) and Habi-Mat 2 months after installation (right).

Habi-Mats is a patent pending product that increases channel surface roughness and provides stable structures to allow the formation of natural leaf packs (Figure 3). Woody debris is woven into a coir fabric mat that allows for the capture, decomposition, and breakdown that reduces the release

of organic matter downstream and facilitates slow release of in-channel detrital material. This roughness and detrital capture creates habitat and food opportunities for benthic macroinvertebrates that are lacking in many urban channels. It is also worth mentioning that restoring these “leaf pack” features to streams also restores the basic ecological function of decomposition (providing a structure where leaf breakdown can occur, as well as supporting both microbial and invertebrate communities that in turn support fish communities).

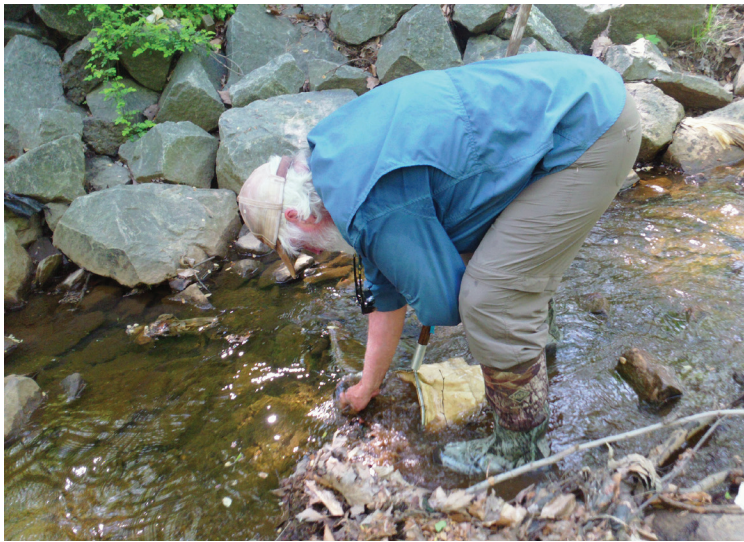
Figure 5. Conducting a jab sample.

The sampling areas that included the Habi-Mats used the 20-jab methods as required by the Virginia Department of Environmental Quality (2008) protocol (Figure 5). The Habi-Mats were included as a part of the sampling protocol as a habitat to be jabbed. The data collected from this sample were presented in the final data as an independent habitat or data set (as shown later in Tables 5–8).

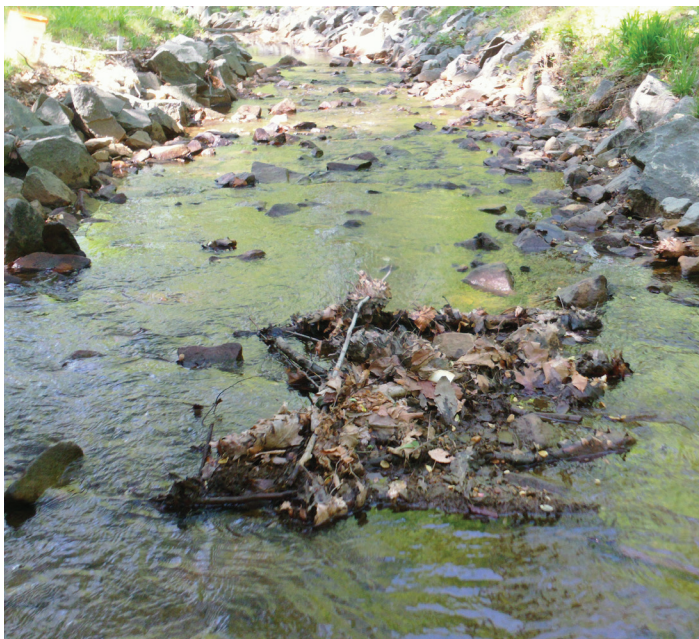
Figure 7. Looking upstream from a Habi-Mat.

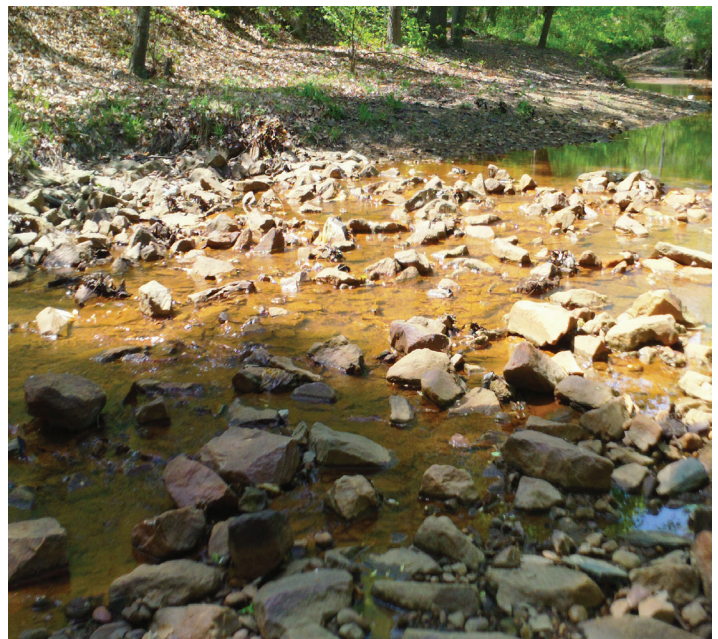
Figure 8. HabiTubes sampling area in Cow Branch 4. (Reddish color is iron flocculent.)

- A very thick coating of iron flocculent on the streambed was observed at the Cow Branch 4 site. This coating covered the entire bottom area of the stream in the study reach. It resulted in a very slick coating that stained the water a reddish-orange and made walking in the stream treacherous. In the pool areas and eddies of the stream, there were large areas of underwater globs or wads of flocculent.

The high iron content in the stream channel that was observed in Cow Branch 4 site is a common site in this region of Virginia. This is considered a natural condition, as the groundwater flows through shallow iron deposits and transports iron depositing it in the local surface water (Gooch, 1954). When the dissolved ferrous iron ( $\text{Fe}^{2+}$ ) is exposed to the air in surface waters, it is oxidized to ferric iron ( $\text{Fe}^{3+}$ ) and precipitates as iron(III) oxyhydroxides; this process consumes oxygen and results in an orange-colored precipitate (iron floc). In addition, iron bacteria incorporate the dissolved iron into their metabolic processes, forming the insoluble  $\text{Fe}^{3+}$ . This insoluble ferric iron is surrounded by filamentous bacteria colonies that create a sticky orange slime, which blankets the substrate. This results in increased conductivity and the loss of habitat for the benthic macroinvertebrates (Koski and Herrick 1999).

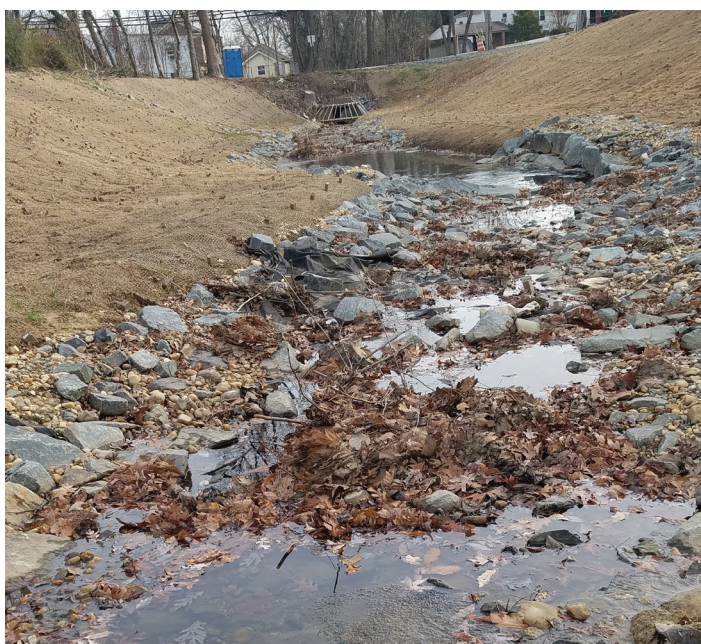
Figure 9. East Longview looking downstream at Habi-Mat.
