NORTON CREEK WATERSHED MANAGEMENT PLAN

2018 — 2022

For the purpose of achieving the Total Maximum Daily Load (TMDL) and removing the dissolved oxygen and sedimentation/siltation impairment of Norton Creek

Developed by the Huron River Watershed Council.

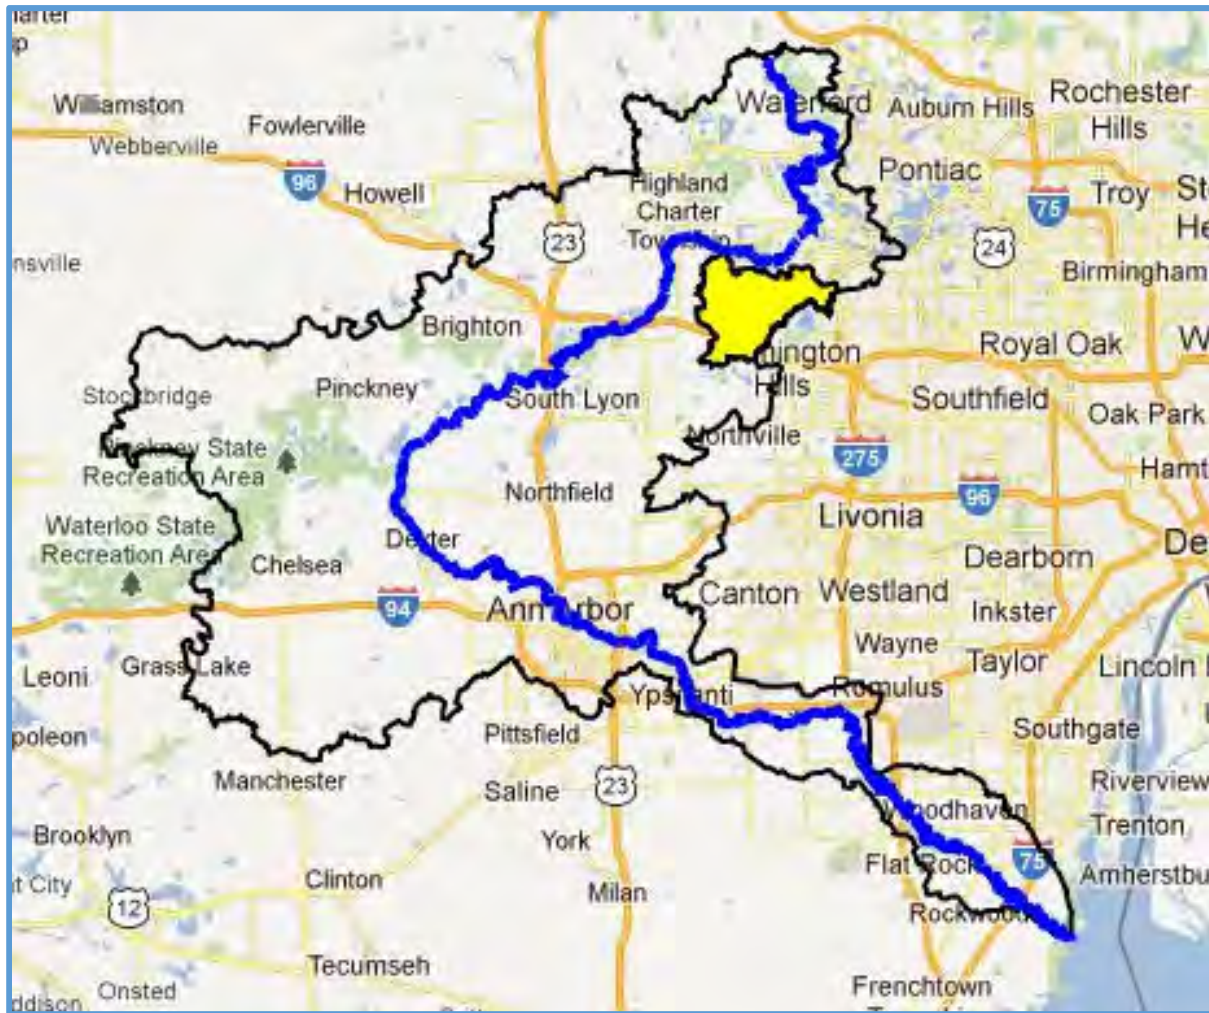
Figure 2: Huron river watershed boundary and river course. Yellow shape denotes location of Norton Creekshed

Flowing a total of 136 miles, the Huron River (HR) originates just north of Indian Springs Metropark. From these headwaters, the main stem meanders through a complex series of wetlands and lakes in a southwesterly fashion to the area of Portage Lake. Here, the river begins to flow south until reaching the Village of Dexter in Washtenaw County, where it redirects southeast through Ann Arbor and Ypsilanti and proceeds to its final destination of Lake Erie; its confluence just south of Detroit. En route, it provides drinking water for 150,000 residents throughout its 900 square mile watershed (Figure 2).³

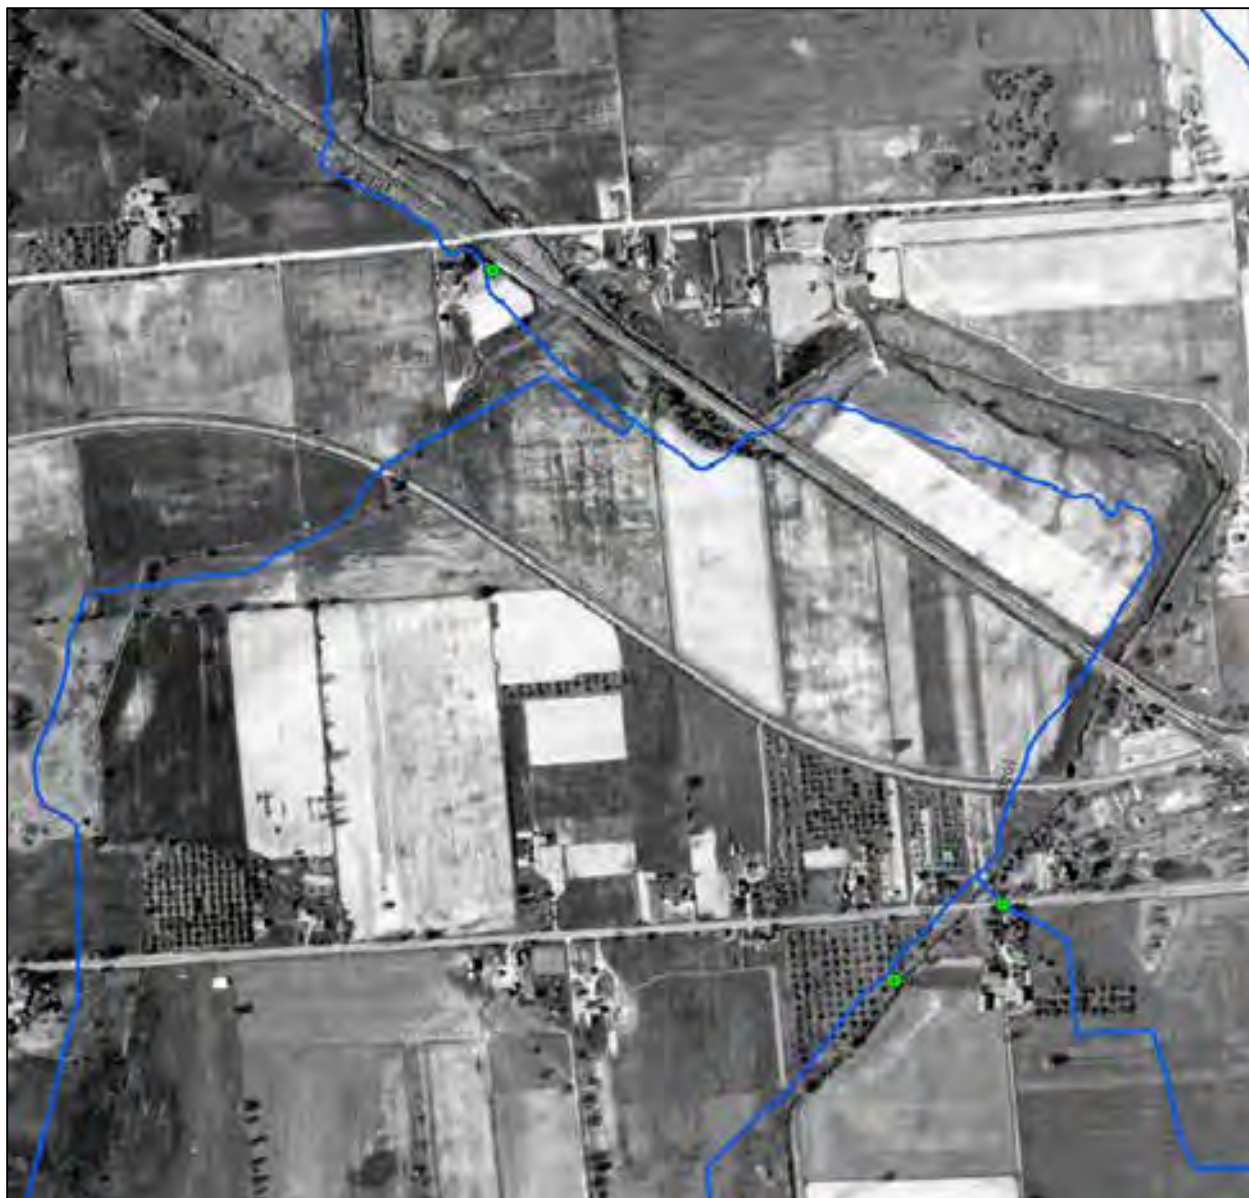
Figure 9: Section of current Norton Creek stream network (between Pontiac Trail and Maple Road) shown on an aerial photo from 1949. Note that the photo is not orthorectified, so the channels do not exactly match. However, current channel shape matches almost identically to 1949.

Given the findings that 1) the Norton Creek watershed has low gradient throughout, 2) its reaches have unnaturally low sinuosity, 3) and most channels have lower width-depth ratios than expected compared to reference conditions, a search was made for historical photo reference. The oldest digitized photos obtainable were obtained from SEMCOG and were dated 1949²². As shown in figure 9, the signature sharp, unnatural, angular creek bends that suggest channel alteration, were also present in 1949. In the past, and sometimes currently, the county drain commissioner would be responsible for altering streams to reduce flooding or “reclaim” land for agriculture. Indeed, the Oakland County Water Resources Office indicates that most of the county drains in Norton Creek were established prior to 1920. It appears from the photo that the channel shape has changed little since 1949.

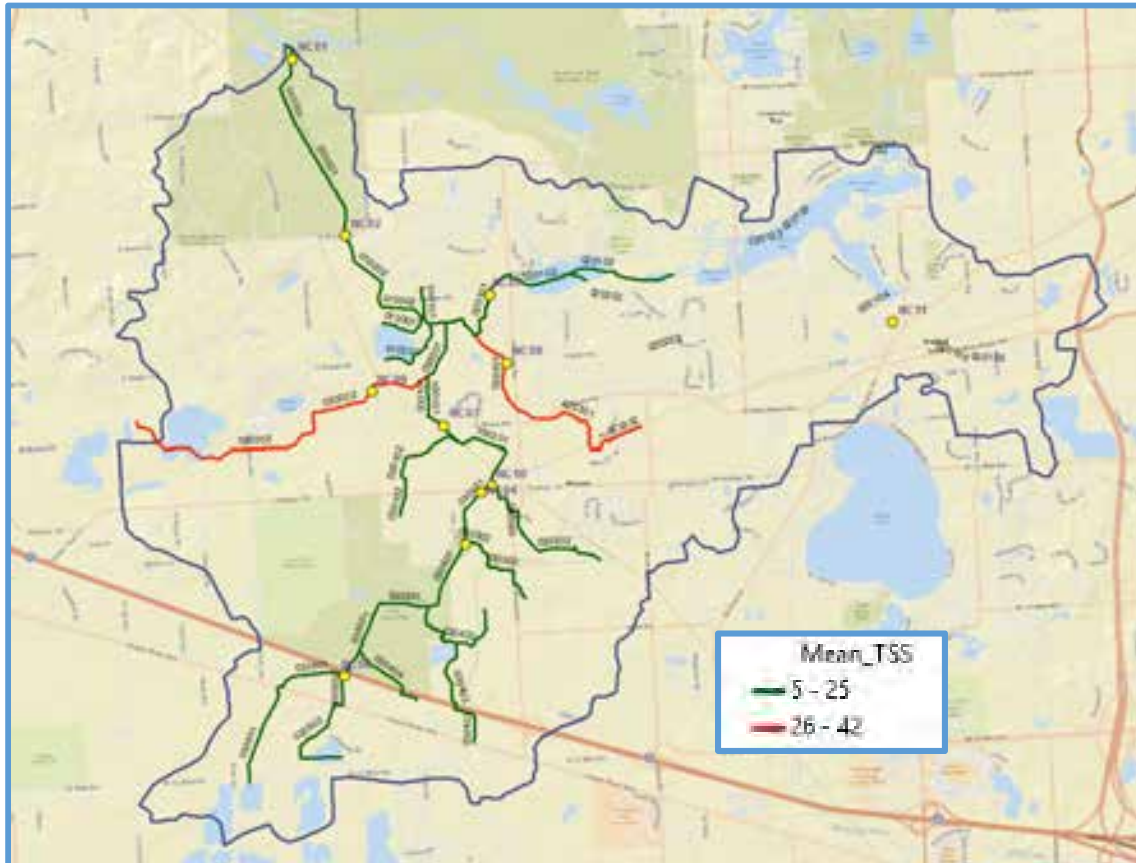
Figure 11: Norton Creek watershed showing stream reaches with corresponding total suspended solids concentrations in mean mg/l.

weather. The highest mean TSS concentration was just under 42 mg/l. Figure 11 shows mean TSS concentrations above and below a 25 mg/l concentration, to set a reasonable target to examine potential erosive reaches. Only two reaches exceed that mean concentration. The reach with station NC09 has the highest gradient in the Norton Creek watershed. The reach that includes station NC08 drains through a number of residential subdivisions and into the Wixom Habitat.

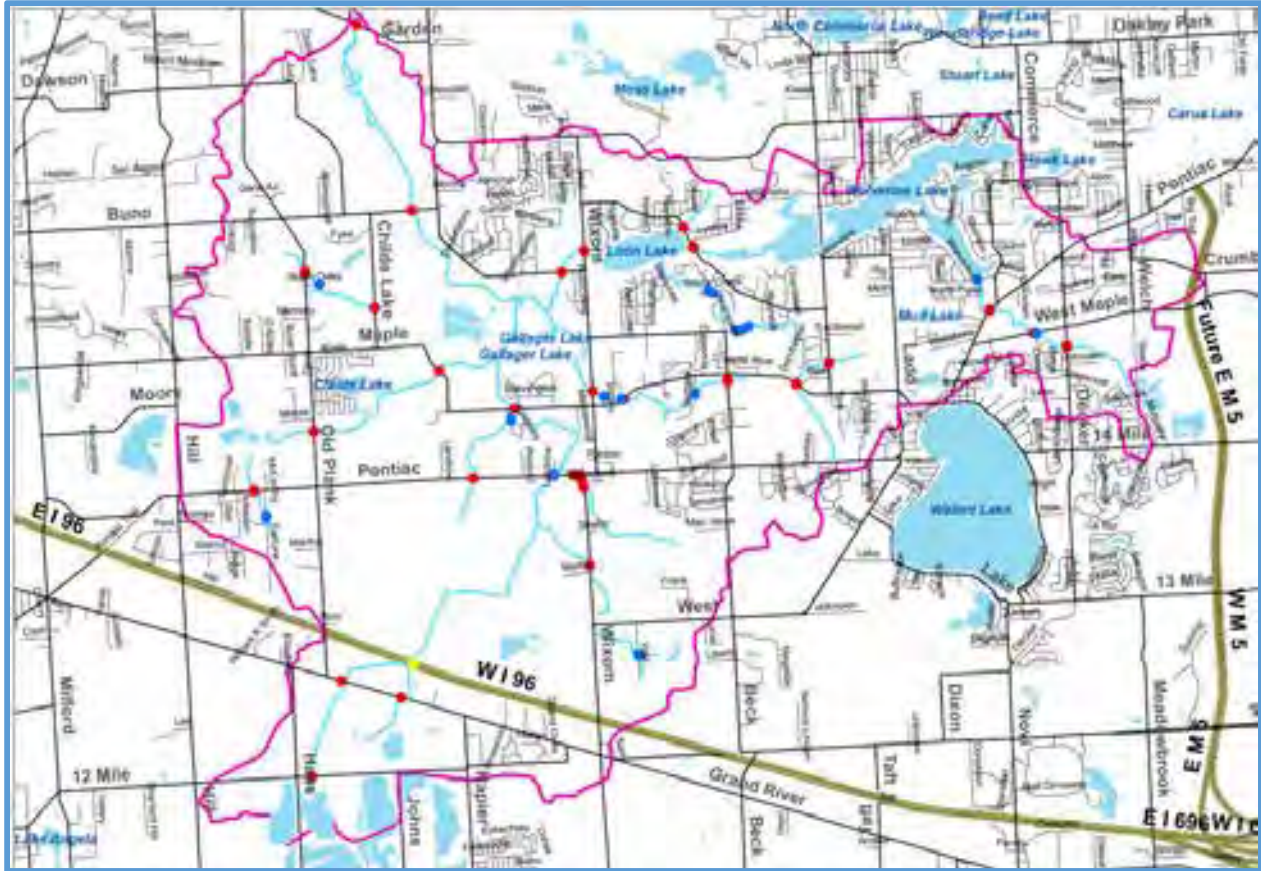
Figure 12: Locations of surveyed road-stream crossings in Norton Creek watershed.

In addition to sampling for TSS concentration, HRWC staff and volunteers assessed the majority of road-stream crossings in the watershed – over 50 crossings (see Figure 12). The purpose of this exercise was to determine if any bridges, culverts or other structures were altering stream flow in such a way as to create excessive erosion downstream or aggradation upstream. Out of all 54 crossings, only two minor erosion/siltation issues were observed. These findings were reported back to the Oakland County Road Commission for prioritization and repair. Given the development that has occurred in the Norton Creek watershed, altered hydrology and erosion were expected. The lack of observational evidence of erosion furthers a conclusion that current sediment loading of Norton Creek reaches is not a significant concern, and is not likely a long-term source of sediment loading or high sediment oxygen demand.

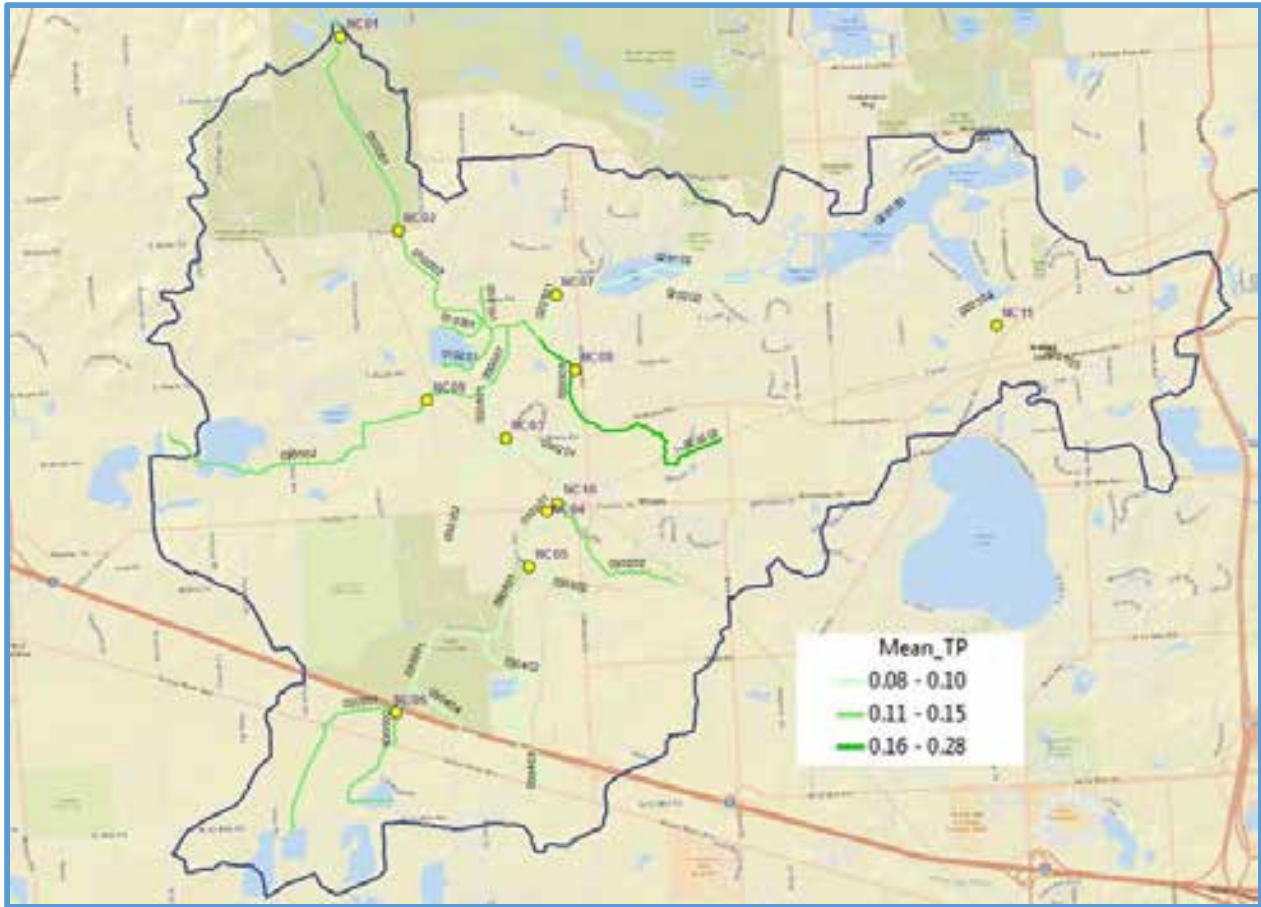
Figure 13: Norton Creek watershed showing stream reaches with corresponding total phosphorus concentrations in mean mg/l.

All sampling sites in Norton Creek had mean total phosphorus levels that exceeded the 0.05 mg/l target. Figure 13 illustrates the range of results. Reach NC08, in particular, had a mean TP of over 5 times the target. Visual inspection revealed active algae growth and blooms in areas.

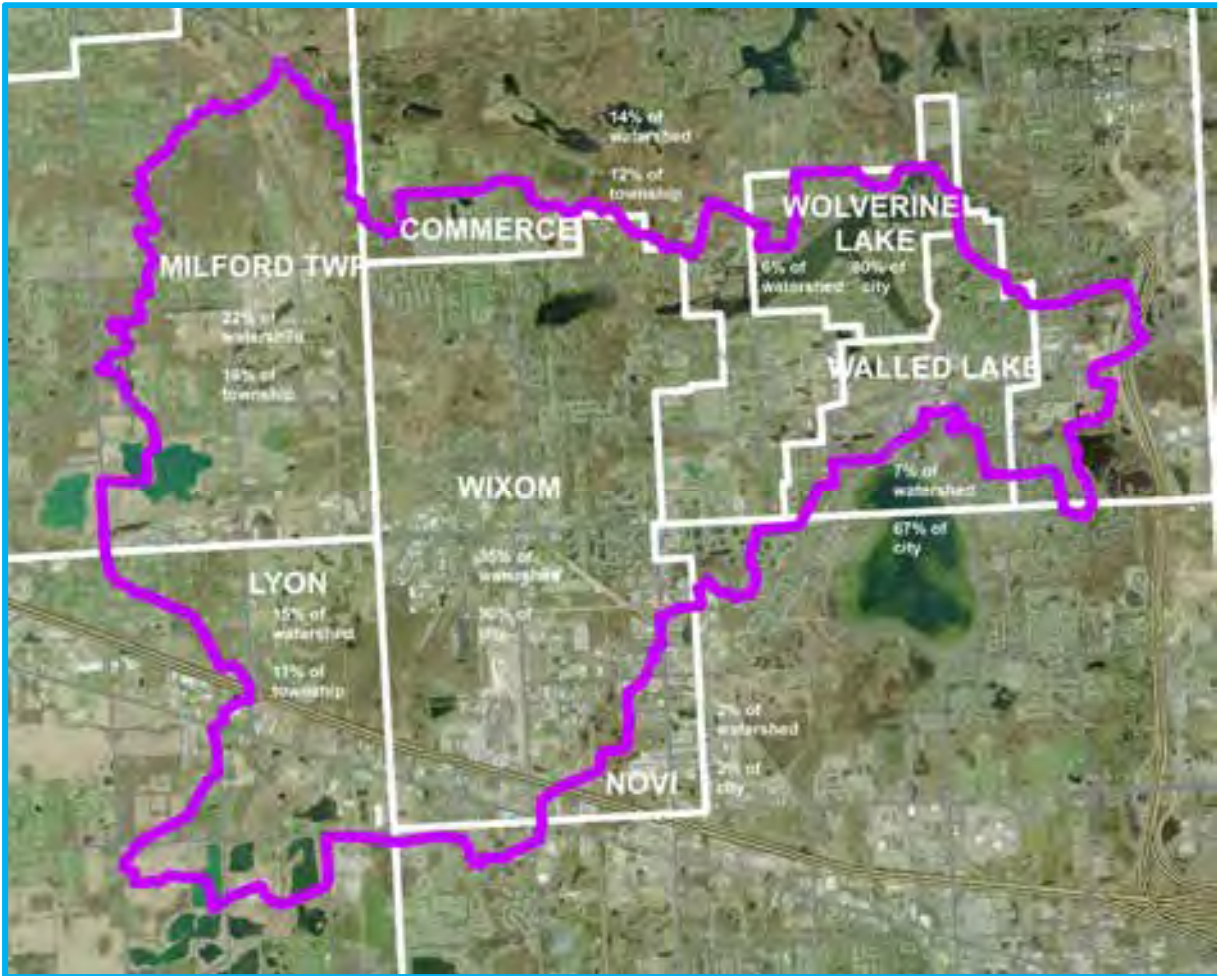
Figure 25: Political boundaries within Norton Creekshed. Percentages indicate relative surface areas such that, for example, 15% of the watershed lies in Lyon Township while 11% of Lyon Township lies in the watershed

Norton Creek drains 24.2 square miles and crosses portions of Commerce, Lyon and Milford Townships, and the cities of Novi, Walled Lake, Wixom, and Wolverine Lake Village (Figure 25).⁵³ All of the Norton Creekshed is located within Oakland County. The City of Wixom accounts for the largest surface area of the creekshed at 35%, and most of the population within the Norton Creekshed is also concentrated in this city. The US Census calculated the 2010 population of Wixom to be about 13,498.
