STUDY ON THE SURFACE INFILTRATION RATE OF PERMEABLE PAVEMENTS

May 26, 2004

Prepared for:
Interlocking Concrete Pavement Institute

By: Eban Z. Bean, Engineering Intern
William F. Hunt, Ph.D., PE
David A. Bidelsbach, Engineering Intern
Jonathan T. Smith, PE

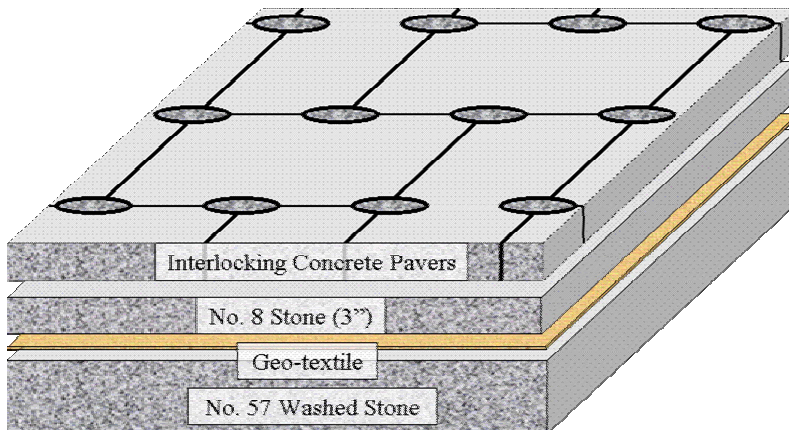
Size (stalls/sq. ft.): 3,360 sq. ft.
Approximate Drainage Area: Equal to permeable area
Construction Date: 2003
Address: 85th St., Ocean City, MD
Test Date: July 29, 2003
Visual Assessment: Condos under construction w/ hay bales around test site.
Maintenance Practice: New

Run #1	Run #2	Run #3	Average
845	1359	338	847

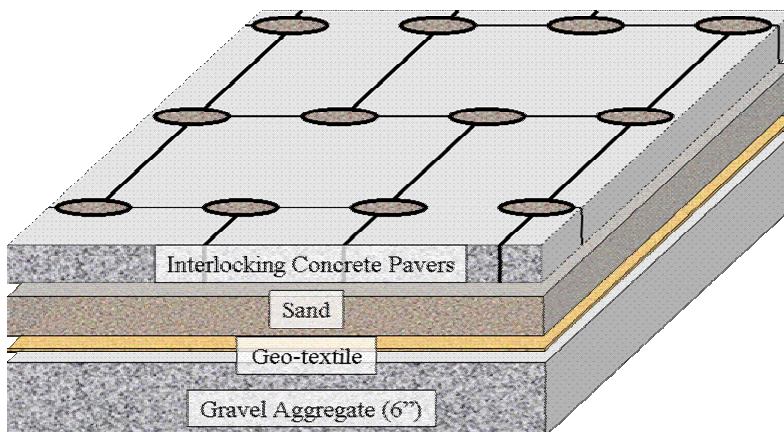
Size (stalls/sq. ft.): 22,000 sq. ft.
Approximate Drainage Area: Equal to permeable area.
Construction Date: 2001
Address: Route 231, Prince Frederick, MD
Test Date: July 28, 2003
Visual Assessment: Heavily used with lots of sand in void spaces.
Maintenance Practice: none

Run #1	Run #2	Run #3	Average
1.72	0.79	0.97	1.16

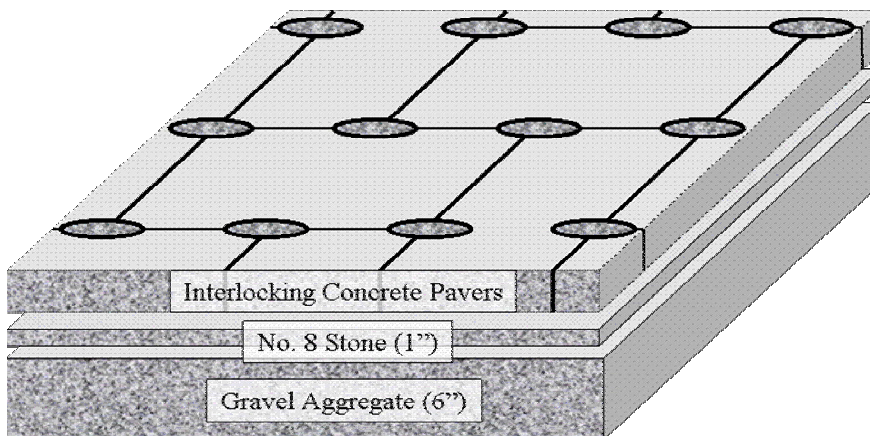
Run #1	Run #2	Run #3	Average
0.00	0.72	1.19	0.64

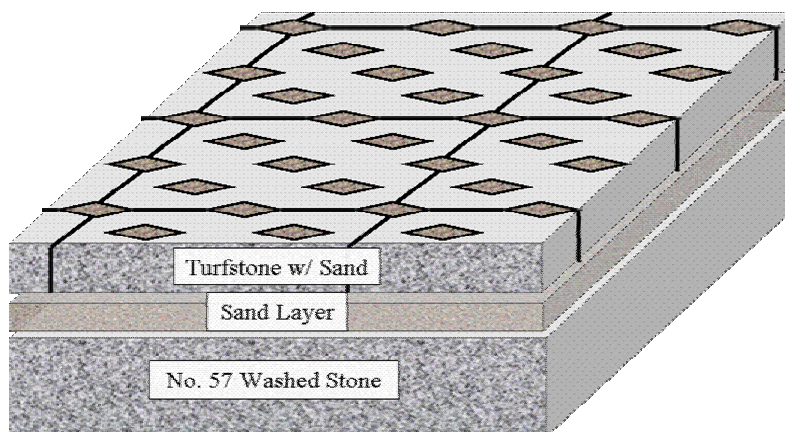
Size (stalls/sq. ft.): 0.75 acre
 Approximate Drainage Area: 1 acre
 Construction Date: 1995
 Address: 400 James Jackson Rd., Cary, NC
 Test Date: August 7, 2003
 Visual Assessment: Small plants, sand, and trash in void spaces, slightly sloped.
 Maintenance Practice: None, only replaced broken blocks

Existing Conditions Test (cfs/ac):			
Run #1	Run #2	Run #3	Average
0.30	0.27	0.60	0.39
Post-Maintenance Condition Test (cfs/ac):			
0.60	0.75	0.56	0.64

Maintenance Performed: Removed top 0.5" of material from drainage pores.

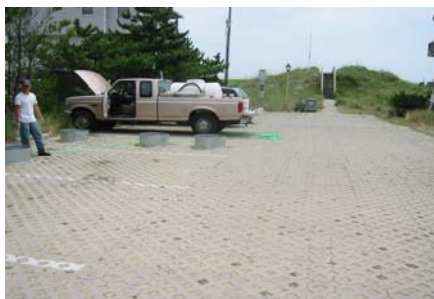
Visual Assessment: Grass in 30% of voids, very sandy and has pine trees.

Maintenance Practice: As needed after large storms (a few times per year).

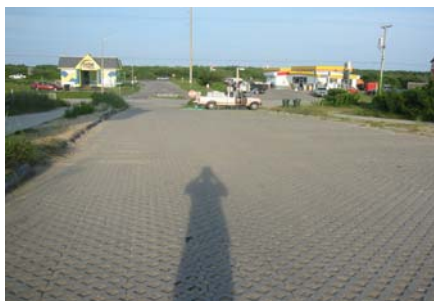
Appendix C16

Size (stalls/sq. ft.): 8200 sq. ft. 20 stalls
 Approximate Drainage Area: 9400 sq. ft.
 Construction Date: 1984
 Address: S. Virginia Dare Tr. & Conch St., Nags Head, NC
 Test Date: July 16, 2003
 Visual Assessment: Very loose sand.
 Maintenance Practice: As needed after large storms (a few times per year).

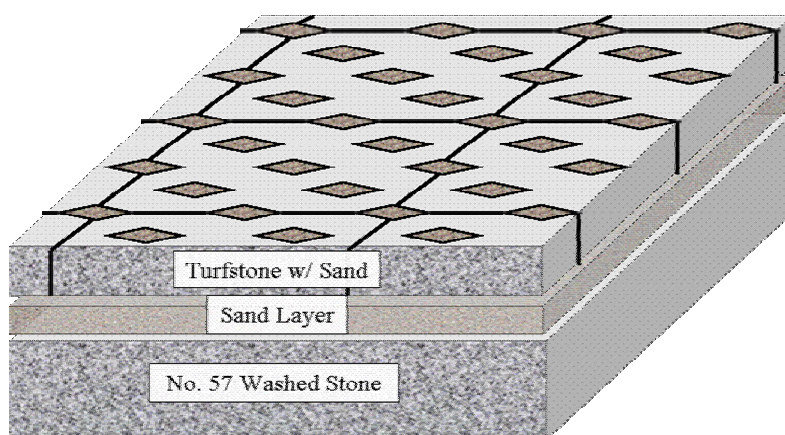
Visual Assessment: Sand and some small grass plants in void spaces.

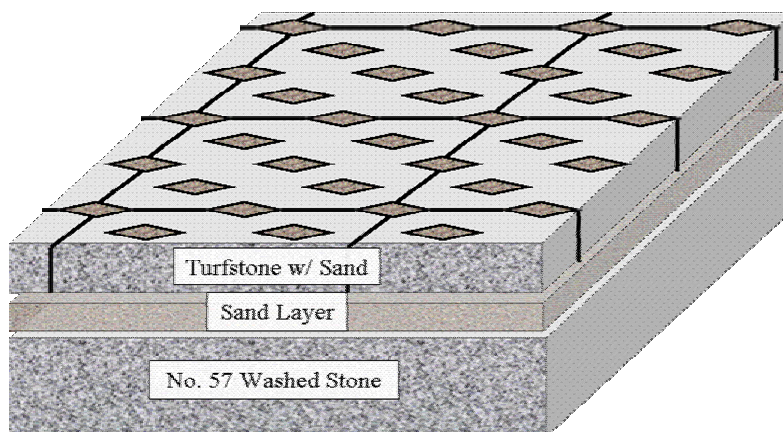
Visual Assessment: Grass in voids, fines only on surface of blocks in low lying areas.

Maintenance Performed: Removed top 0.5" of material from drainage pores.

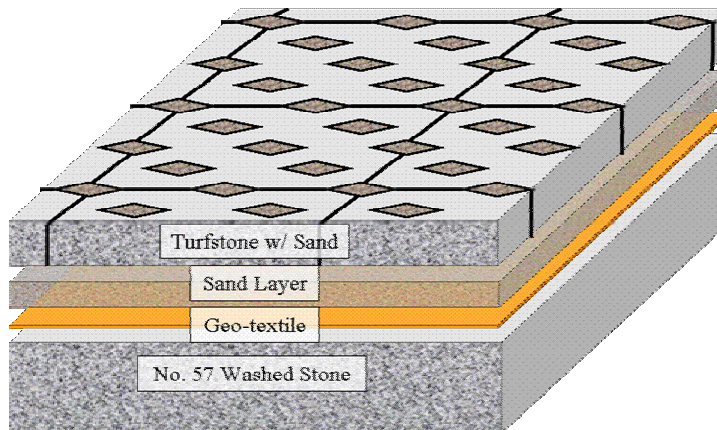
Appendix C23

Size (stalls/sq. ft.): 6300 sq. ft. 20 stalls
 Approximate Drainage Area: 6300 sq. ft.
 Construction Date: Summer 1999
 Address: 207 E. King St., Kinston, NC
 Test Date: July 21, 2003
 Visual Assessment: Very sandy with less than 10% grass in void spaces.
 Maintenance Practice: One sweep per year with a street sweeper.

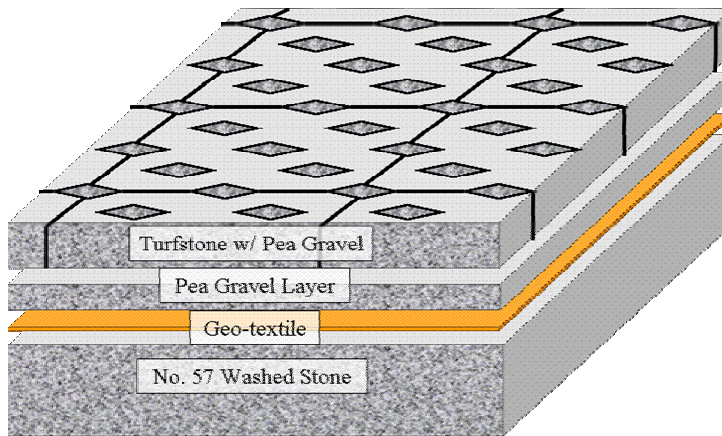
Appendix C24

Size (stalls/sq. ft.): 8 stalls
 Approximate Drainage Area: Permeable Area
 Construction Date: 2001
 Address: 101 S. Lumina Ave., Wrightsville Beach, NC
 Test Date: July 23, 2003
 Visual Assessment: Some sand filled in voids, and negligible grass growth.
 Maintenance Practice: Once every two weeks with a street sweeper.
 (Tracy Dail, Wrightsville Beach)
