## Bioengineering in Four Mile Run, Virginia

by Jay West, Save Our Streams Program, Izaak Walton League of America, Inc.

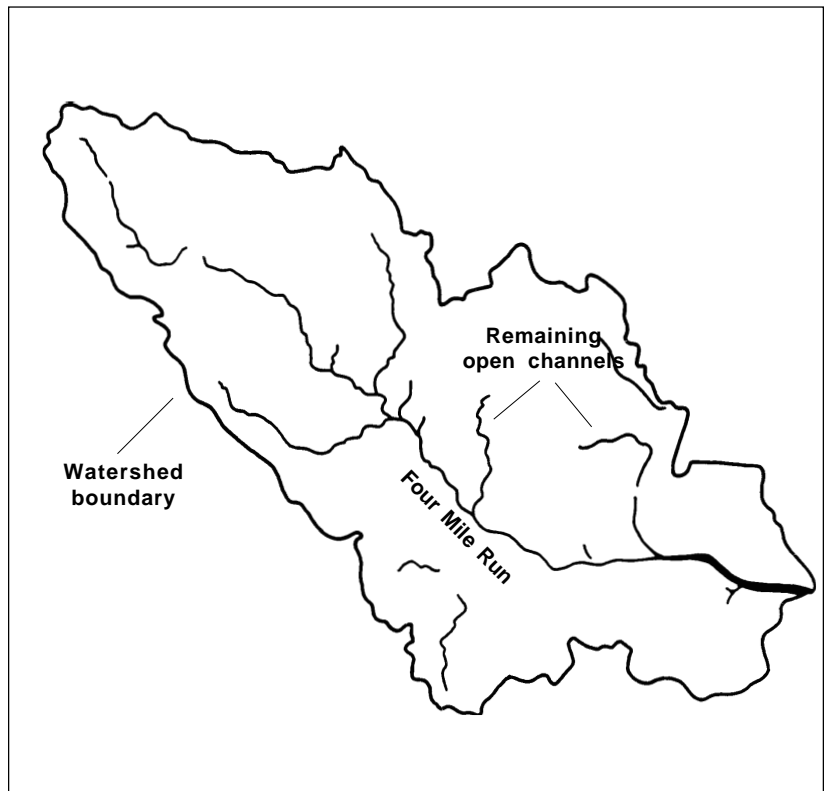
Four Mile Run drains an urban watershed of some 20 square miles, that is about 40% impervious (Figure 1). Many of the small headwater streams that drained to Four Mile Run have been enclosed in stormdrain pipes. Over 35 stream miles have been lost in this manner over many decades of development (Waye 1994.) As a consequence, Four Mile Run is heavily influenced by stormwater runoff. Both water quality and aquatic habi-

**Figure 1: Four Mile Run Watershed Post-Urbanization; Over 35 Miles of Natural Drainage Replaced by Storm Sewers**
