Kilmarnock Watershed Assessment Report

April 2013

**PREPARED FOR:
Town of Kilmarnock, VA**

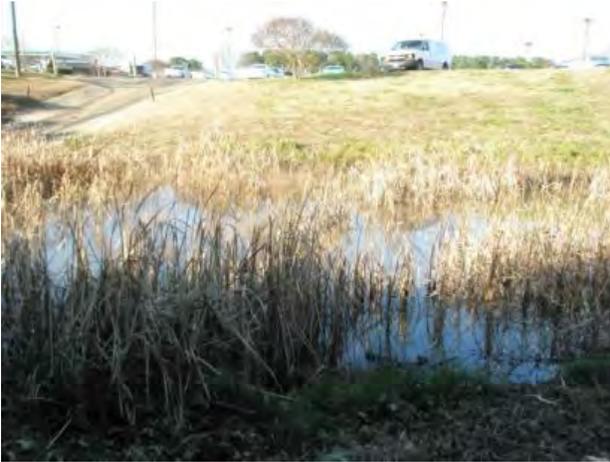
Figure 1: Existing stormwater basin

Description: Site H-105 is a gas station, H-120 is a McDonald's restaurant, and a third outparcel, a bank, all combine with the main parking lot of the Lancaster Square Shopping Center anchor building, H-121 (Food Lion and several other smaller stores) and drain to an existing stormwater BMP on the southern edge of the parking lot. The BMP is a small basin that could be considered a constructed wetland, extended detention pond with a clogged orifice, or a wet pond with an undersized permanent pool. The site visit noted 3 important observations about the basin:

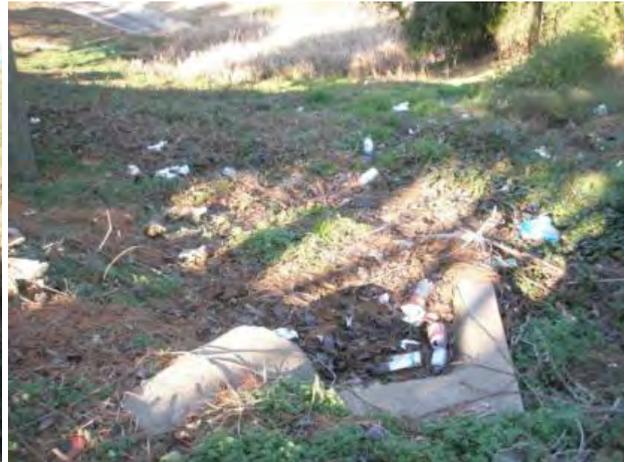
Figure 1: Inflow from McDonald's parking lot

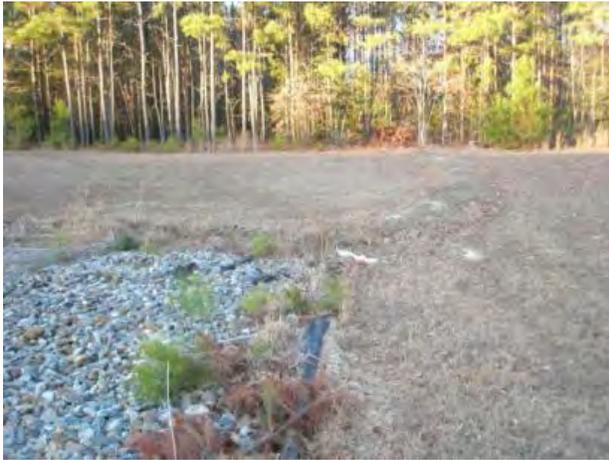
Figure 1: Infiltration trench w/ low earthen berm

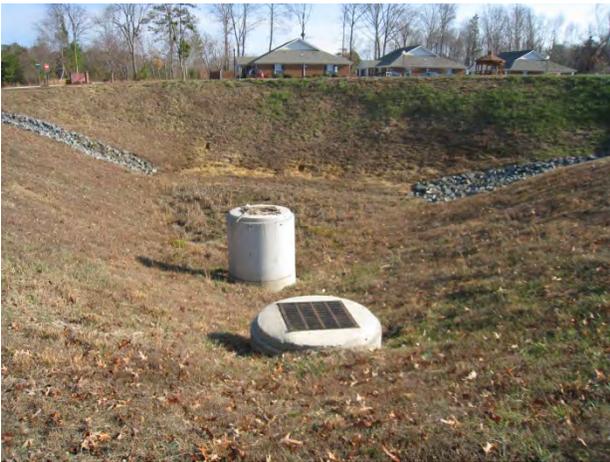
Figure 3. Detention basin in communal area

The large detention basin in the central communal area (Figure 3) has some erosion problems, due in part to its steep side slopes, lack of vegetation, and sandy soils. A hole is starting to develop in the ground surrounding the concrete riser structure (Figure 4) and is certain to get worse. And the soil in at least one of the steep rip-rap inlet channels is eroding beneath the stone (Figure 5).

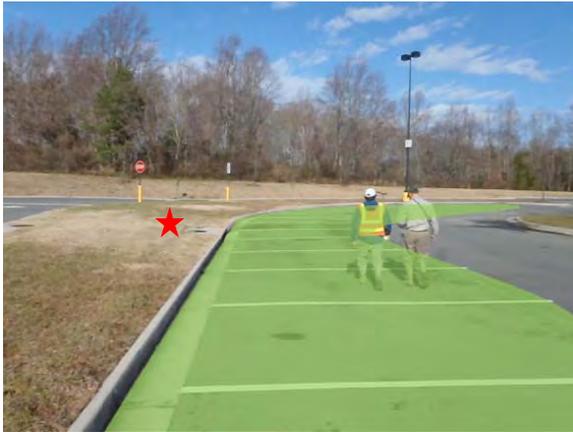
Figure 1: Proposed bioretention location in green

Description: Most or all of the runoff from the large parking lot and roof at WalMart drains to a wet pond behind the building. There is certainly some water quality treatment benefit to this stormwater management practice, but very little infiltration and groundwater recharge usually occurs in a wet pond. The retrofit proposed here would not only allow better groundwater recharge on the site, but also serve as a highly visible stormwater management and landscaping feature at the entrance of the parking lot.

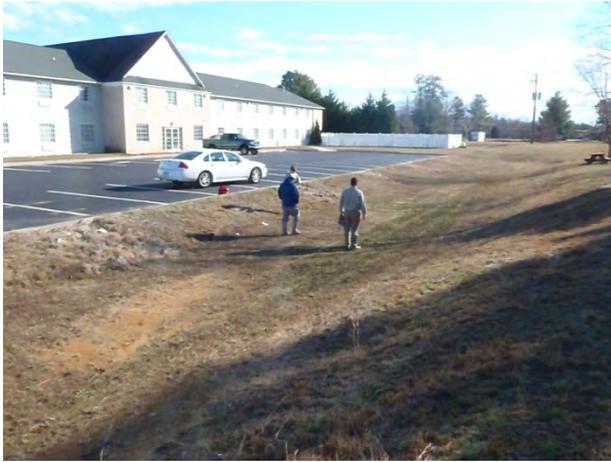
Figure 1: Basin behind Holiday Inn

Description: The *detention basin shown in the photos above is located at the back of the parking lot behind the Holiday Inn Express. The surface dimensions of the basin are 29' x 180' and runoff from half of the hotel roof and parking lot enters the basin via several curb inlets. There is a concrete riser-type structure at the northern end of the basin (Figure 2), but it is unclear if and how this structure functions as an overflow outlet. The entire basin is currently managed as grass turf and the soil is very sandy.

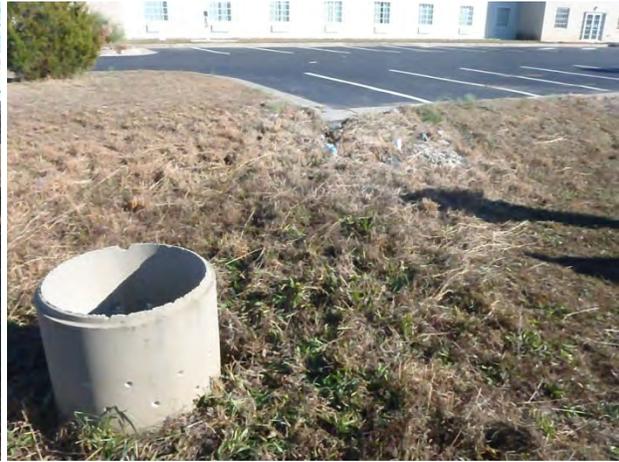
Figure 2: Riser structure at northern end of basin

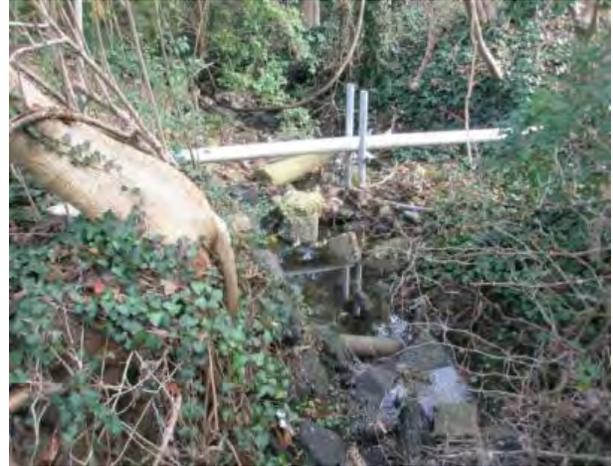
Figure 1: Downstream of existing BMP

The Channel downstream of the BMP does not appear to have the significant head cut drops of some of the other channels investigated. However, it could benefit from spot clearing of debris and shaping the channel banks. Also, the sewer connection bracing across the channel should be evaluated for stability and durability since it is very exposed.

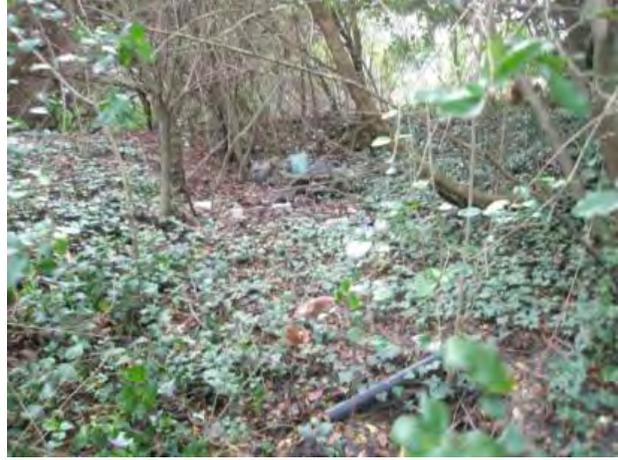
The riser and outlet pipe appear in good condition, although the outlet protection should be restored in conjunction with channel stabilization. (Figure 4)

Figure 4: BMP ponding area and riser (blue pipe in background)

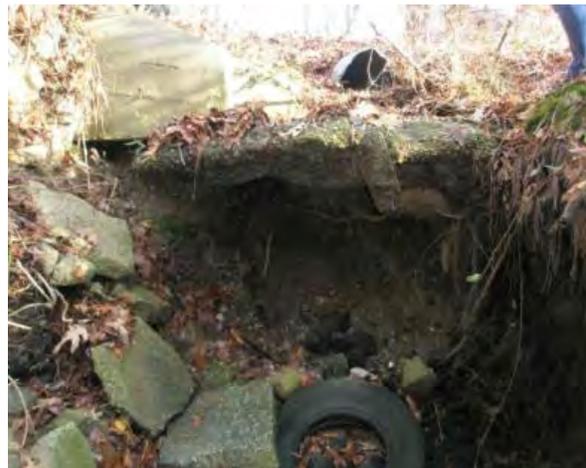
Figure 1: Outfall (end section, upper left)

Description: The Lancaster Middle School property includes a typical amount of impervious cover: a bus loop (Figure 1), teacher and visitor parking, and rooftop, all directly connected to a drainage system. The system outfall is hidden in the dense vegetation adjacent to the property and is undergoing significant erosion (Figure 2).

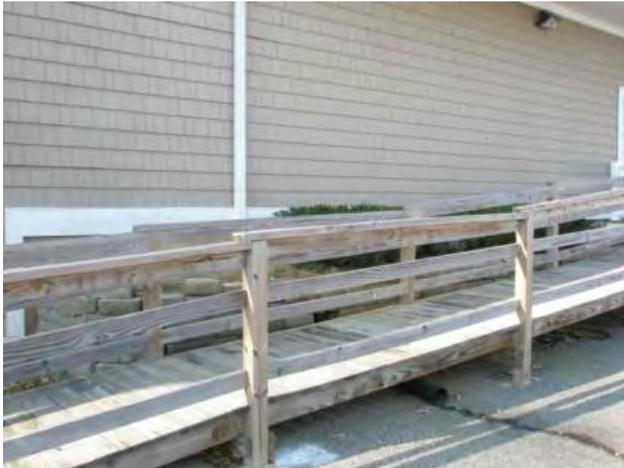
Figure 1: Left side of building downspout

Description: The Boys and Girls Club building on North Main Street is set in a large expanse of pavement that is shared with the adjacent property – more so than appears needed for parking demand (but it's unclear if the area is used temporarily for other purposes; Figure 3). There are two foundation planters in front of the building on either side of the front entrance: see Figure 1 and Figure 2 (planter in Figure 1 is partially hidden by the wooden ramp).

1) Redirect the downspouts located at each corner of the building into the foundation planters. The current downspout configuration includes piping to convey the roof water around, through, or under the planters (the downspout pipe is shown protruding from under the wooden ramp in Figure 1, and in Figure 2, it daylights where the two planter walls meet). This appears to be a very simple retrofit to redirect these downspouts into the existing planters. This type of practice is referred to as Urban Planters in the Virginia Stormwater BMP Design Specifications, primarily because they are suited for buildings in urban areas that may not have room for traditional bioretention.

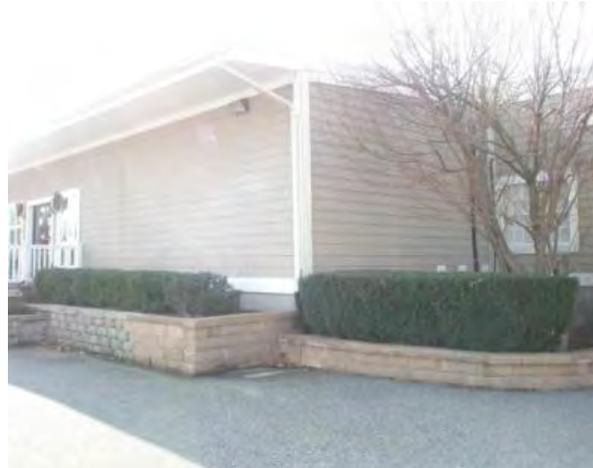
Figure 1: Right side downspout

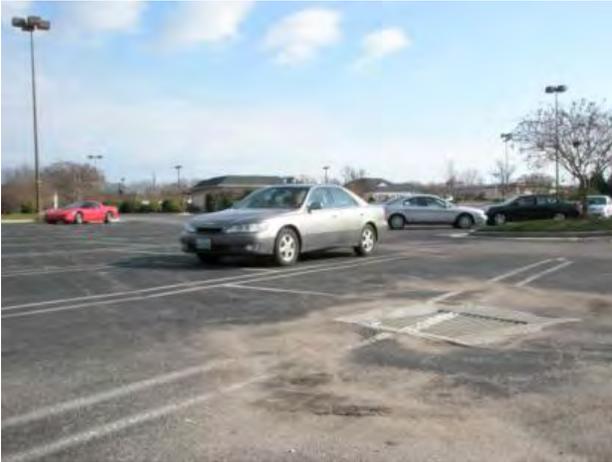
Figure 1: Typical parking lot inlet

Description: This shopping center has several tenants – Peebles appears to be the biggest. The entire front of the shopping center is a parking lot, approximately 3.6 acres, served by three drainage inlets. The shopping center rooftop is approximately 2 acres, and additional rooftop and parking for restaurants and a bank are located on the out parcels between the main parking lot and North Main Street (an additional 3 acres of impervious cover). There is also a large stormwater pond behind the shopping center. It is uncertain if this pond was designed to hold water (retention pond), or if it was intended to be a dry (extended detention) pond. In either case, there is evidence of erosion at one pipe outlet into the pond (the relatively small drainage from the rear loading dock) and sloughing on the side slopes in multiple locations. The combined effect of the internal erosion is the loss of storage volume (or pool volume if intended as a wet pond).

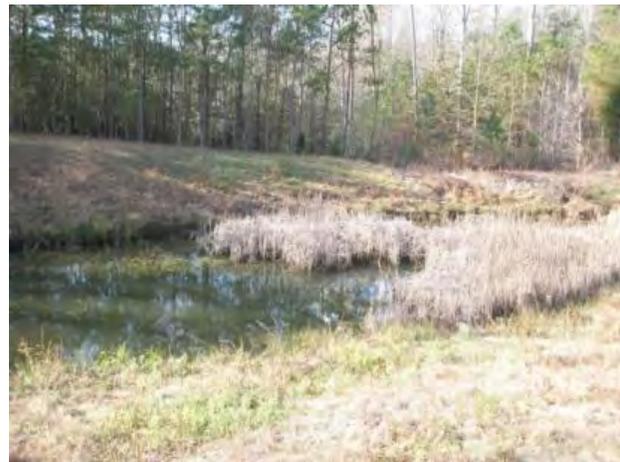
Figure 1: Stormwater basin behind shopping center

Proposed Retrofits: While the pond requires basic maintenance to fix the erosion, it appears to be functioning. A more rigorous analysis of the initial design and a survey of the current condition will verify if any dredging of the storage area is needed. Alternatively, installing bioretention retrofits in the front parking lot can possibly offset the loss in storage and provide an educational tool since it is a high traffic parking lot.
