# **Urban Stream Restoration Practices: An Initial Assessment**

## **Final Report**

Kenneth Brown  
Center for Watershed Protection  
8391 Main Street

**October, 2000**

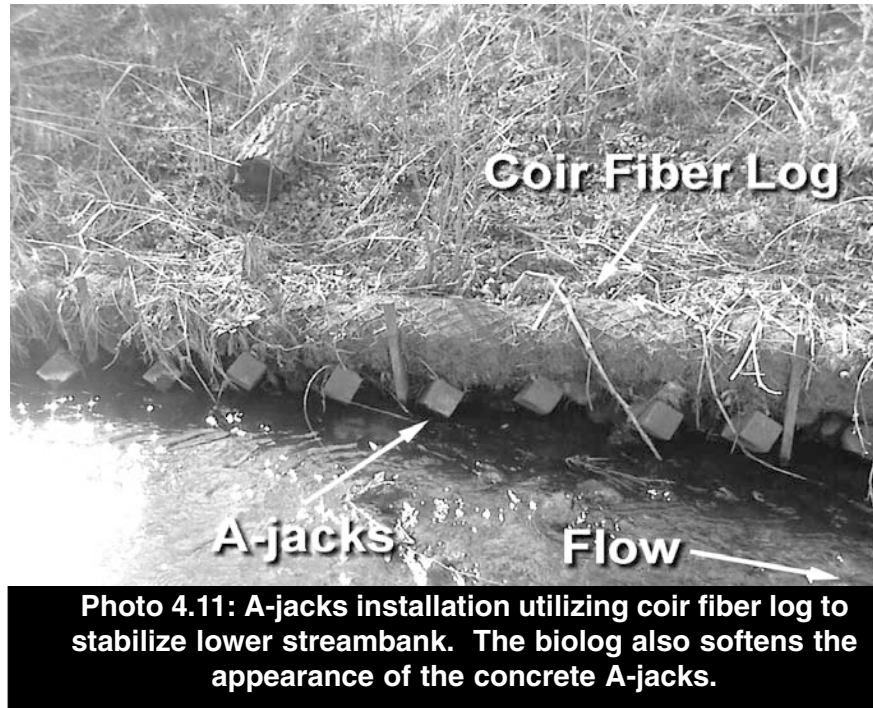
**Photo 4.11: A-jacks installation utilizing coir fiber log to stabilize lower streambank. The biolog also softens the appearance of the concrete A-jacks.**

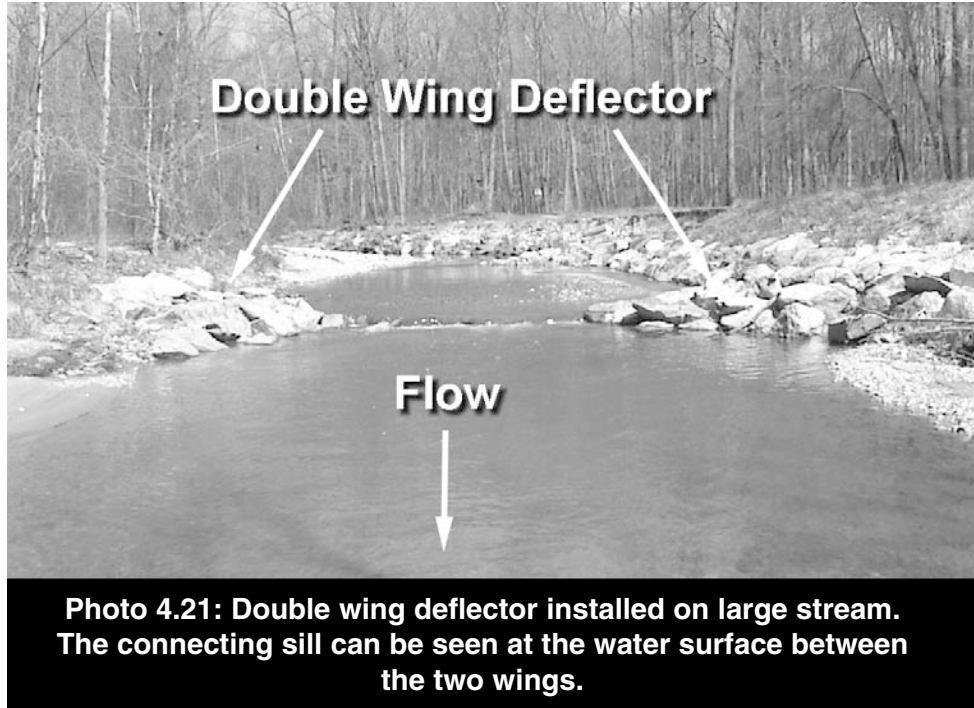
There were mixed results in terms of whether the practices achieved the design objective of flow deflection/concentration. Only two of the double wing deflectors fully met the design objective, and three partially did so (Figure 4.15). The only single wing deflector included in the assessment was found to fully meet the design objective of flow deflection/concentration. Photos 4.21 and 4.22 depict two of the double wing deflectors included in the assessment.

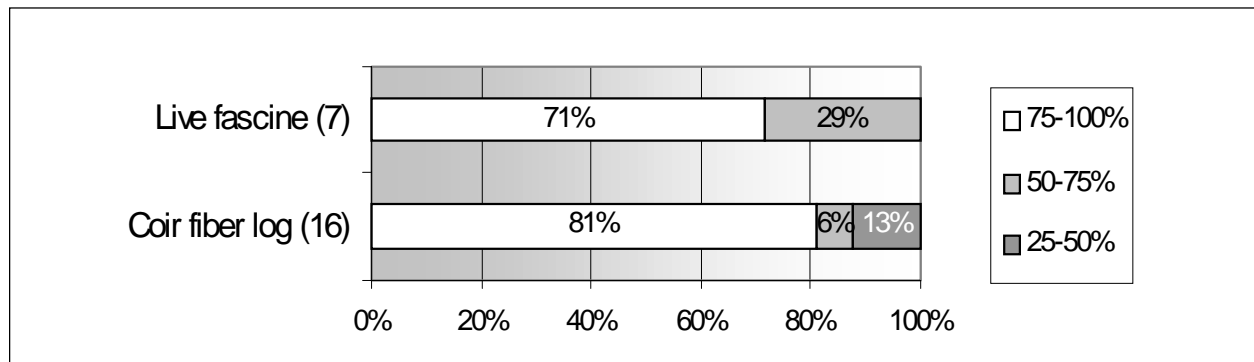
Thirteen of the 16 coir fiber log installations were found to be greater than 75% intact (Figure 4.19). The remaining coir fiber logs had lost 25 to 75% of their integrity. An intact coir fiber log was indicated by the presence of either a coir fiber log or by the decomposition of a log that had been replaced by plant materials serving the same function. Moderate or significant movement/dislocation or erosion/scour were all noted at three problem installations (Figure 4.20). Moderate sediment deposition was also observed at three installations, with the remaining 13 coir fiber log installations found to have experienced little or no sediment deposition. Only one of the 16 coir fiber log installations did not achieve the practice objective of bank stabilization, with six only partially achieving this objective (Figure 4.21). Photos 4.28 and 4.29 depict a typical coir fiber log installation.

Figure 4.19: Bank Stabilization - Percent of Original Practice Intact

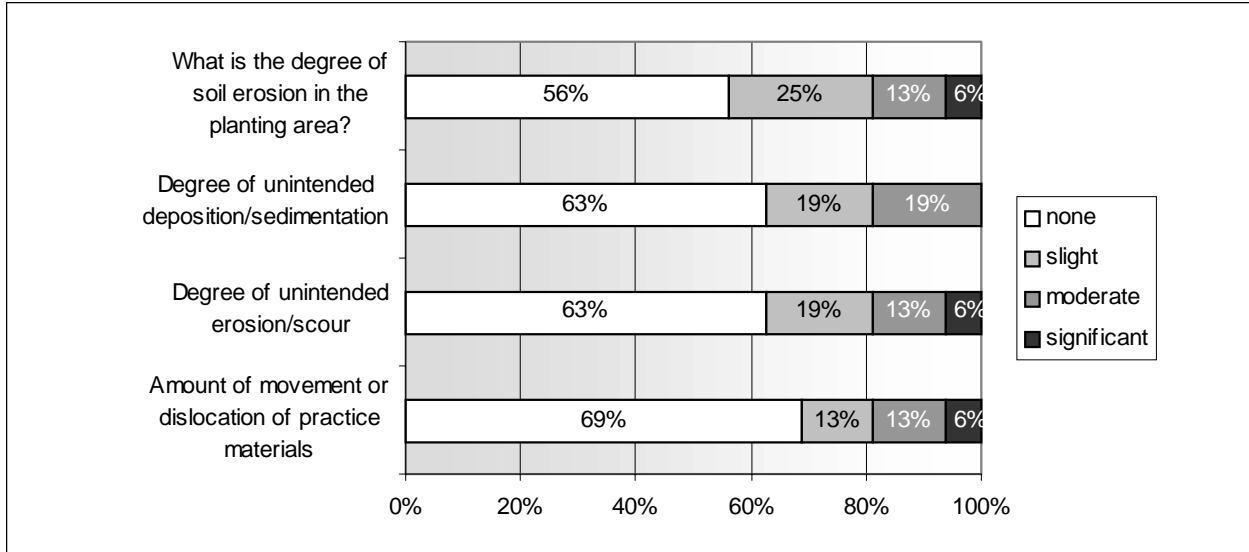
Figure 4.20: Bank Stabilization - Results of Coir Fiber Log Assessment

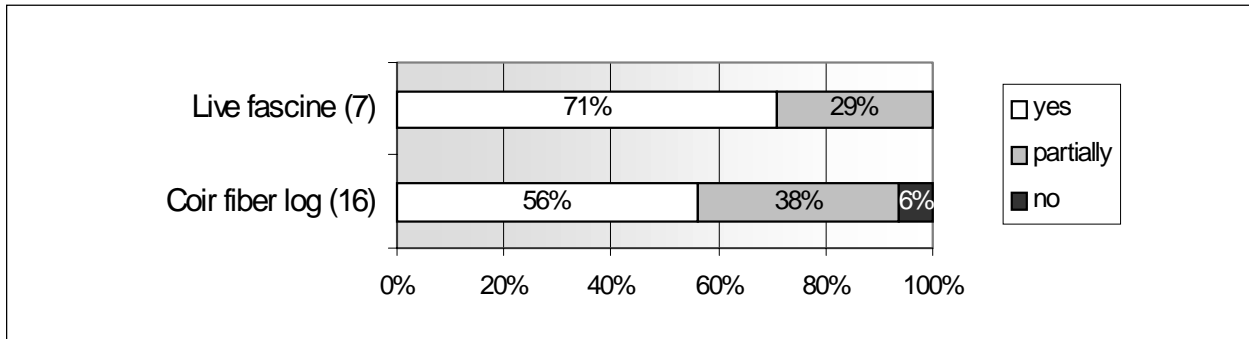
Figure 4.21: Bank Stabilization - Is the Practice Serving the Design Objective?

Seven live fascine installations were evaluated in the field. Although this is a rather small sample size, live fascines were generally found to be an effective practice for protecting the toe of streambanks, as well as for stabilizing soils higher up on the streambank. Over 70% of the live fascine installations were mostly intact (75 to 100%), with the remainder between 50% and 75% intact (Figure 4.19). No significant movement or displacement of the live fascines was noted (Figure 4.25). Two live fascine installations experienced slight or moderate erosion/scour. One live fascine application experienced slight sediment deposition. Overall, 70% of the live fascine installations fully achieved the design objective of bank stabilization, and the remainder partially achieved this objective (Figure 4.21).

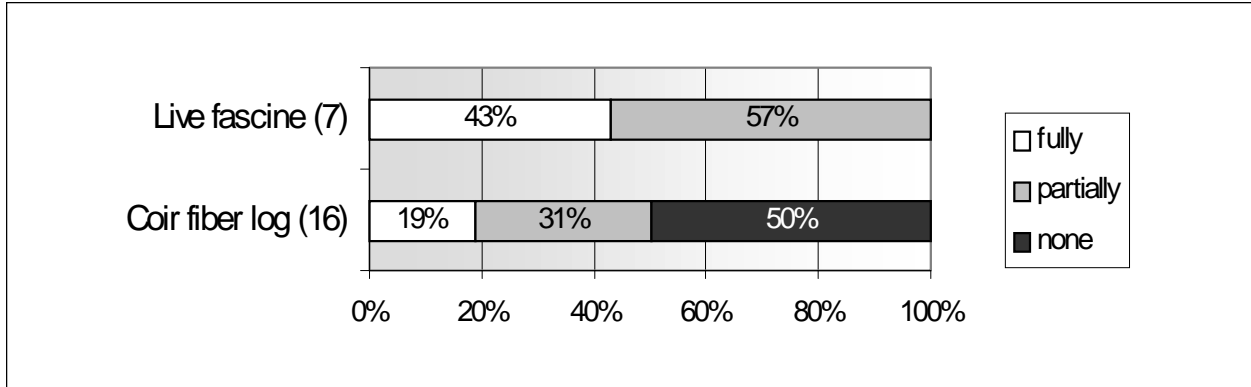
The habitat enhancement objective of a vegetated, stable streambank toe was fully or partially attained at only half of the coir fiber log installations (Figure 4.22). The remaining coir fiber log installations did not create a stable, vegetated streambank toe. This is indicated by only eight installations having 75 to 100% plant survival (Figure 4.23). Almost all of the coir fiber logs partially or fully stabilized the toe of the streambank, despite the relatively poor plant survival (Figure 4.24). However, it is not clear how long the streambank toe will remain stable once the poorly vegetated coir fiber logs decompose and leave the streambank unprotected and subject to erosion.

Figure 4.22: Bank Stabilization - Degree of Habitat Enhancement

slope. In these cases, fascines have less direct habitat enhancement potential. Fascines were observed to fully achieve their modest habitat potential at 43% of the installations, and to partially achieve it at 57% of the installations (Figure 4.22).

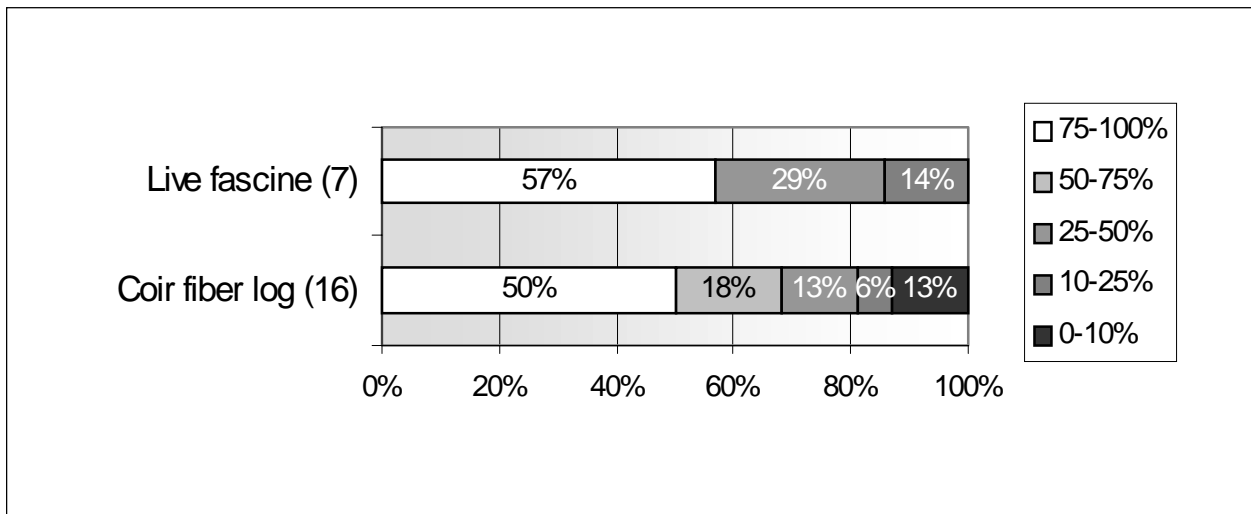
Figure 4.23: Bank Stabilization - What Percent of Plant Material Is Living?

Both rooting success and plant survival were mixed. More than half of the fascine installations achieved 75 to 100% plant growth and survival (Figure 4.23), but three installations encountered problems. Plant survival did not play a large role in whether or not the fascines met the design objective, but it did influence how much habitat was created. In general, the fascines that fully achieved their habitat enhancement potential had at least 75% plant survival. Some fascine installations had less than 50% plant survival, but still achieved their bank stabilization objective because of colonization by other plants (Figure 4.24).

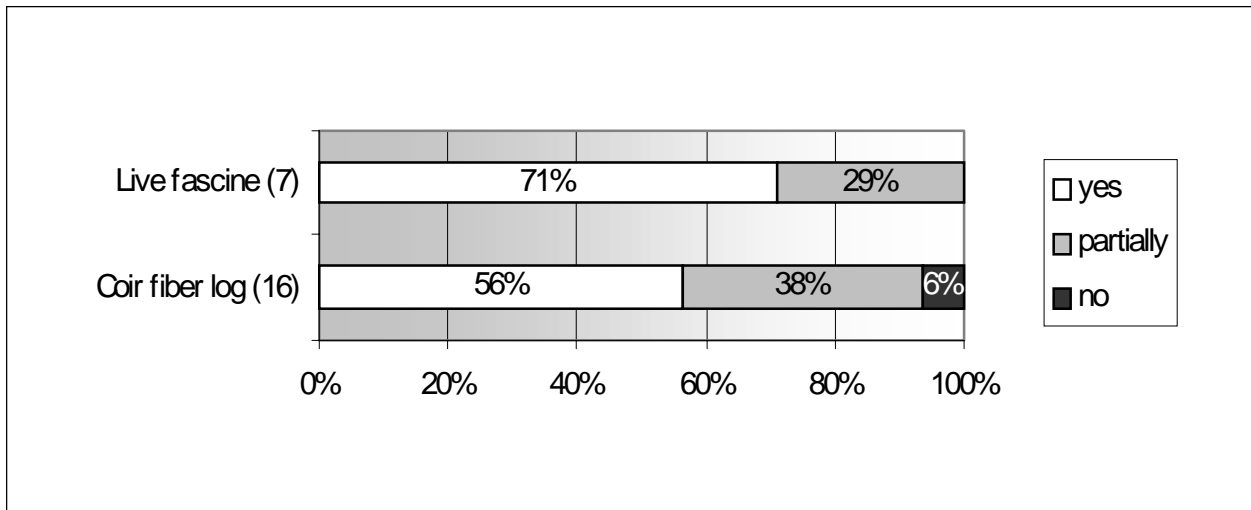
Figure 4.24: Bank Stabilization - Is the Practice Serving the Design Objective Regardless of Plant Survival?

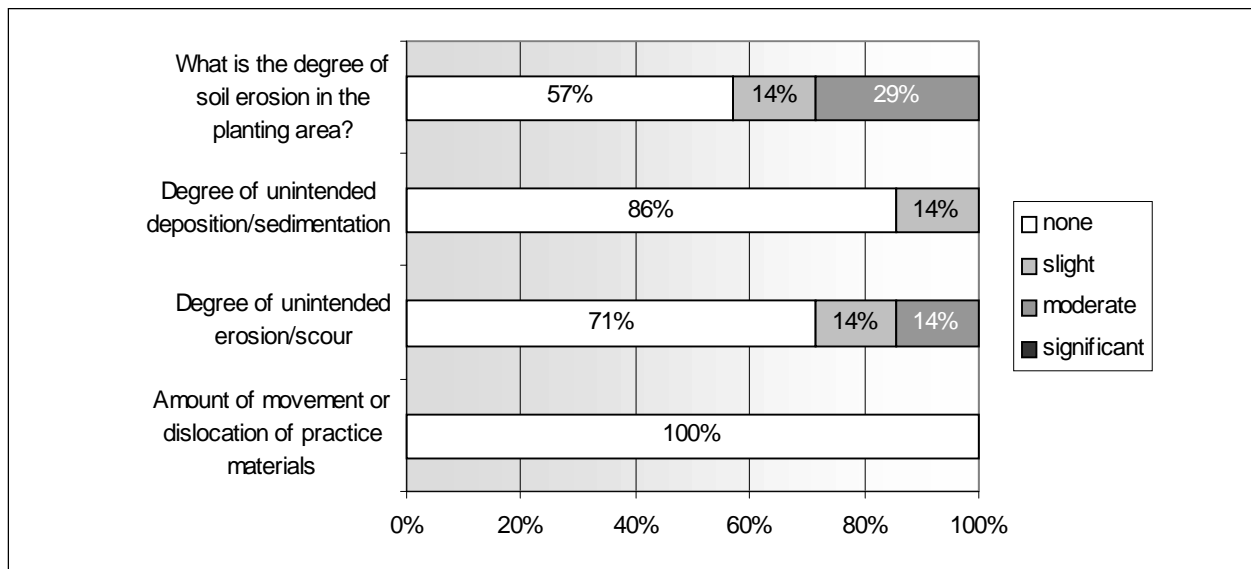
**Figure 4.25: Bank Stabilization - Results of Live Fascine Assessment**

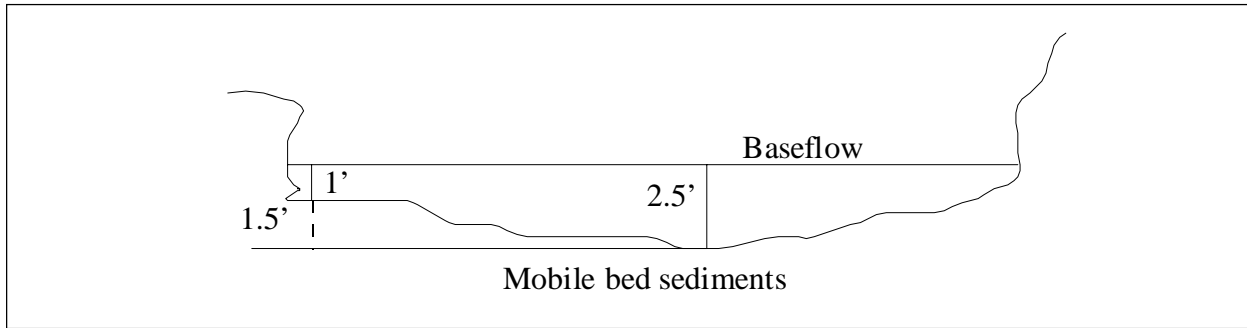
The primary reason for full or partial boulder revetment failure was scouring beneath the boulders. This problem was frequently encountered where large boulder revetments lacked footer rocks. Designers often fail to consider that the current stream channel invert may adjust in response to the restoration practice, thus creating the potential for bed scouring. This design issue is critical in streams that have highly mobile bed sediments (USDA, 1998b). The revetment boulders must extend down at least six inches below the expected depth of scouring. Detailed geomorphic and mathematical models exist to estimate the depth of potential scouring. However, in the absence of these models, there are some general rules of thumb that designers can use. For example, for revetments located on generally straight reaches with mobile bed sediments, the difference between the maximum channel invert (thalweg) at the revetment location and the water depth at the streambank toe is a good indication of the potential depth of scouring (Figure 5.1). For revetments located on meander bends, the maximum scour depth can be estimated by finding the greatest pool depth on similar radius meander bends in the same reach and ensuring the revetment extends a foot below this depth. Depth of scouring is less important in streams with less mobile bed sediments.

**Figure 5.1: Estimating the Potential Depth of Scour**
