SECTION 5: SUBWATERSHED MANAGEMENT PLANS

UPPER SUBWATERSHEDS

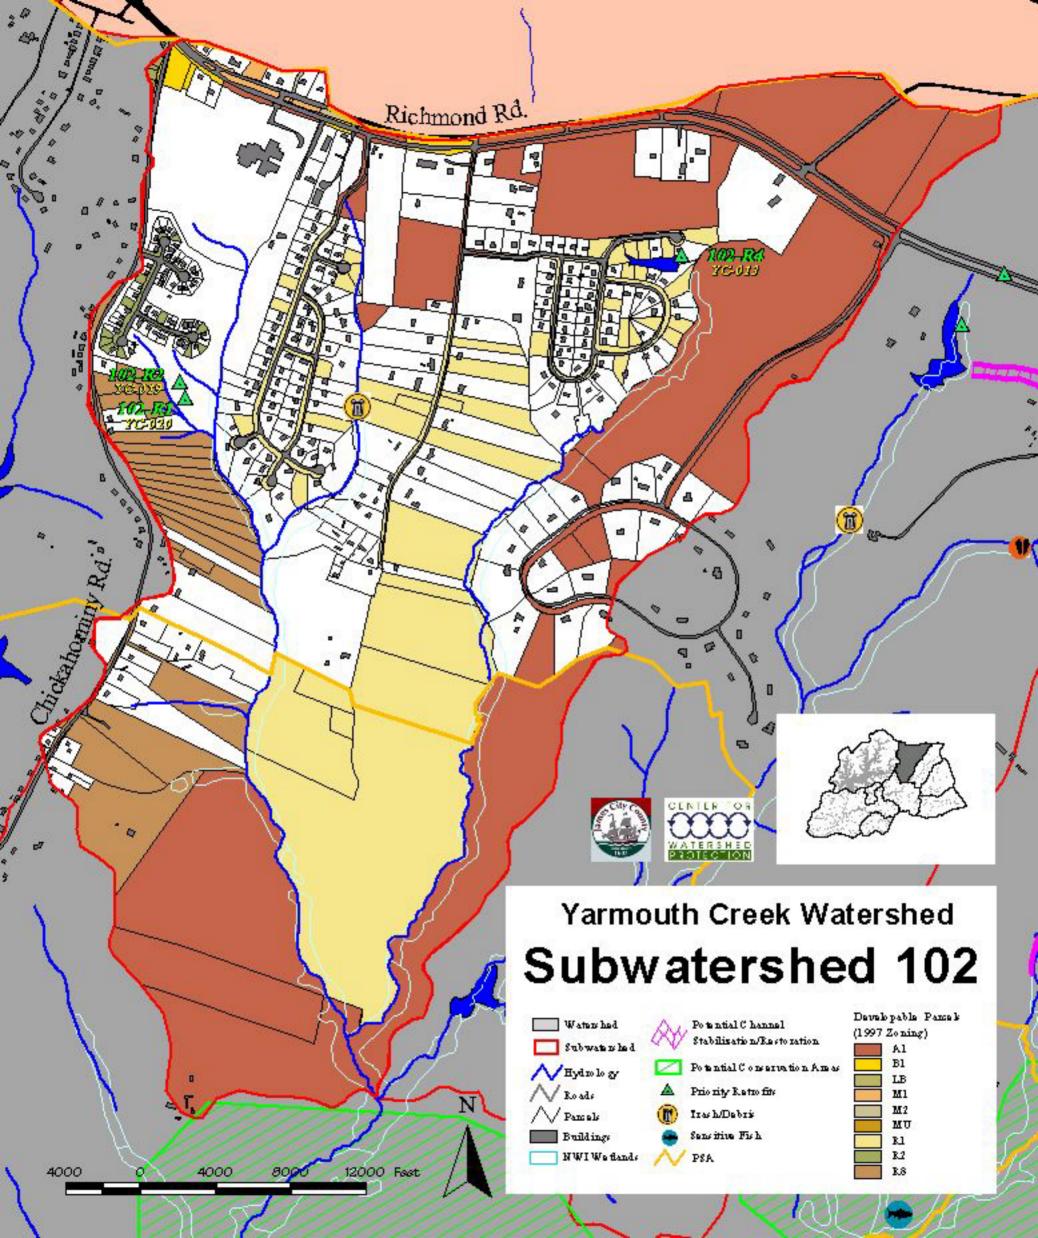
Subwatershed maps have also been created to accompany the text and serve as a blueprint for the protection and restoration of the Yarmouth Creek watershed. They also can be used as a tool in which to review future development projects, negotiate proffers, or review re-zoning requests. The maps contain priority conservation areas such as contiguous forest tracts, sensitive streams and locations of rare, threatened or endangered species. The maps also contain locations for priority retrofit sites, stream restoration and trash cleanups. Zoning is also included on the maps according to the categories as follows.

The watersheds are organized into the Upper and Lower Subwatersheds because of their physical proximity to each other and the ability to combine maps for the Lower watershed. The Upper subwatersheds include Subwatersheds 102,103,104, 105 and Little Creek Reservoir. The Lower subwatersheds include Subwatersheds 101, 102, Non-tidal Mainstem and Tidal Mainstem.
